Final Report Geophysical Survey Compilation and Re-evaluation of Previous Survey Data Fort Monmouth, Oceanport, NJ Enviroscan Project Number 111019

Prepared for: US Army, Fort Monmouth Prepared By: Enviroscan, Inc. March 10, 2011

Compilation and Re-evaluation of Previous Survey Data

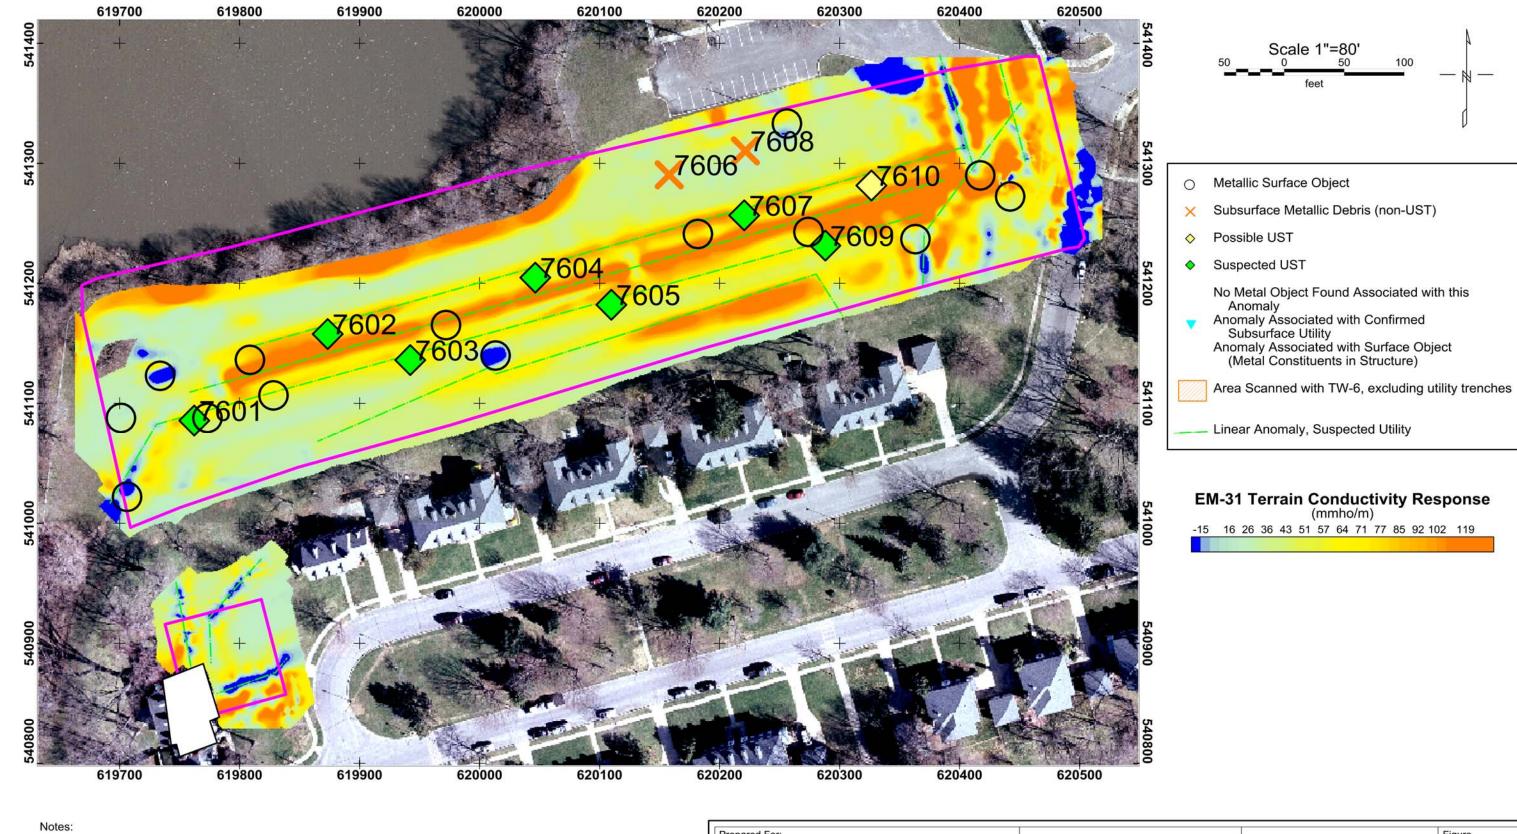
Main	el 76 Base mouth, NJ	76 B
Project Number 111019 Original 060706d	Survey Ending Date: 08/18/08	Drawn By: WES
Original Scale 1"=80'	Revision/Issue: 12/03/10 Original 10/28/08	Approved By: FKB

Note: During the data re-evaluation (100814), Enviroscan was tasked with confirming that an eighth UST located near Anomaly 7610 (Figure 76 B), not found during the ECP survey, was in-fact no longer present. Enviroscan employed an EM-61 to scan the area directly adjacent to the suspected location of the UST. The results of that scan are depicted in Figure 76 D. The results show only anomalies consistent with utilities. As a visual comparison, Enviroscan also scanned several known suspected USTs to compare the resulting anomalies with the area scanned for Anomaly 7610. The target 7610 classification will remain a possible UST due to the close proximity of the utilities to the possible UST location.
