U.S. Army - Fort Monmouth

Volume 2B - Building Reports for a Comprehensive Asbestos Survey in Various Buildings at Fort Monmouth, New Jersey

May 1993

Roy F. Weston, Inc. West Chester, Pennsylvania 19380

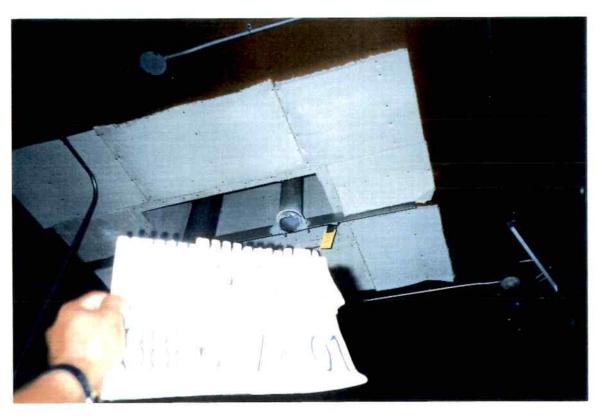
Ceiling insulation (exhaust flue) was the material in Building 2542 found to be ACM.

Bldg. 2542 Storehouse Ceiling: (Sample FK930) Ceiling (Furnace Exhaust Opening) Insulation Tested Positive

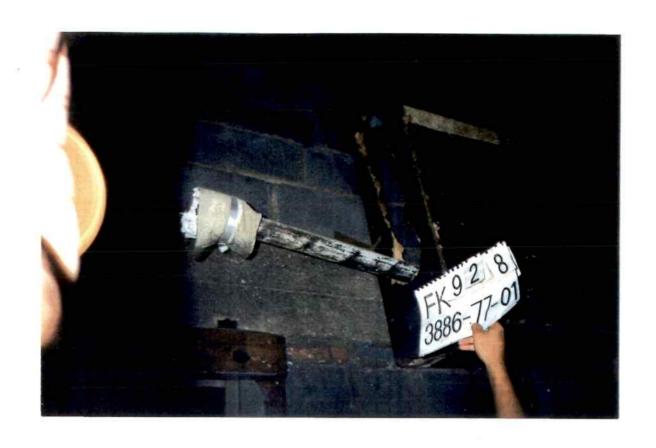
- Pipe insulation (abandoned pipe) was the material in Building 2543 found to be ACM.
- The ACM listed above should be labeled under the O&M Program.

Bldg. 2543 Storage Room: (Sample FK928) Abandoned <4" Pipe Run Insulation Tested Positive

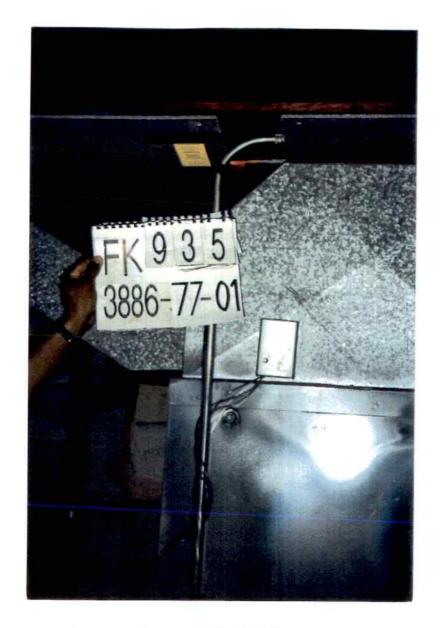
Bldg. 2564 Mech. Room: (Sample FK935) Transite Panel Located Above Furnace Tested Positive

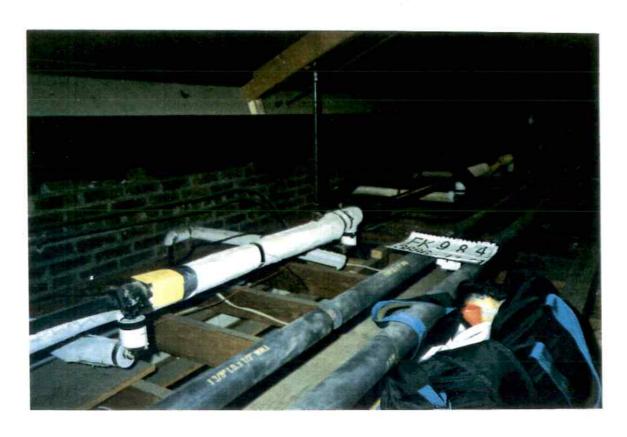
Bldg. 9006 Attic: (Sample(s) FK984 and 985) <4" Pipe Run and Fitting Insulation Tested Positive

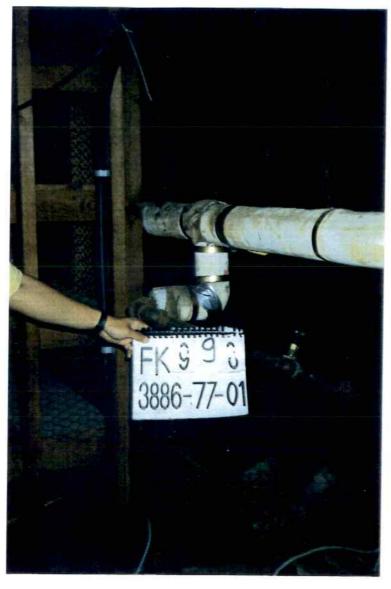
Bldg. 9027 Attic: (Sample FK998 and 999) 4"-8" Pipe Run and Fitting Insulation Tested Positive

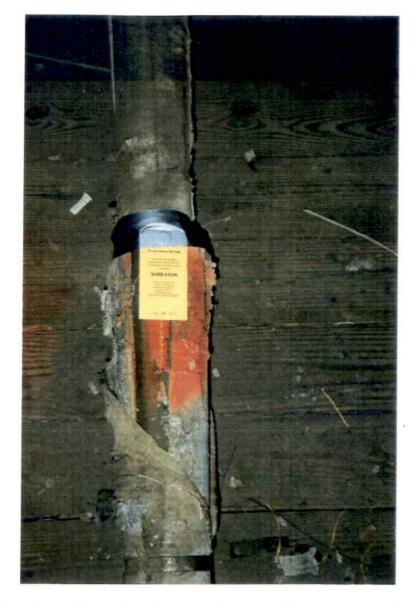
Bldg. 9027 Attic: (Sample HF500) 4"-8" Pipe Run Insulation Located at the Floor Level of the Attic and Tested Positive

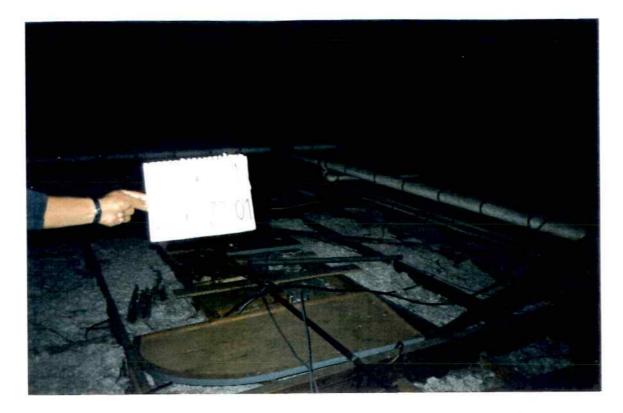
Bldg. 9029 Attic: (Sample(s) FK991 and 992) 4"-8" Pipe Run and Fitting Insulation Tested Positive

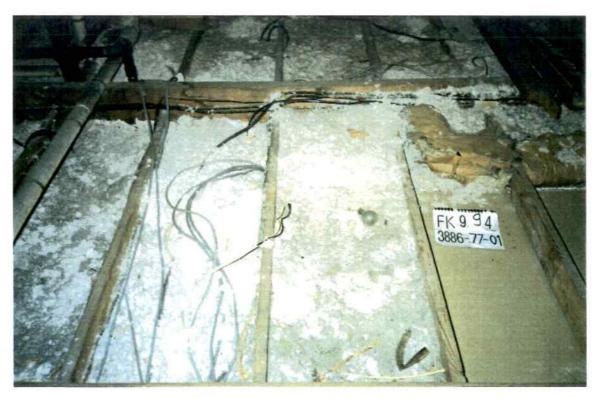
Bldg. 9029 Attic: (Sample FK994) Attic Insulation Tested Positive

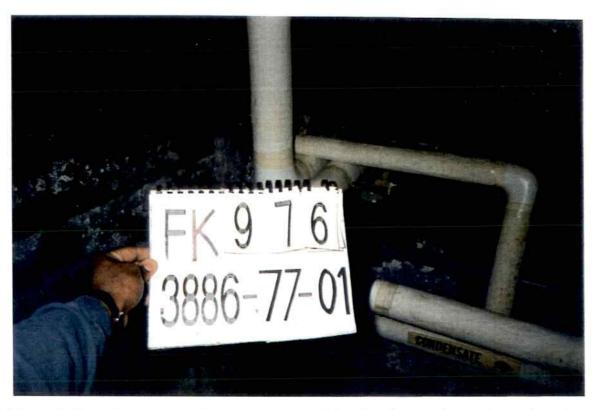
Bldg. 9035 Pipe Tunnel: (Sample FK976) 4"-8" Pipe Run Insulation Located in the (Pipe) Tunnel Tested Positive

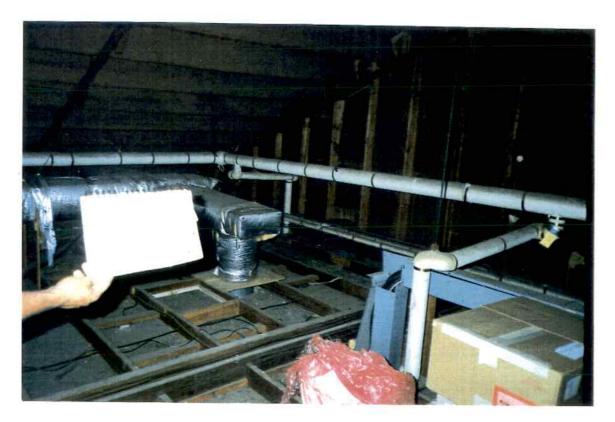
Bldg. 9043 Attic: (Sample(s) FK955 and 956) 4"-8" Pipe Run and Fitting Insulation Tested Positive

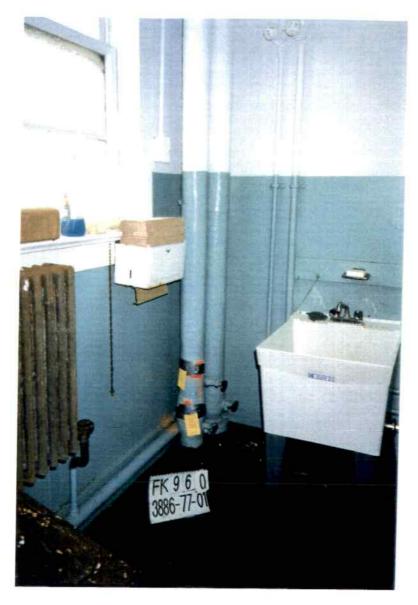
Bldg. 9044 Room 11, Men's Room: (Sample(s) FK960 and 961) 4"-8" Pipe Run and Fitting Insulation Tested Positive

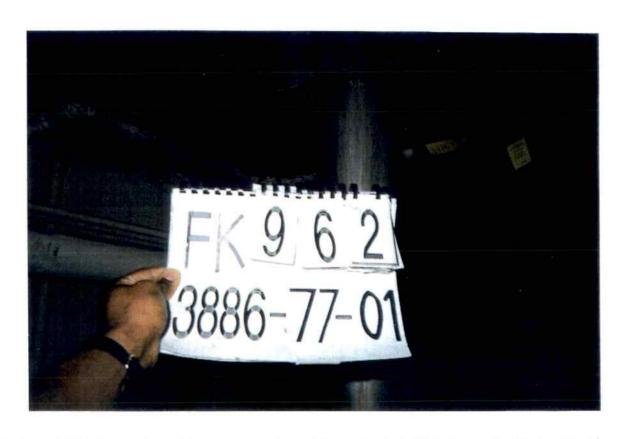
Bldg. 9044 Room 5A, Upper Level: (Sample(s) FK962 and 963)<4" Pipe Run and Fitting Insulation Tested Positive

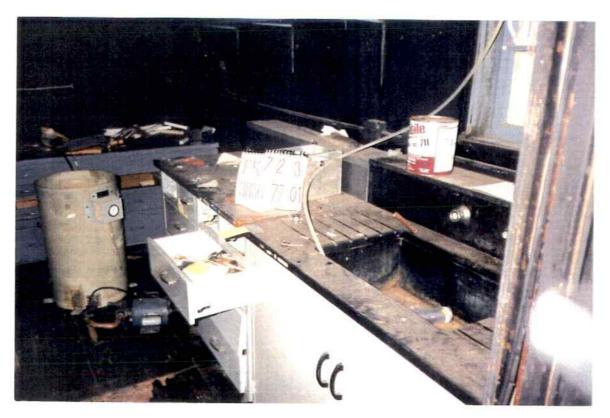
Bldg. 9049 Laboratory, 1st Floor: (Sample(s) FK723 and 724) Lab Table Top and Gloves (in the Drawer) were Tested Positive

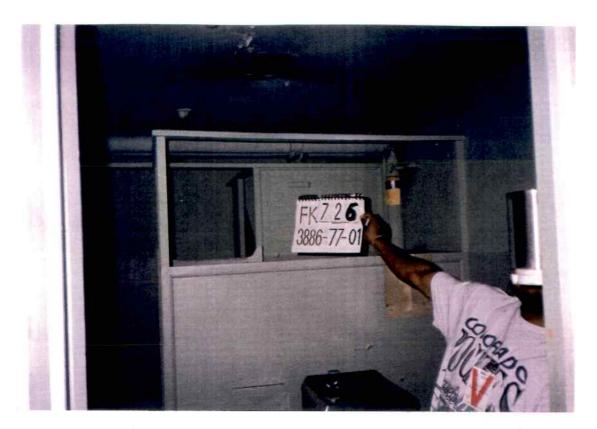
Bldg. 9049 Latrine: (Sample FK726) <4" Pipe Run Insulation Tested

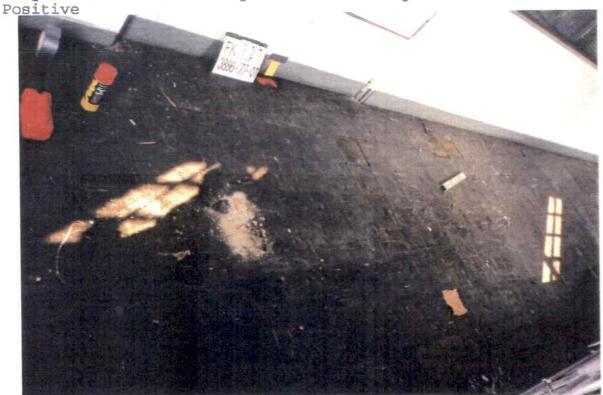
Bldg. 9049 2nd Floor Area: (Sample FK727) 9" x 9" Black Floor Tile Tested Positive

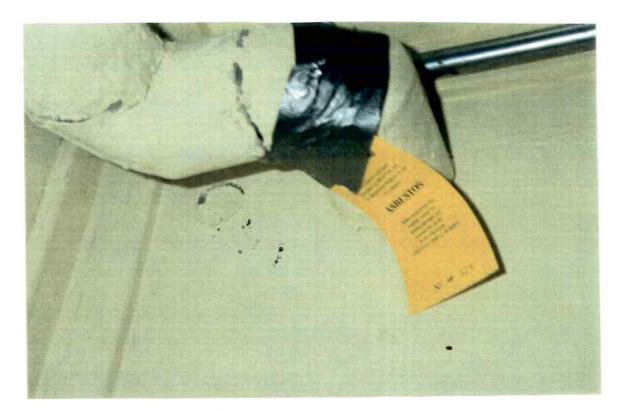
Bldg. 9059 Area 2, Along the Ceiling: (Sample HF528) <4" Pipe Fitting Insulation Tested Positive

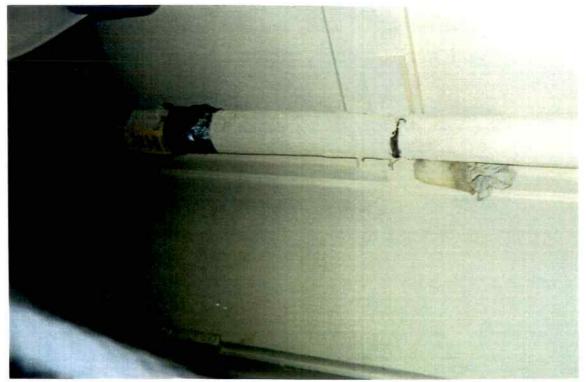
Bldg. 9059 Ladies Room: (Sample HF529) <4" Pipe Run Insulation Tested Positive

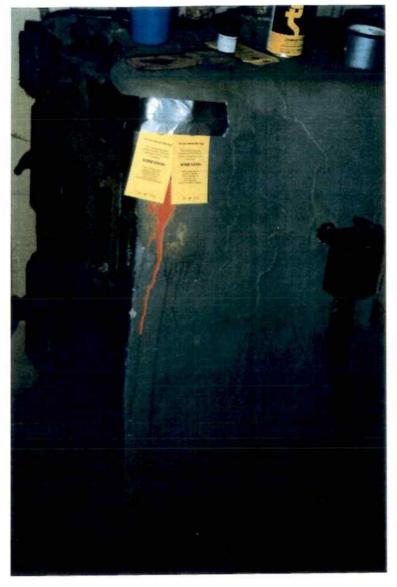
Bldg. 9080 Basement, Mech. Room: (Sample(s) HF508 and 509) Boiler Insulation Tested Positive

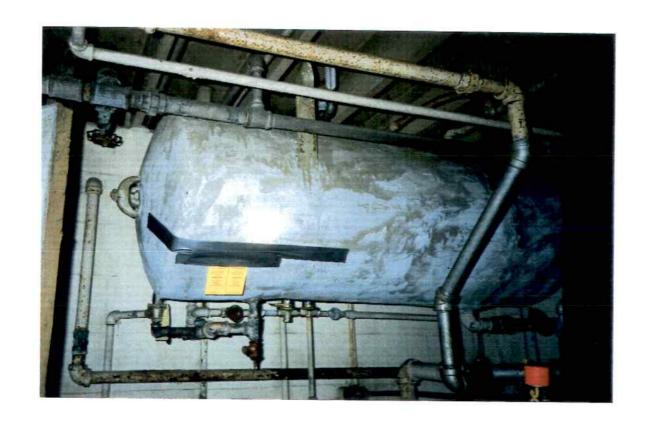
Bldg. 9080 Basement, Mech. Room: (Sample(s) HF510 and 511) Tank Insulation Tested Positive

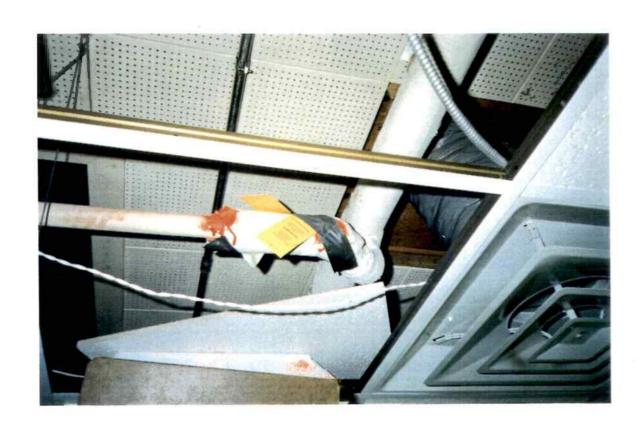
Bldg. 9086 Office Area, Above Ceiling: (Sample(s) HF501 and 502) <4" Pipe Run and Fitting Insulation Tested Positive

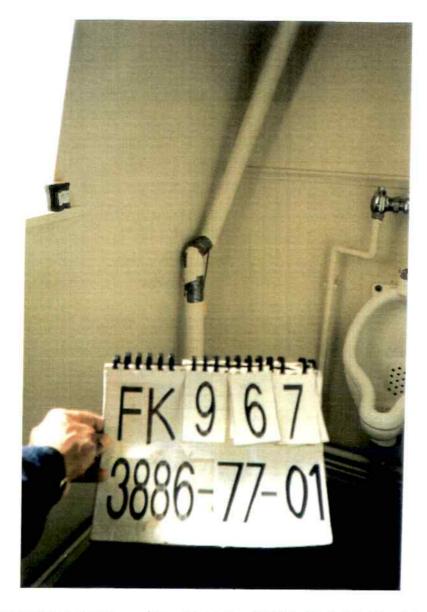
Bldg. 9089 Men's Room: (Sample(s) FK967 and 968) <4" Pipe Run and Fitting Insulation

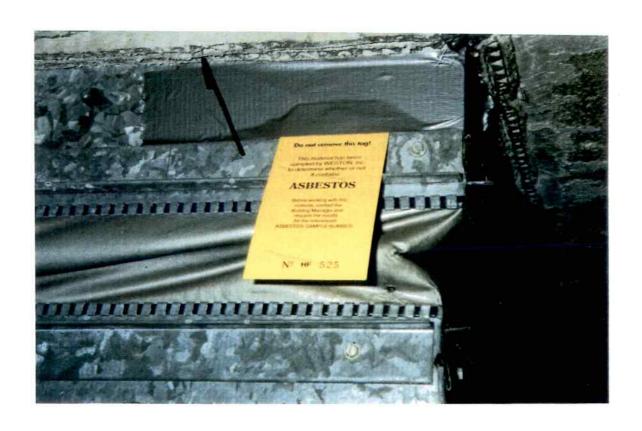
Bldg. 9116 Mech. Room, Ceiling Opening: (Sample HF525) Duct Opening Insulation Tested Positive

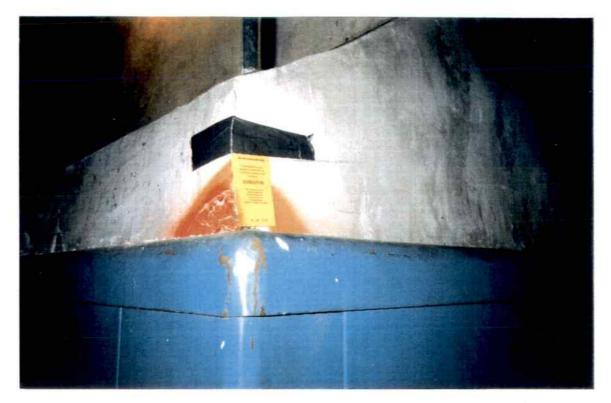
Bldg. 9162 Mech. Room: (Sample HF504) Duct Insulation Tested Positive

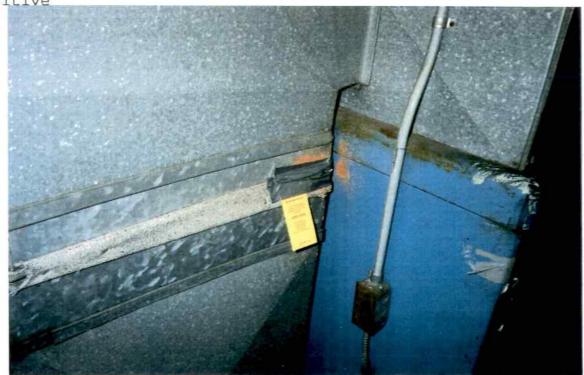
Bldg. 9162 Mech. Room: (Sample HF505) Expansion Cloth Tested Positive

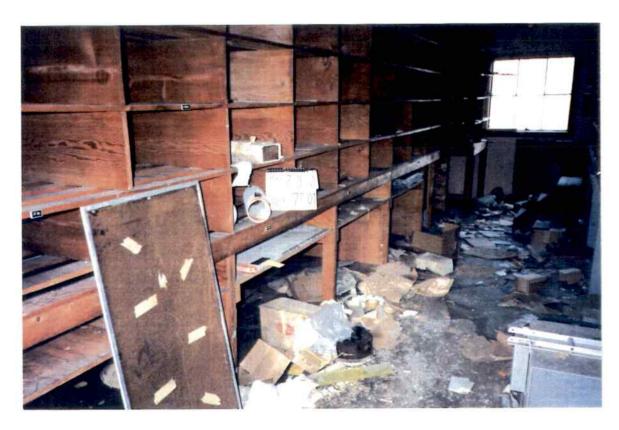
Bldg. 9312 Storage Area: (Sample(s) FK730 and 731) Asbestos Pipe and Transite Panel Tested Positive. Asbestos Cloth was also Found in this Area.
