### **U.S. Army - Fort Monmouth**

Volume 2A - Building Reports for a Comprehensive Asbestos Survey in Various Buildings at Fort Monmouth, New Jersey

Contract Number DACA51-91-D-0028

May 1993

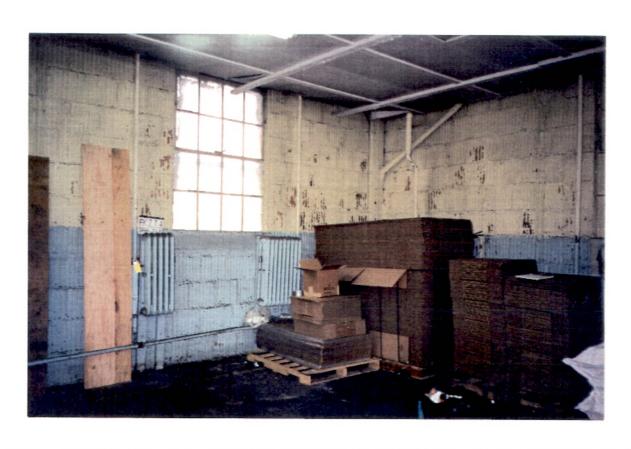
142.4

- Asbestos-containing pipe insulation and floor tile are present in the building.
- The pipe insulation located in the warehouse area of Building 142 qualifies for the Army Asbestos Deficiency Abatement Project (AADAP).
- Asbestos-containing floor tile should be labeled under the O&M Program.

Bldg. 142 Warehouse: (Sample FK774) <4" Pipe Run Insulation Tested Positive

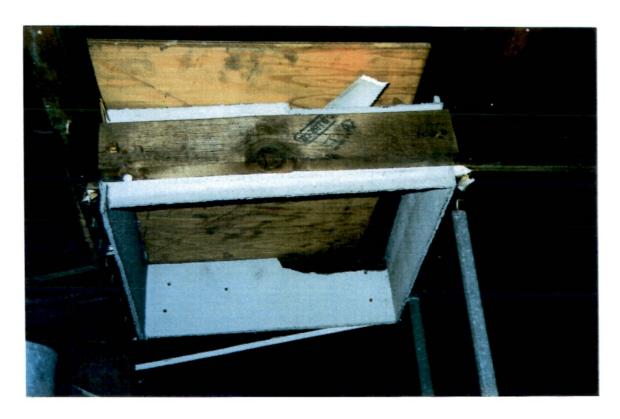
161.4

- Per the Directorate of Engineering and Housing (DEH), Building 161 is scheduled for demolition.
- The ACMs present in Building 161 are:
  - Floor tile
  - Linoleum flooring
  - Transite panel
  - Exhaust flue insulation
- The ACMs listed above shall be removed under the Army Asbestos Deficiency Abatement Project (AADAP) prior to demolition of Building 161; however, in accordance to the latest revisions of the National Emission Standard for Hazardous Air Pollutants (NESHAPs, 40 CFR Part 61, Subpart M, 20 November 1990), the floor tile and linoleum flooring can be left in place during demolition provided they are in good condition and will not become friable during demolition.

Bldg. 161 Garage: (Same HF520) Transite Panels Tested Positive

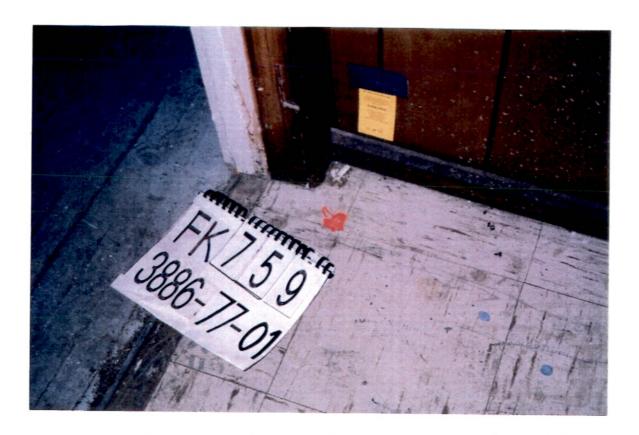
- Floor tile and transite panel in Building 165 were found to be ACM.
- Asbestos-containing floor tile and transite panel should be labeled under the O&M Program.

Bldg. 165 Office: (Sample FK759) 12" x 12" Tan Floor Tile Tested Positive

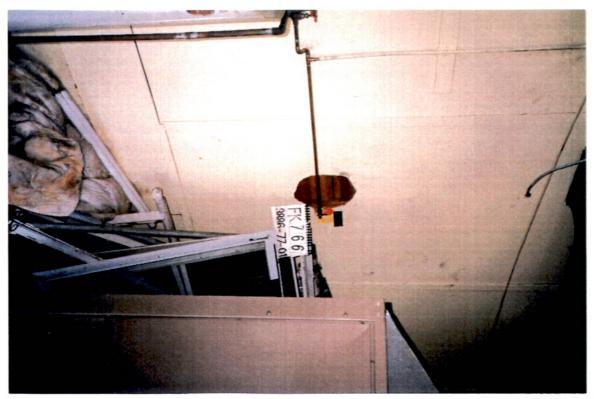
Bldg. 165 Mech. Room: (Sample FK766) Transite Wall and Ceiling Panels Tested Positive

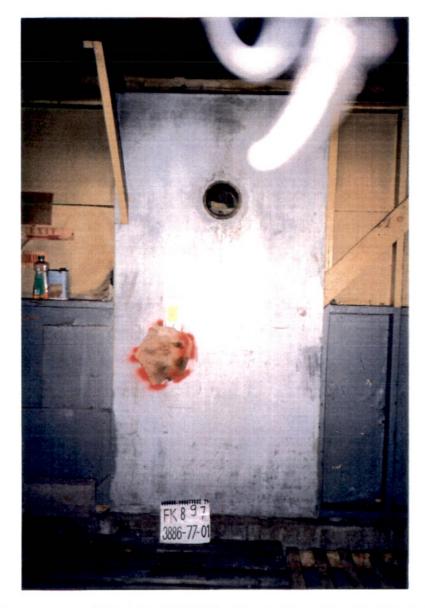
# 171.4

- Transite panel was the material in Building 171 found to be ACM.
- The storage area in Building 171 qualifies for the Army Asbestos Deficiency Abatement Project (AADAP).

Bldg. 171 Storage: (Sample FK897) Transite Panel Tested Positive

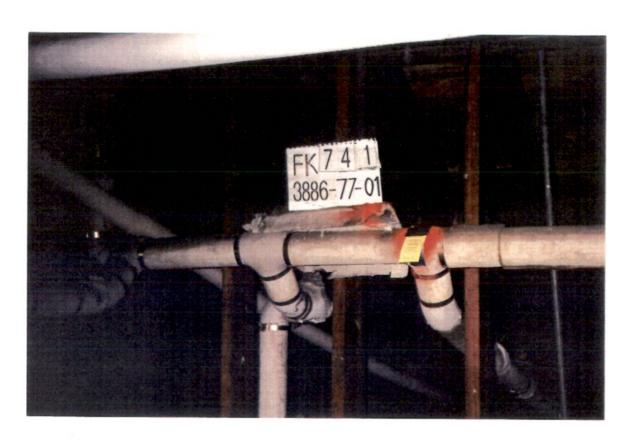
Bldg. 275 Attic: (Sample FK741) 4"-8" Pipe Run and Fitting Insulation Tested Positive

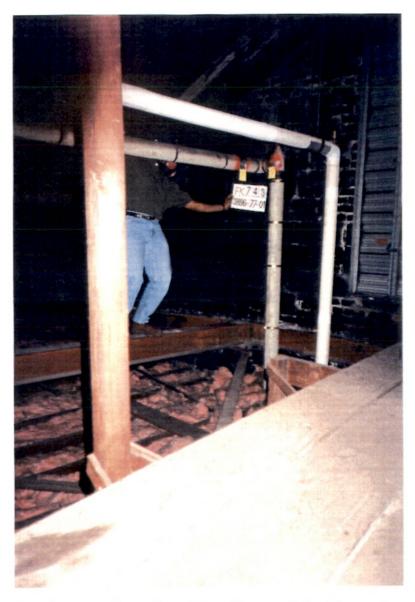
Bldg. 275 Attic: (Sample FK743) 4"-8" Pipe Run and Fitting Insulation Tested Positive

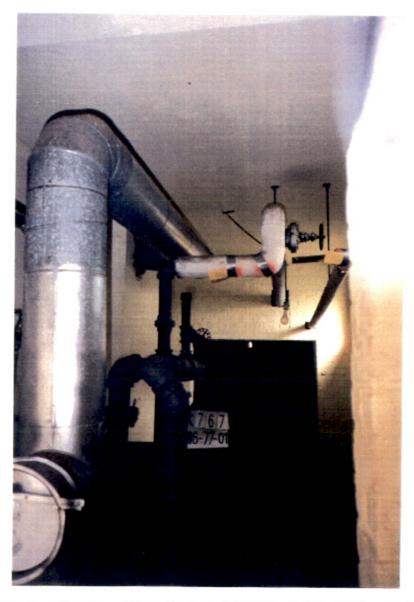
Bldg. 276 Mech. Room: (Sample(s) FK767, 768, 769, and 770) <4" and 4"-8" Pipe Runs and Fittings Insulation Tested Positive

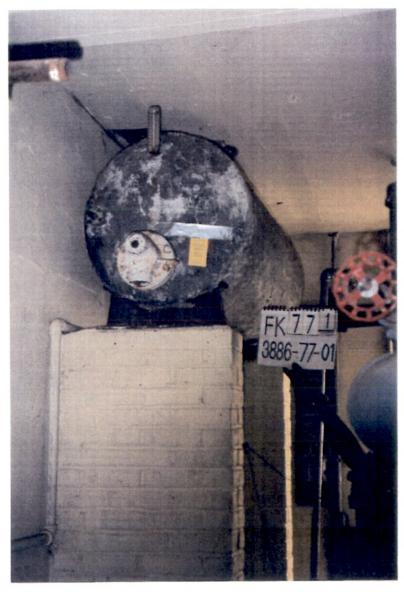
Bldg. 276 Mech. Room: (Sample FK771) Tank Insulation Tested Positive

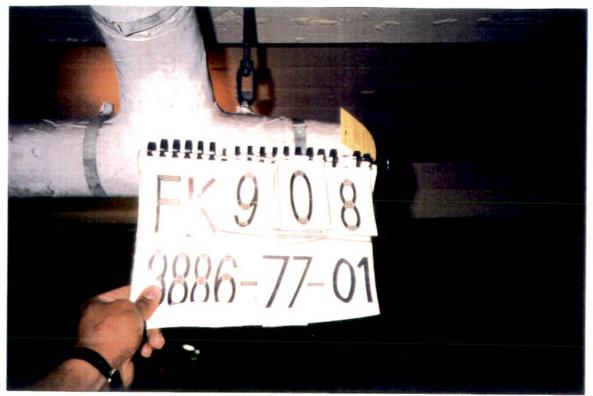
Bldg. 277 Boiler Room, Material Storage: (Sample(s) FK908 and 909) <4" Pipe Run and Fitting Insulation Tested Positive

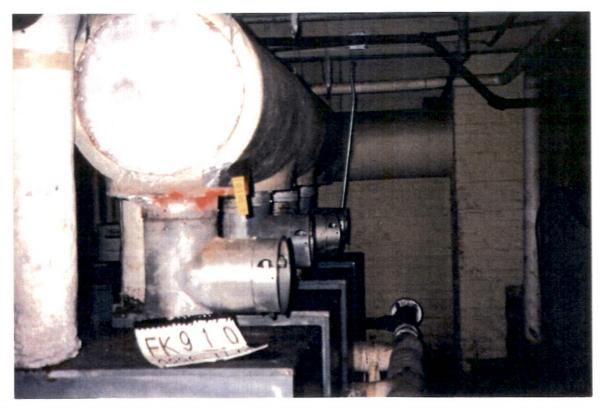
Bldg. 277 Boiler Room: (Sample FK910) Boiler(s) Breeching Insulation Tested Positive

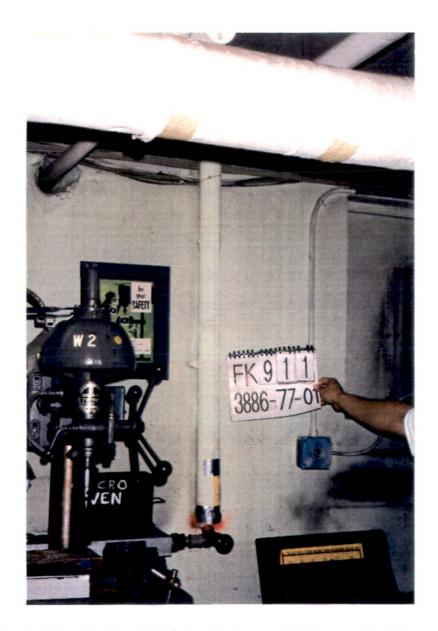
Bldg. 277 Small Arms Repair Shop: (Sample FK911) <4" Pipe Run Insulation Tested Positive

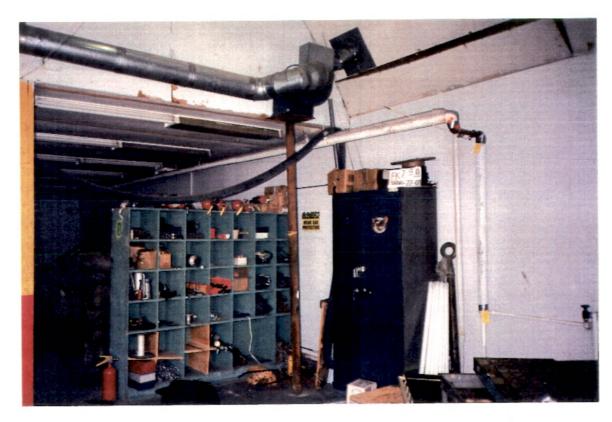
294.4

Bldg. 294 Garage 1: (Sample(s) FK790 and 791) <4" Pipe Run and Fitting Insulation Tested Positive

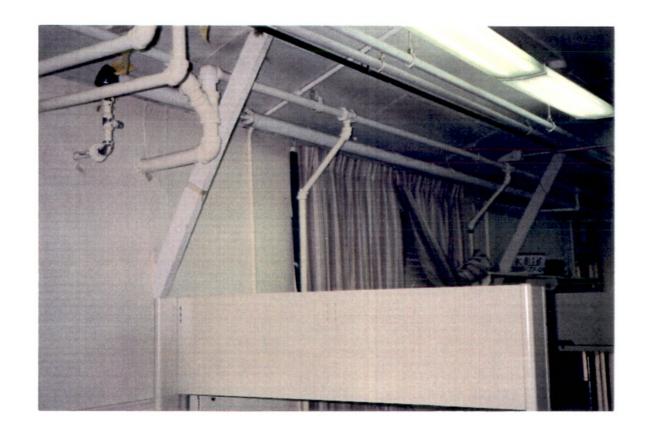
434.4

Bldg. 434 Open office Area: (Sample(s) FK816 and 817) <4" Pipe Run and Fitting Insulation Tested Positive

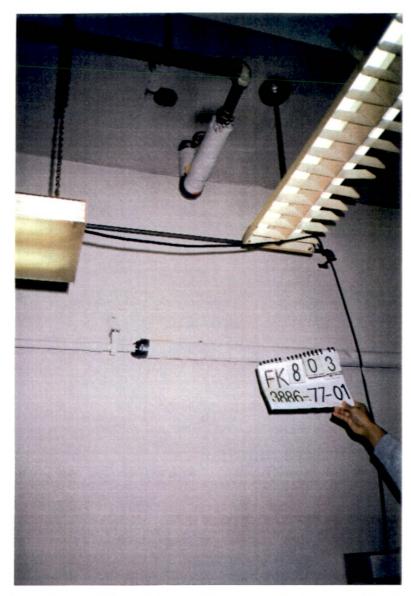
483.4

Bldg. 483 Office 1: (Sample(s) FK803 and 804) <4" Pipe Run and Fitting Insulation Tested Positive

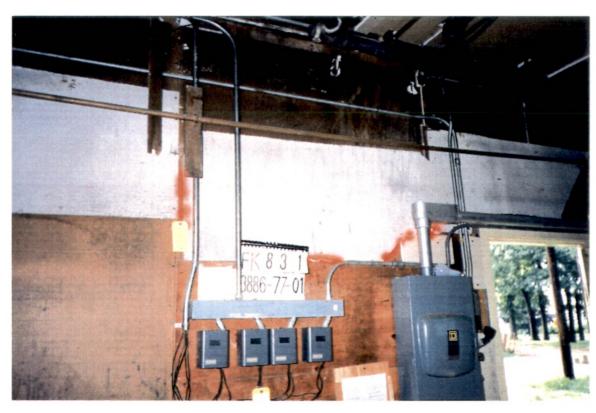
545.4

Bldg. 545 Mech. Room: (Sample FK831) Transite Panel Tested Positive

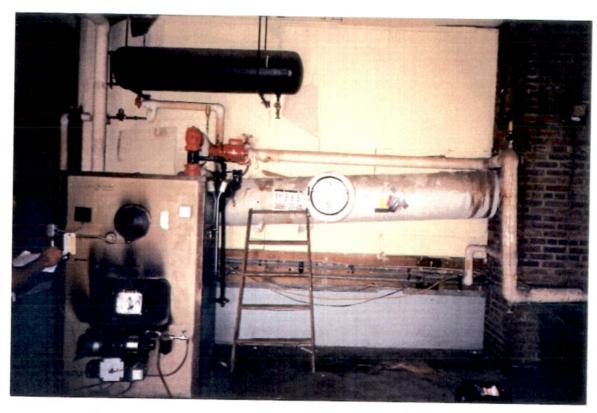
563.4

Bldg. 563 Boiler Room: (Sample FK885) Breeching Insulation (9"-14" Dia.) Tested Positive

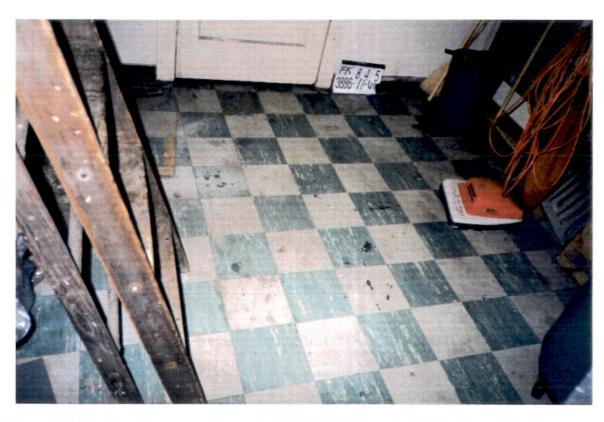
695.4

Bldg. 695 Mech. Room: (Sample(s) FK845 and 846) 9"  $\times$  9" Green and Gray Floor Tiles Tested Positive

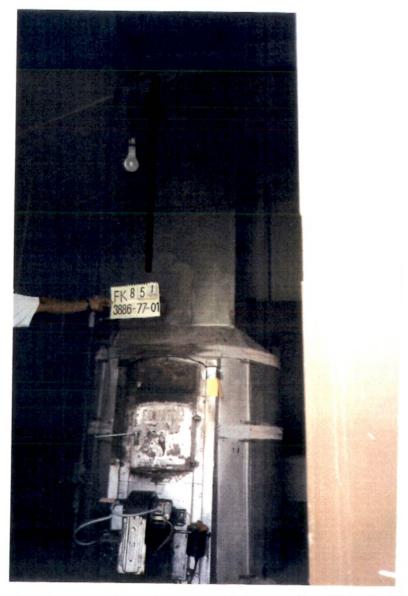
# 701.4 PHOTOGRAPH

Bldg. 701 Mech. Room: (Sample FK851) Transite Panel (Located Above the Furnace) Tested Positive

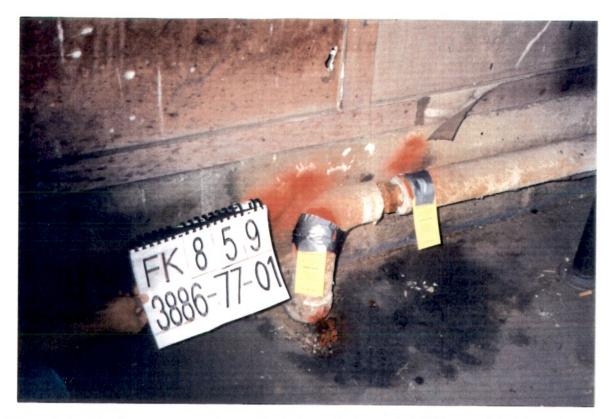
Bldg. 866 Mech. Room: (Sample(s) FK859 and 860) 4"-8" Pipe Run and Fitting Insulation Tested Positive

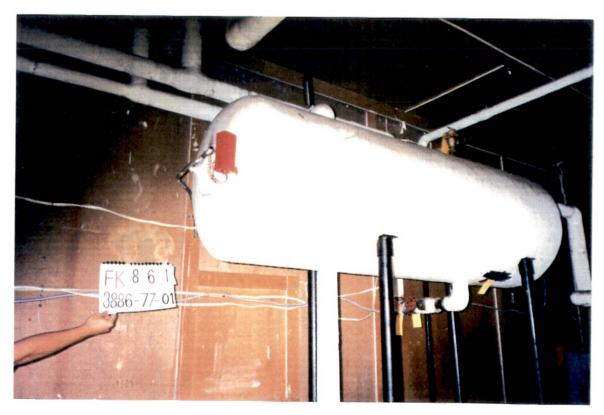
Bldg. 866 Mech. Room: (Sample(s) Fk861) Tank Insulation Tested Positive

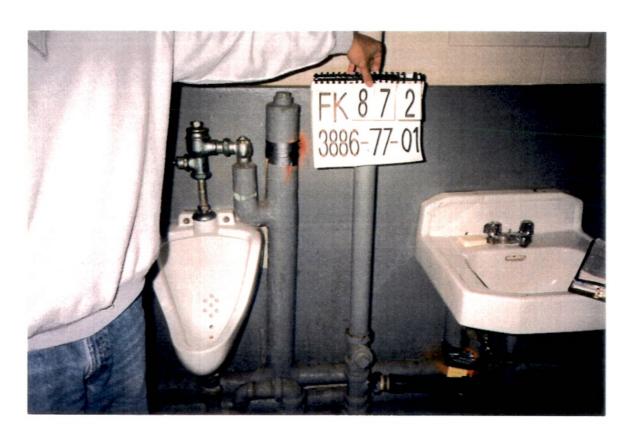
976.4

Bldg. 976 Public Bathroom: (Sample(s) 872 and 873) <4" Pipe Run and Fitting Insulation Tested Positive

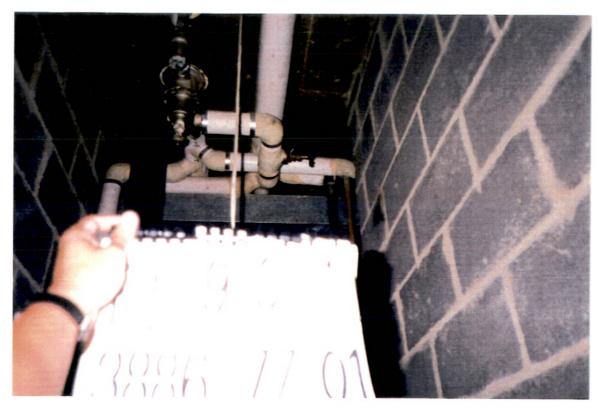
977.4

Bldg. 977 E. Wing Pipe Galley: (Sample(s) FK901 and 902) <4" Pipe Run and Fitting Insulation Tested Positive
