***Volume III - Building Reports for a
Comprehensive Asbestos Survey
in Various Buildings at
Fort Monmouth, New Jersey***

Contract Number DACA61-91-R-0039

January 1993

Roy F. Weston, Inc.
West Chester,
Pennsylvania 19380

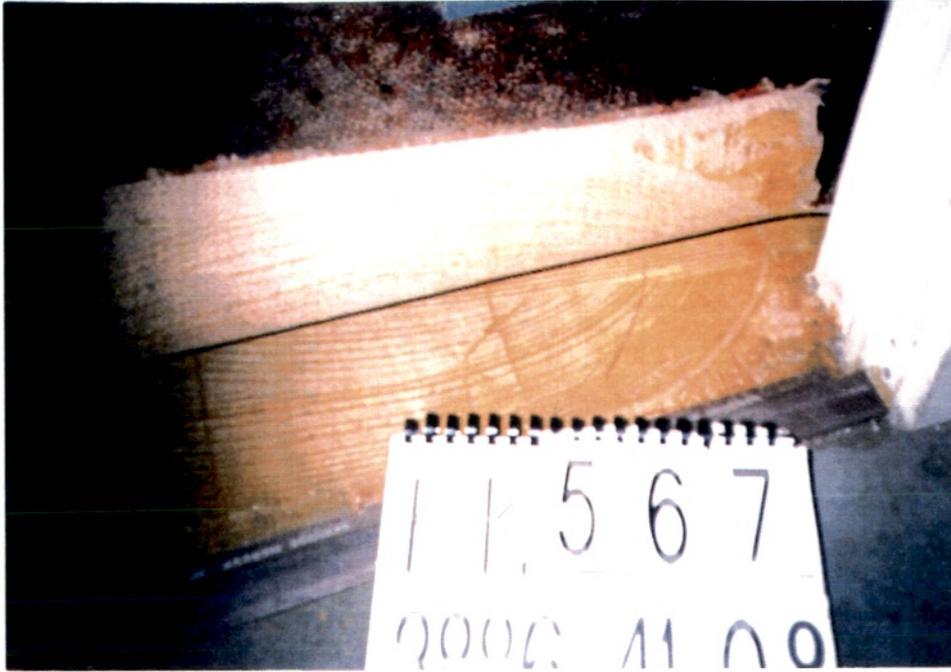
975.4

Bldg. 975 - Office A: 9" x 9" floor tile sample FK567 tested positive.

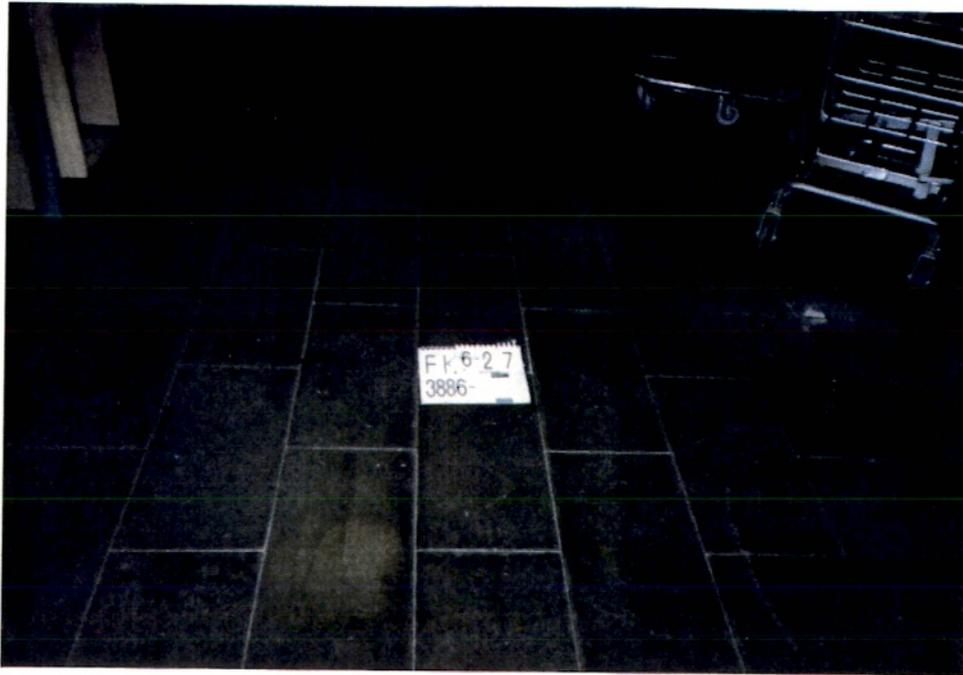
1005.4

Bldg. 1005 - Mail Prep./Work Rm.: 12" x 24" Floor Tile Sample
FK627 Tested Positive.

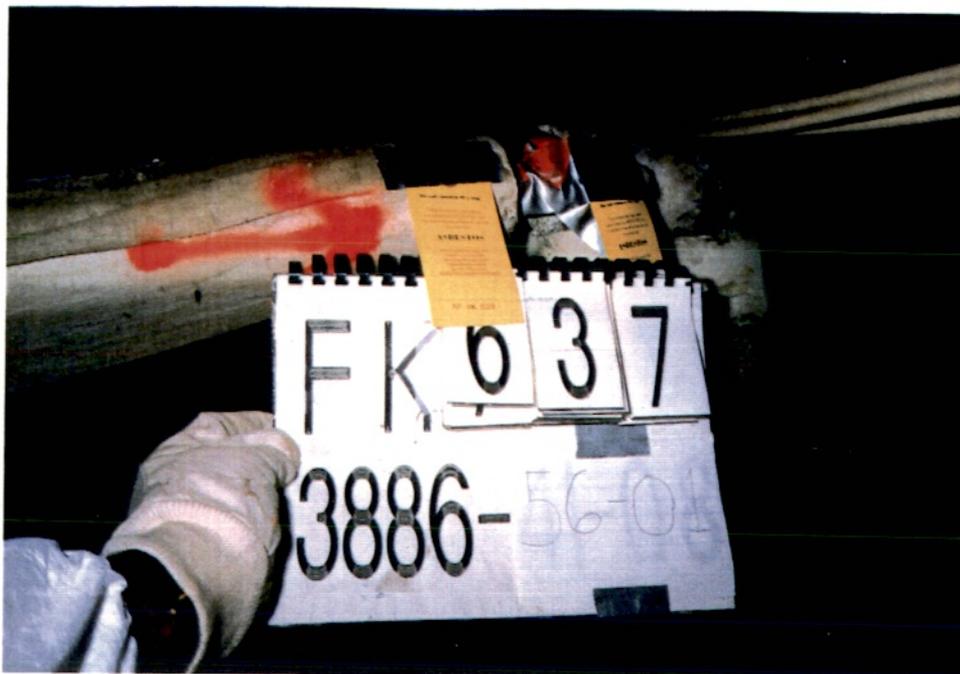
Bldg. 3028 - Crawlspace: Less Than 4" Fitting Sample FK637 Tested Positive.

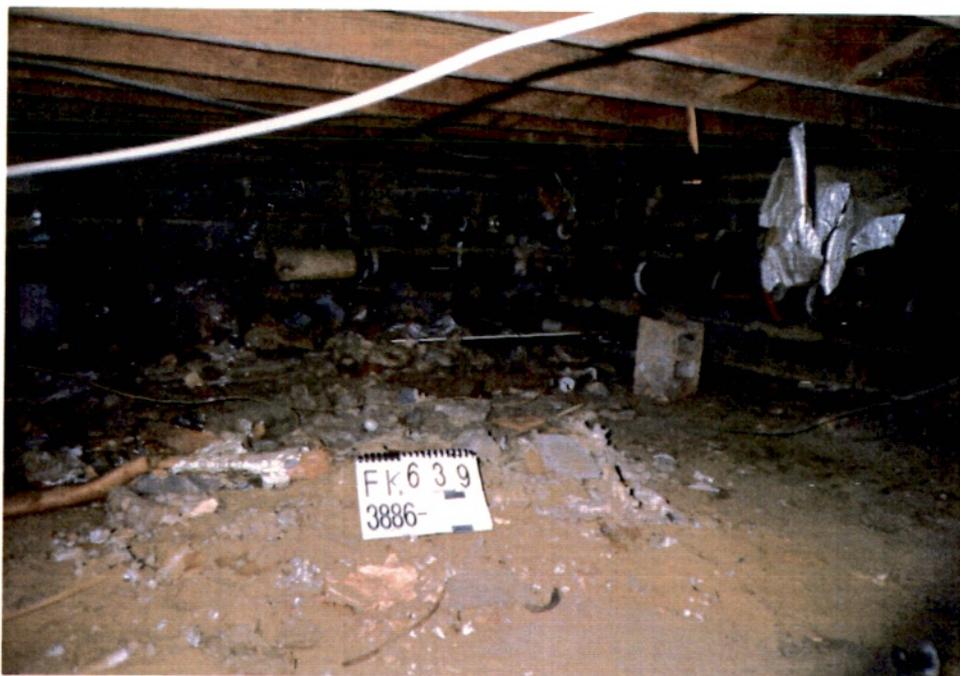
Bldg. 3028 - Crawlspace: 4" - 8" Fitting Sample FK639 Tested Positive.

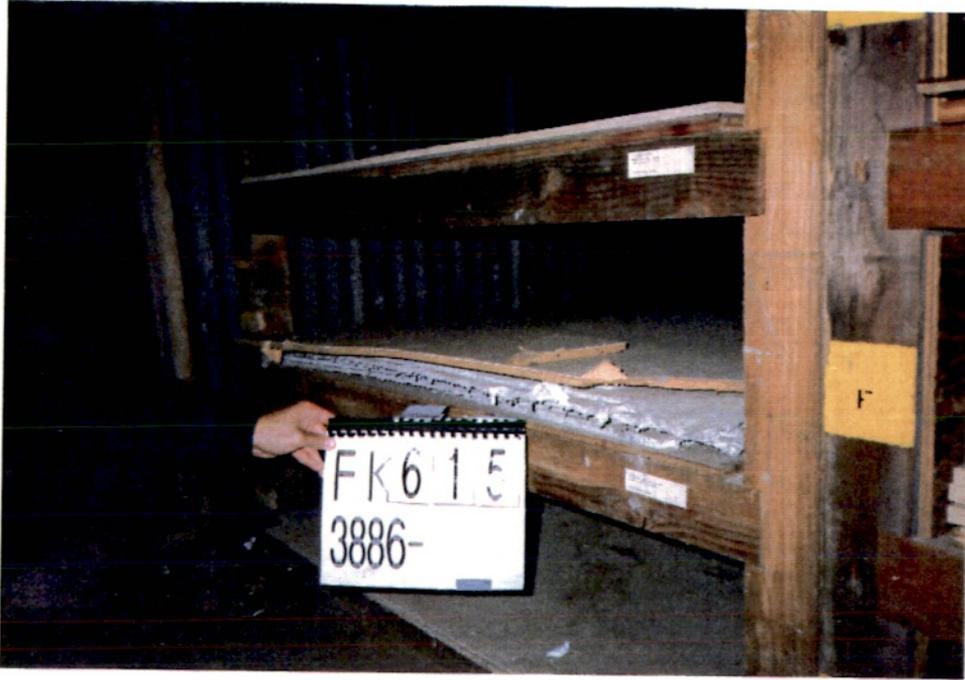
Bldg. 9351 - Storage 1: (Soft) Transite Panels Sample FK615 Tested Positive.

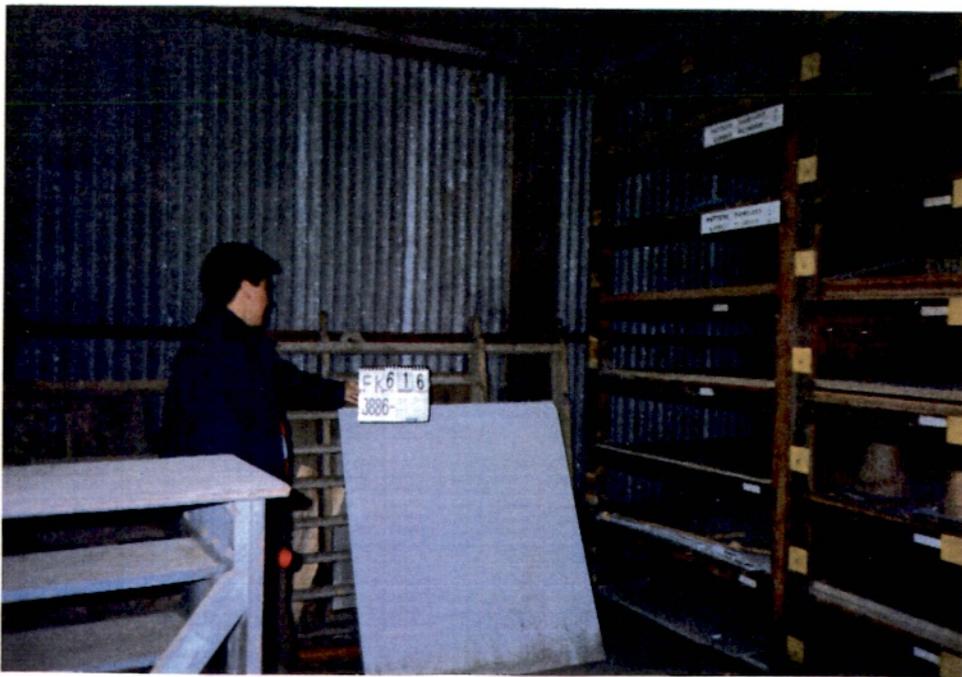
Bldg. 9351 - Storage 1: (Hard) Transite Panels Sample FK616 Tested Positive.
