**U.S. Army Corps of Engineers  
Philadelphia District**

***Volume II - Building Reports for a  
Comprehensive Asbestos  
Survey in Various Buildings at  
Fort Monmouth, New Jersey***

**February 1992**

Roy F. Weston, Inc.  
West Chester,  
Pennsylvania 19380

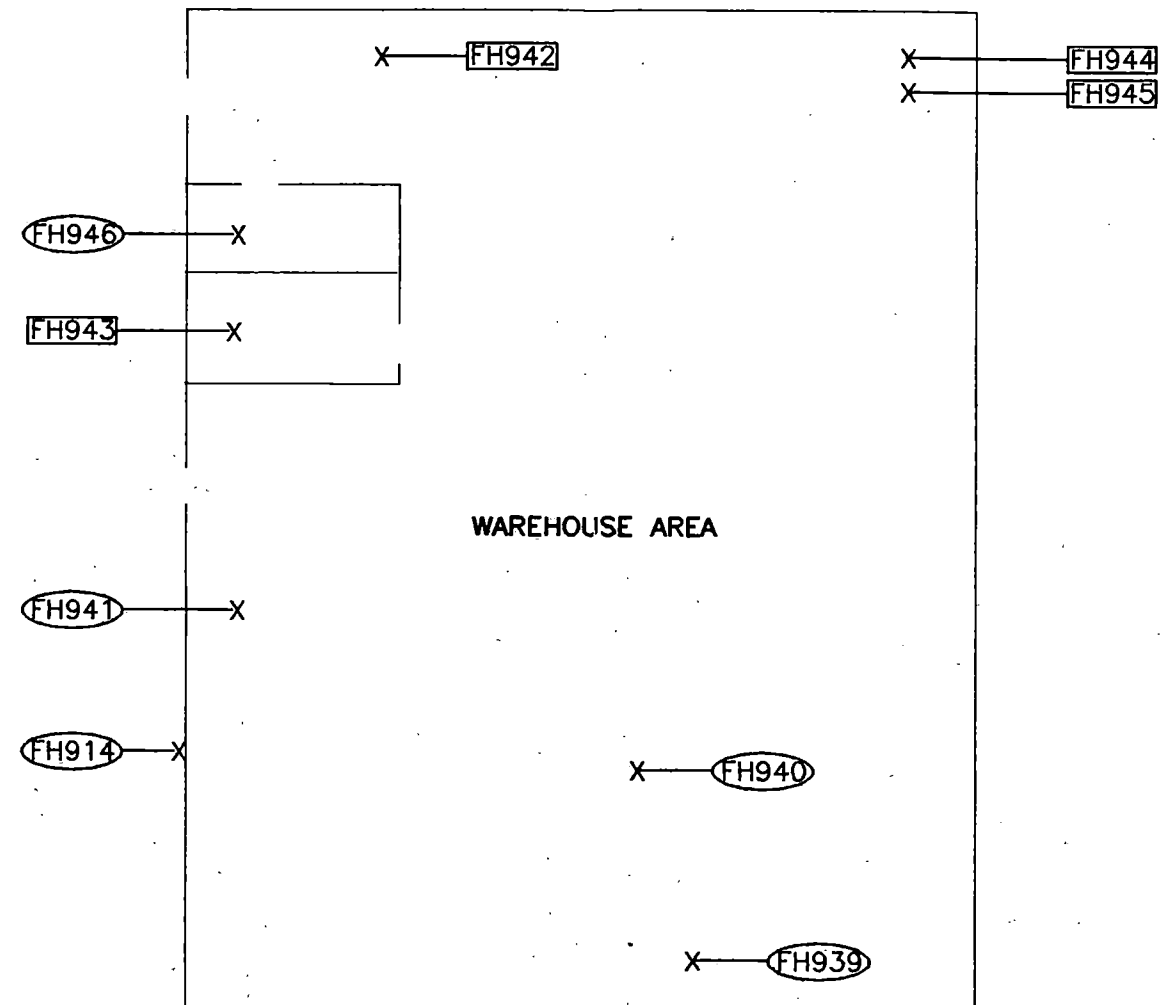
BLDG. 673

FIRST FLOOR: (SAMPLE FH946) WHITE ELECTRICAL  
LAMP WIRE TESTED POSITIVE.

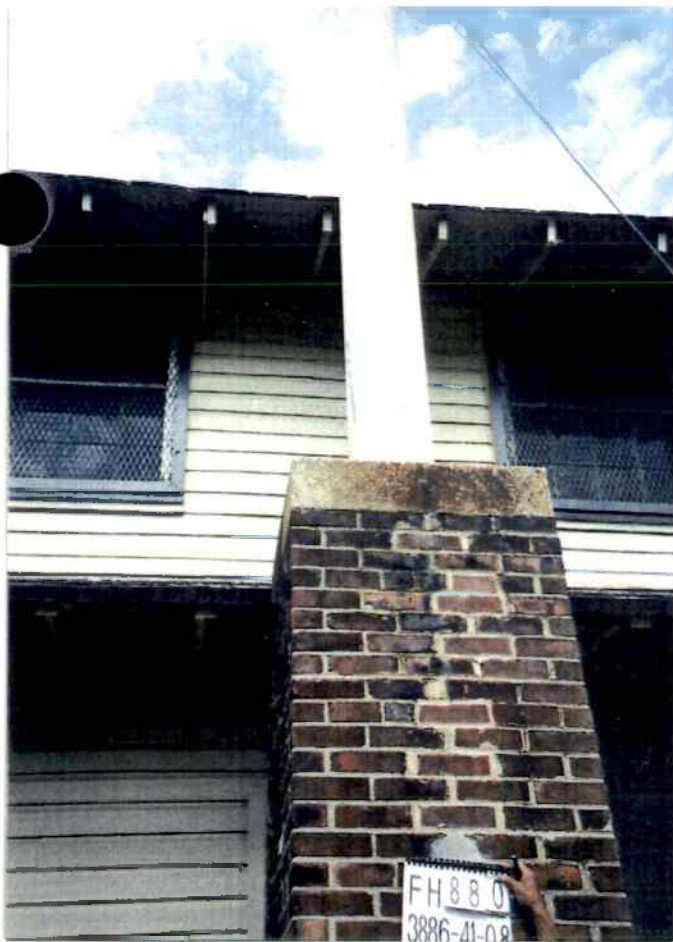
BLDG. 682

FLUE STACK: (SAMPLE FH880)  
TAN EXTERIOR STACK INSULATION  
TESTED POSITIVE.

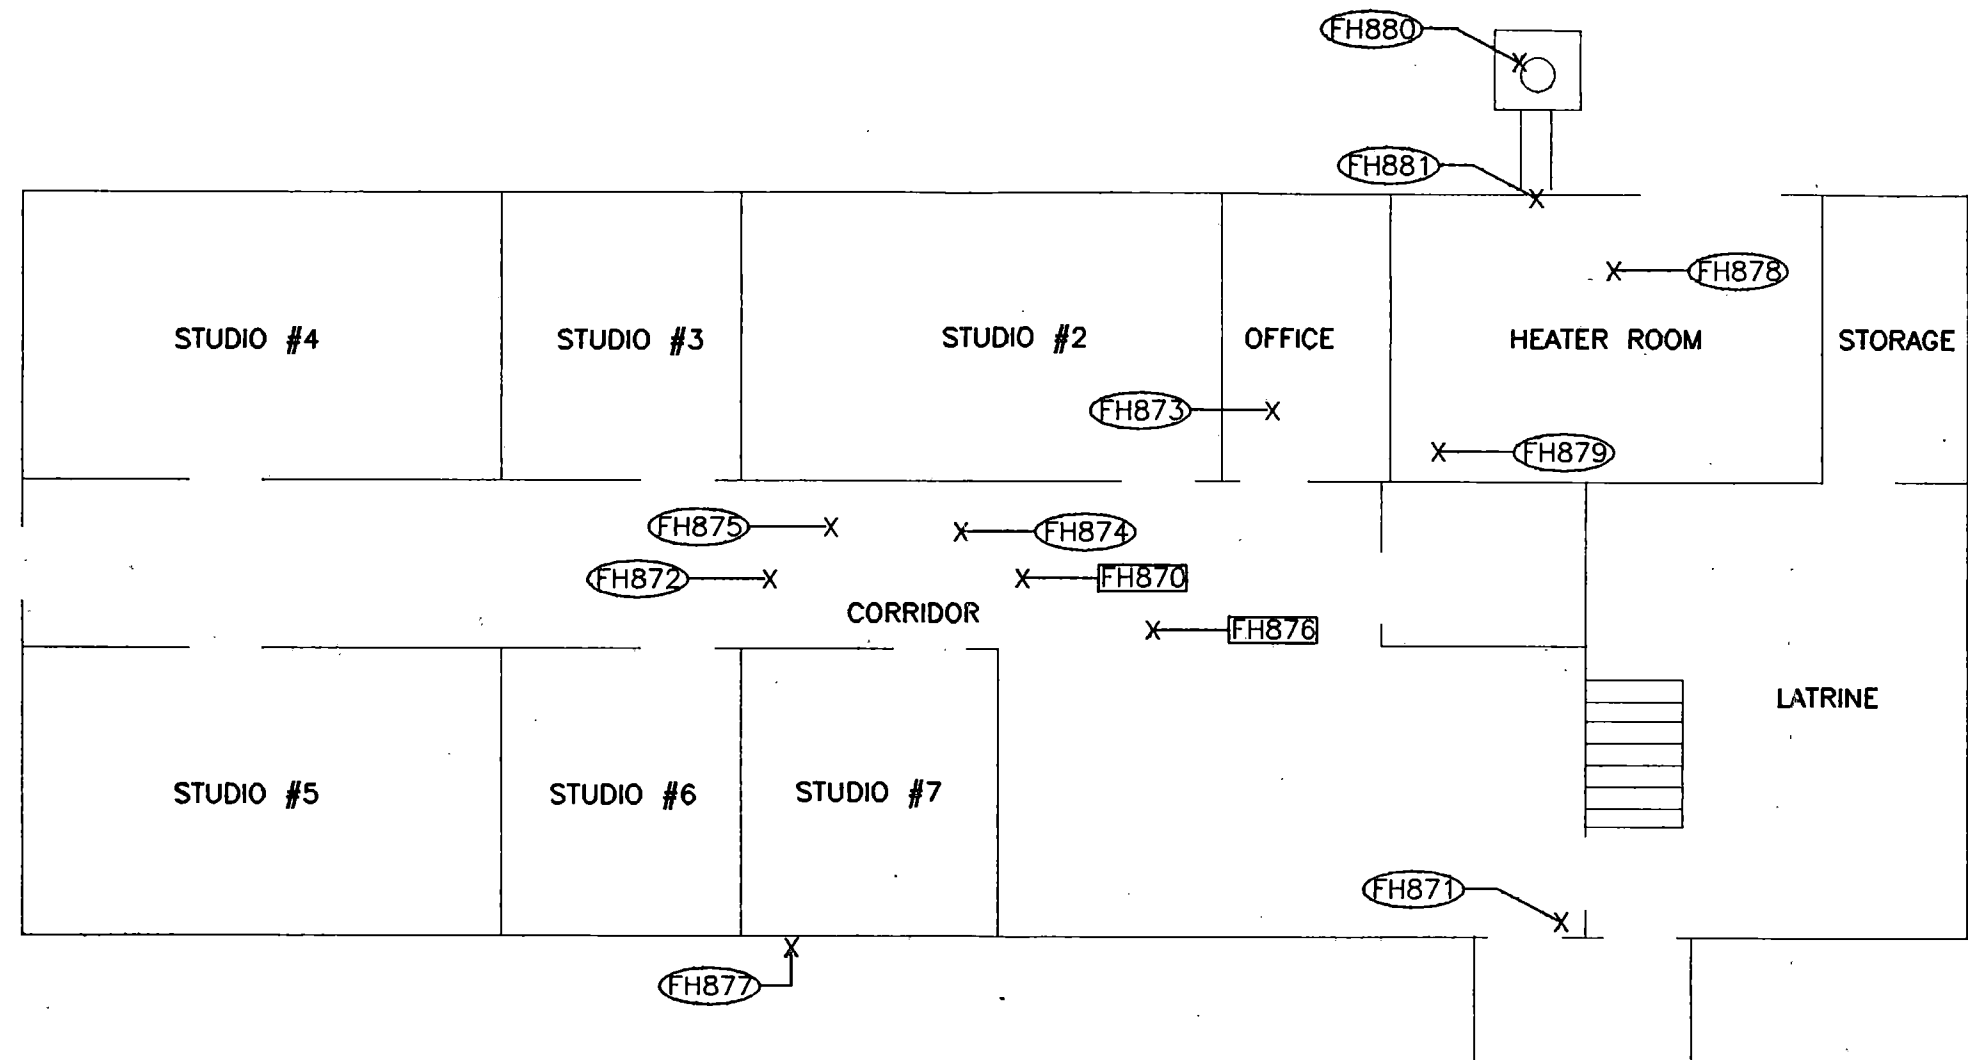
BLDG. 682

HEATER ROOM: (SAMPLE FH879) GRAY CORRUGATED  
PAPER INSULATION TESTED POSITIVE.

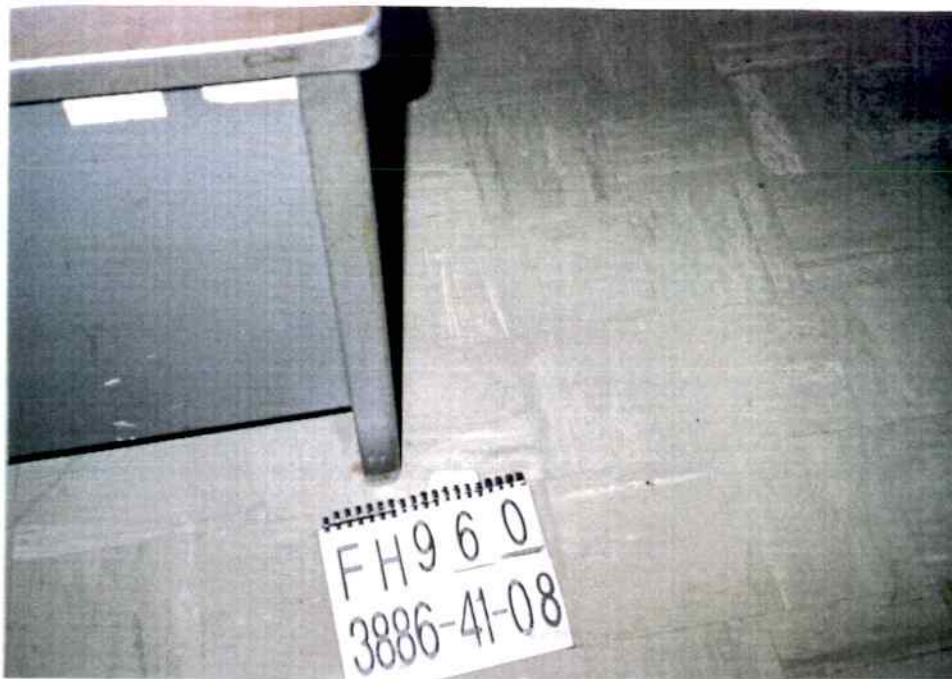
BLDG. 689

OFFICE: (SAMPLE FH960) GRAY 9" X 9" FLOOR  
TILE TESTED POSITIVE.

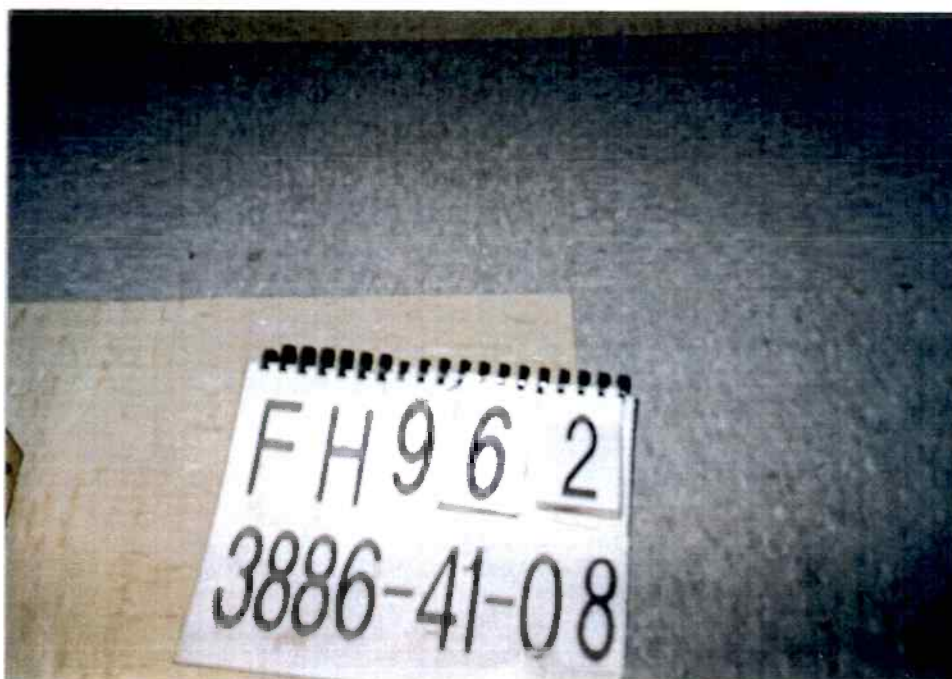
BLDG. 689

KITCHEN AREA: (SAMPLE FH962) TAN 1' X 1'  
FLOOR TILE TESTED POSITIVE.

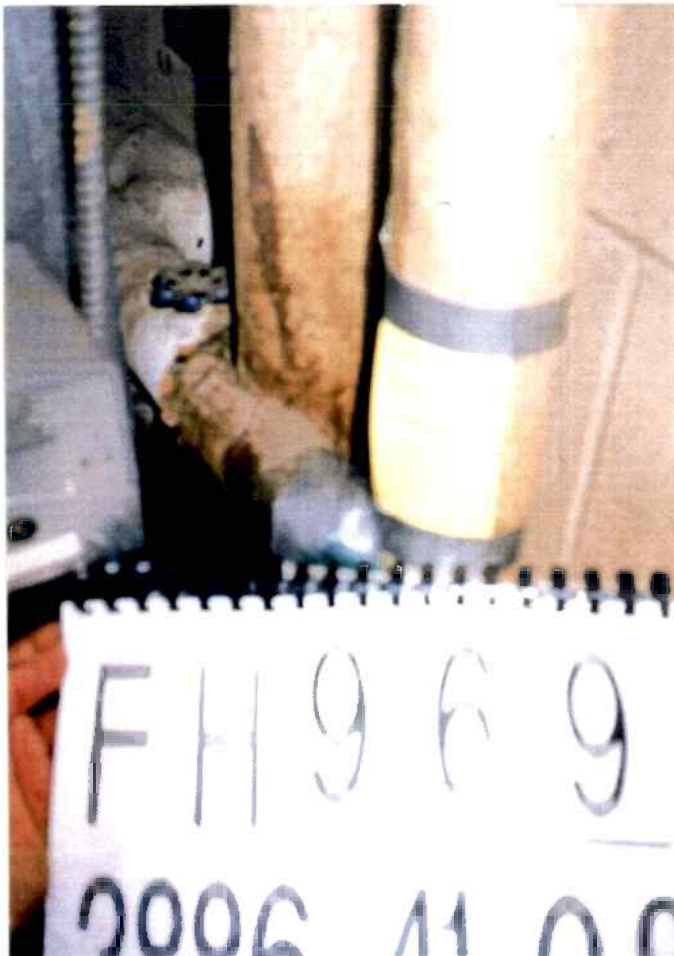
BLDG. 689

MECHANICAL ROOM: (SAMPLE FH969) GRAY <4" PIPE FITTING INSULATION TESTED POSITIVE.

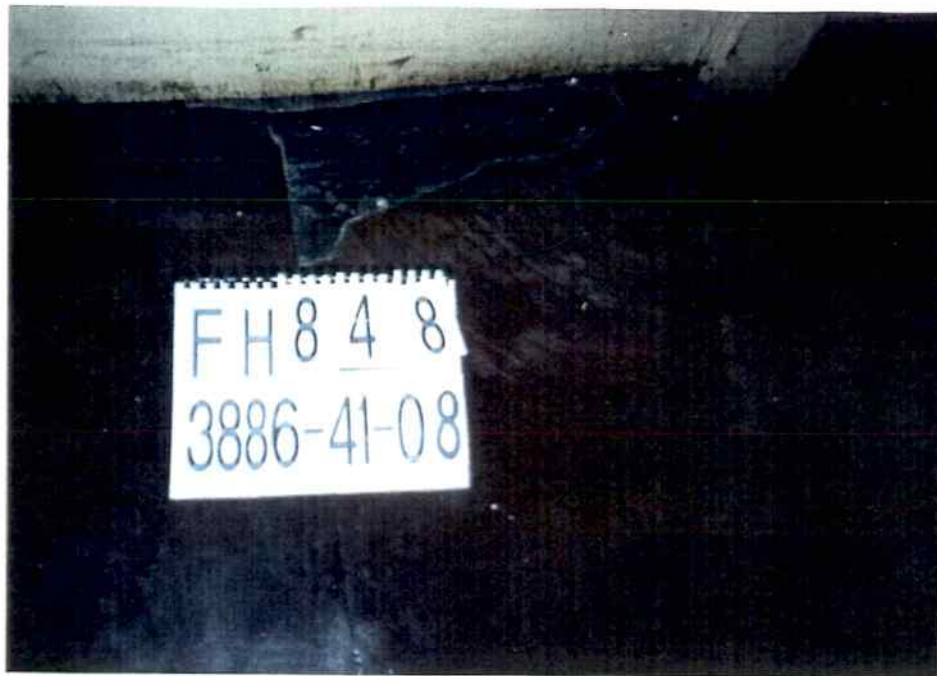
BLDG. 707

ENTIRE FIRST FLOOR: (SAMPLE FH848) BROWN  
FLOORING STRIPS TESTED POSITIVE.

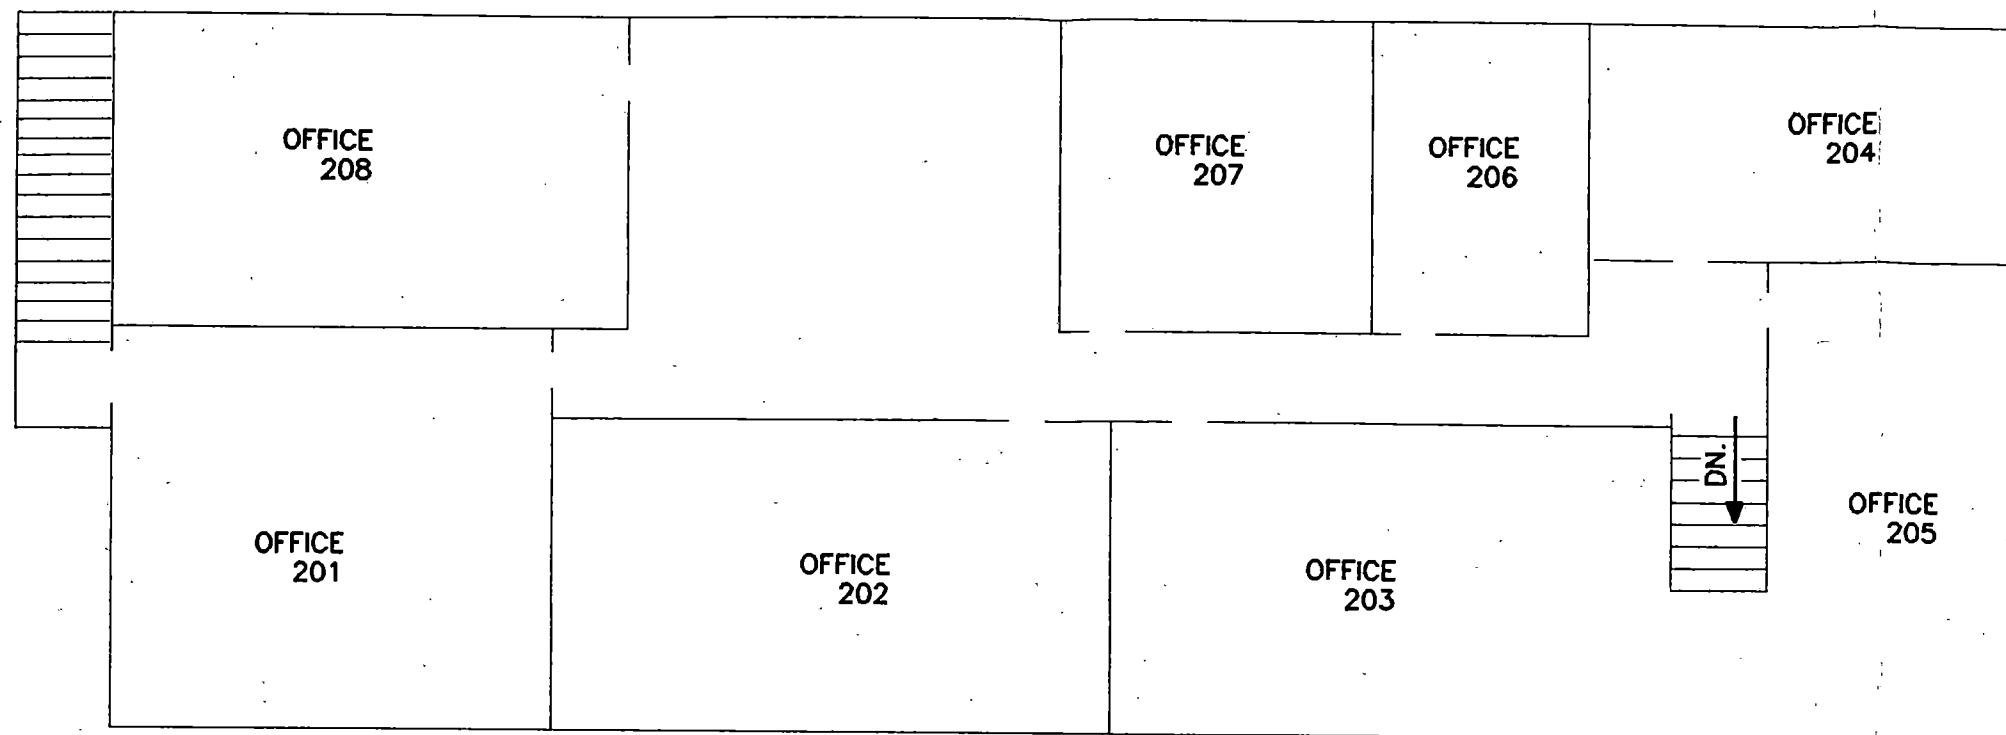
BLDG. 746

EXTERIOR WALLS: (SAMPLE FH938) GRAY TRANSITE PANEL TESTED POSITIVE.

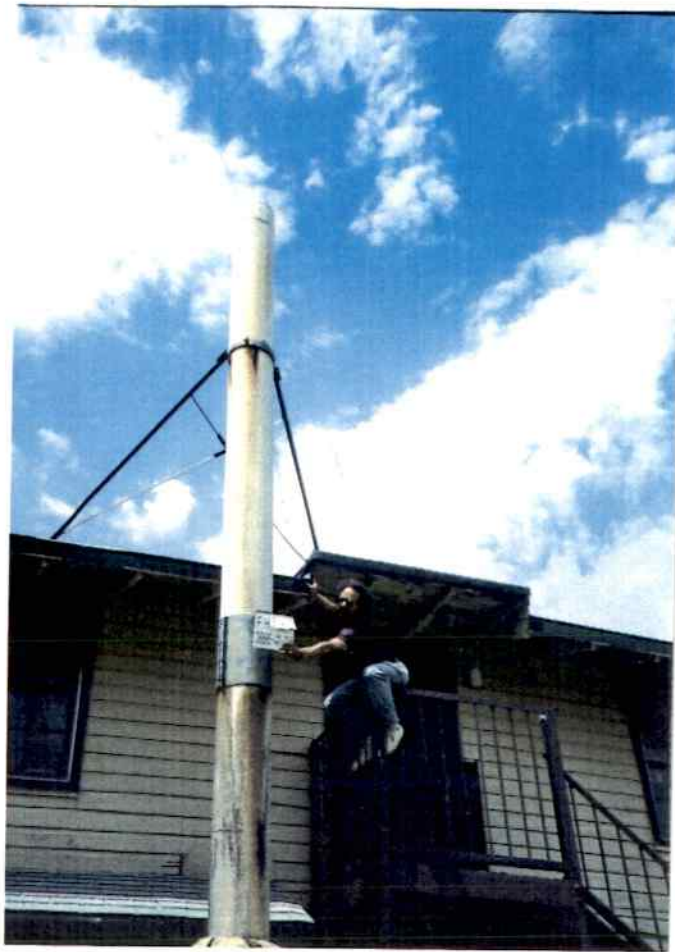
BLDG. 787

EXTERIOR STACK: (SAMPLE FH844) TAN STACK  
INSULATION TESTED POSITIVE.

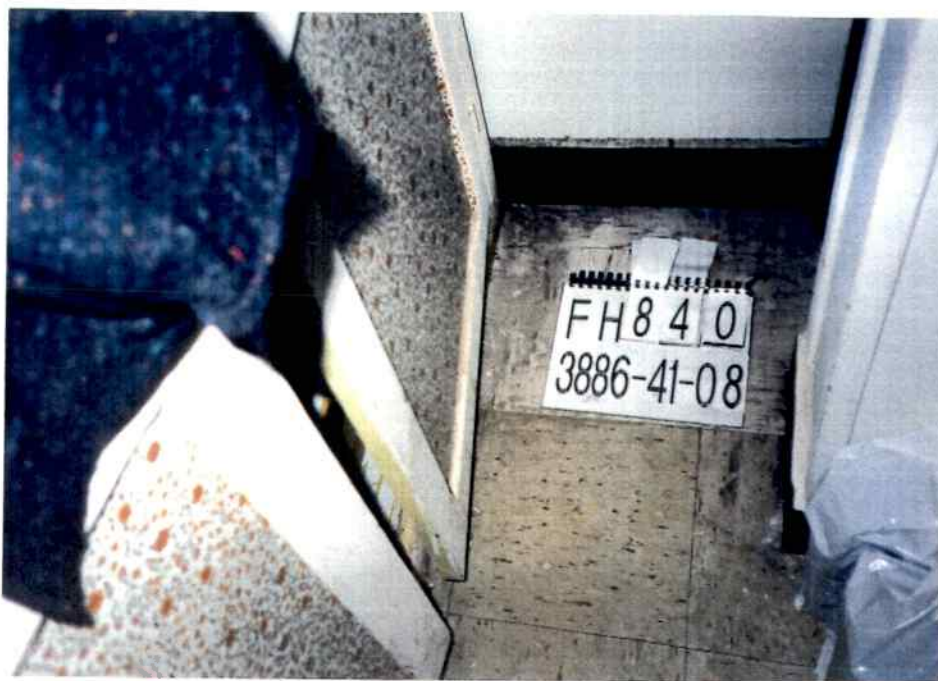
BLDG. 787

STORAGE: (SAMPLE FH840) TAN 1' X 1' FLOOR TILE TESTED POSITIVE. THIS FLOOR TILE IS ALSO PRESENT IN OPEN OFFICE 1ST FLOOR AND OPEN OFFICE 2ND FLOOR.

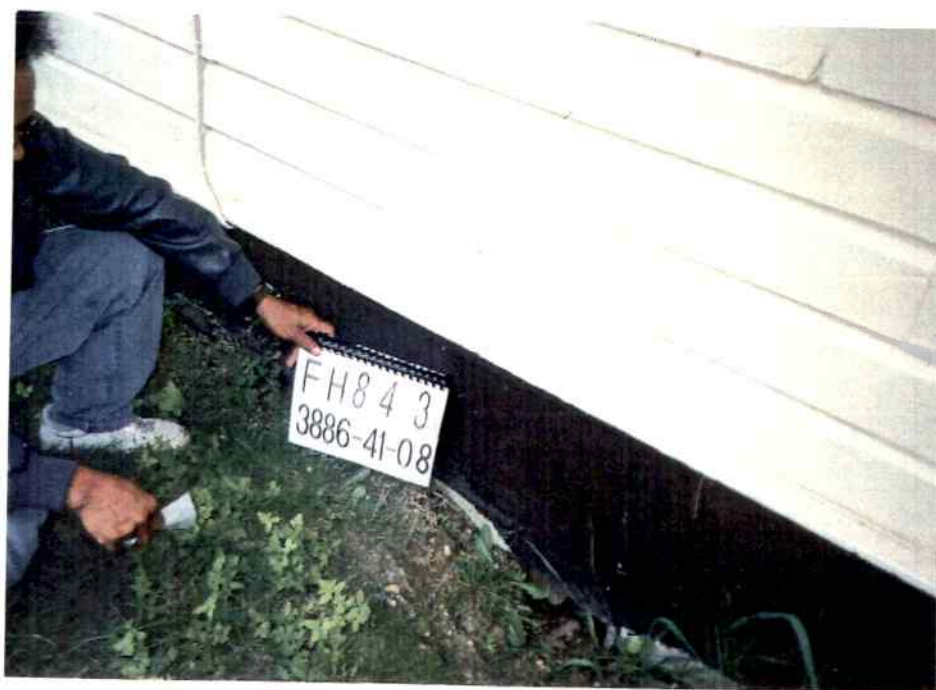
BLDG. 787

EXTERIOR SIDING: (SAMPLE FH843) BROWN TRANSITE PANEL BOARD TESTED POSITIVE.

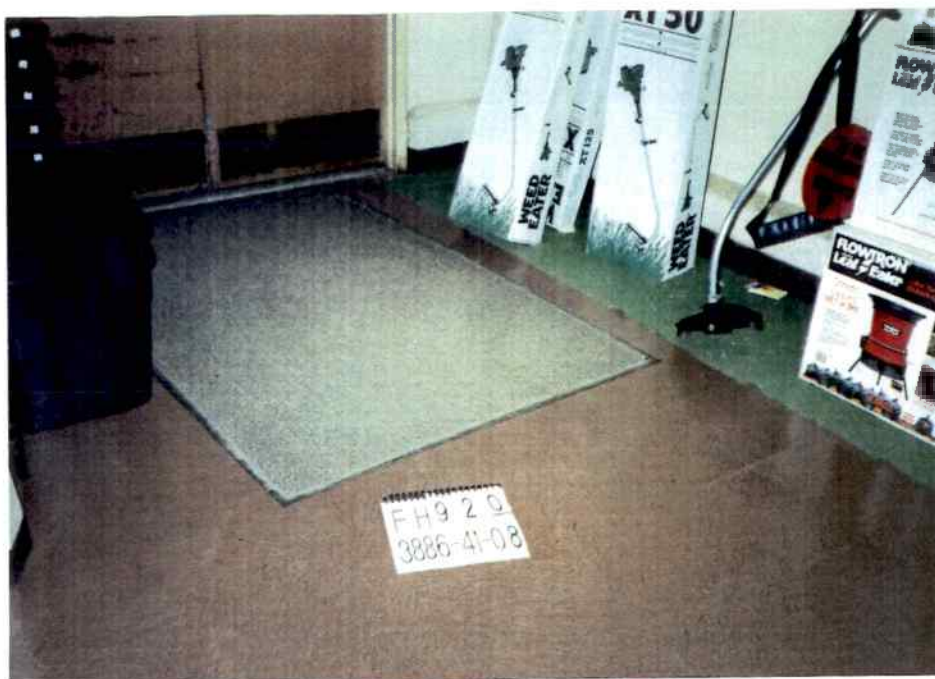
BLDG. 800

OUTDOOR SALES: (SAMPLE FH920) TAN/BROWN 1' X 1' FLOOR TILE TESTED POSITIVE. TAN/BROWN FLOOR TILES ARE ALSO PRESENT IN THE SALES AREA.

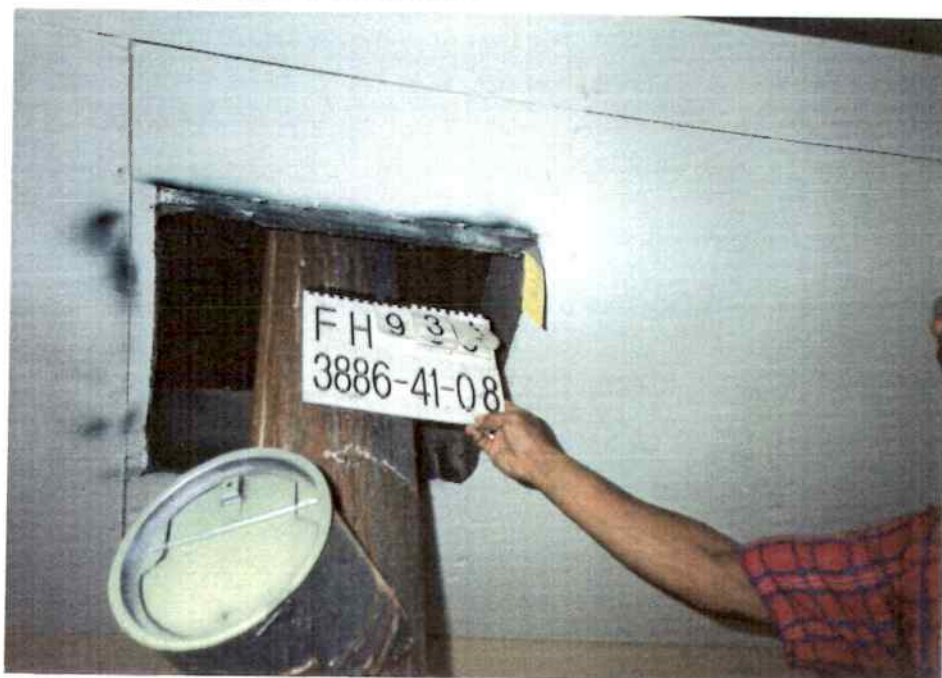
BLDG. 800

STORAGE NO. 2: (SAMPLE FH931) WHITE  
FIBERBOARD TESTED POSITIVE.

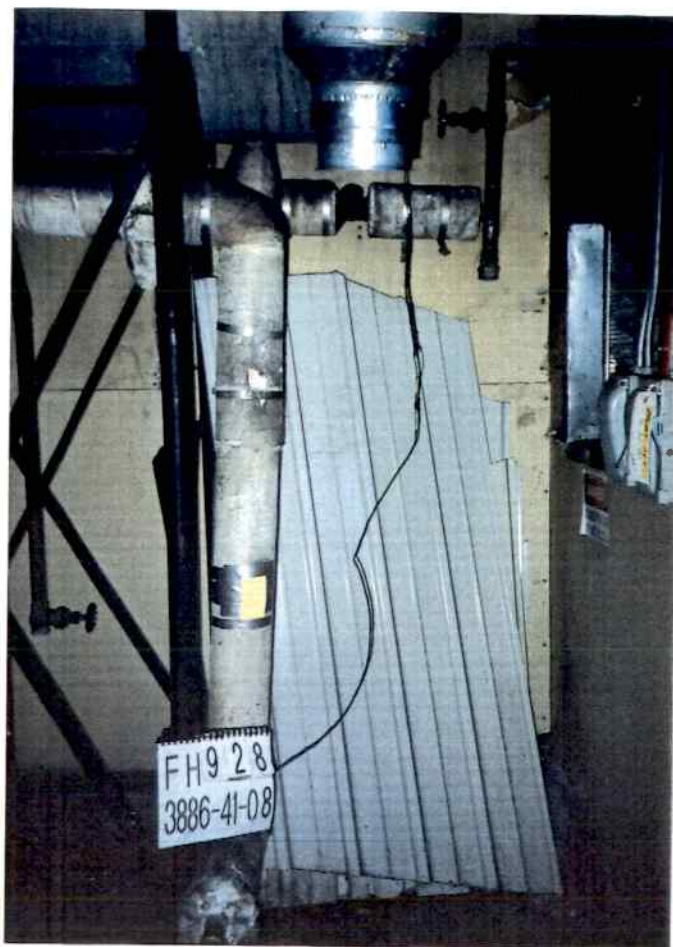
BLDG. 800

BOILER ROOM: (SAMPLE FH927) GRAY 4"-8"  
PIPE FITTING INSULATION AND (SAMPLE FH928)  
GRAY 4"-8" PIPE RUN INSULATION BOTH TESTED  
POSITIVE.

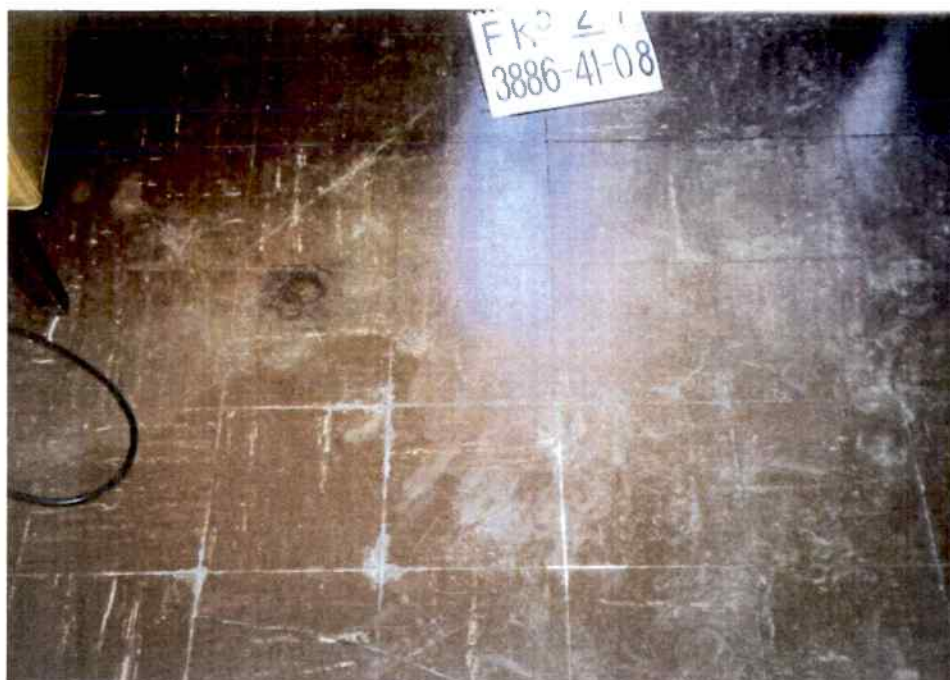
BLDG. 899

SUPPLY ROOM: (SAMPLE FK527) BROWN 9" X 9"  
FLOOR TILE TESTED POSITIVE.

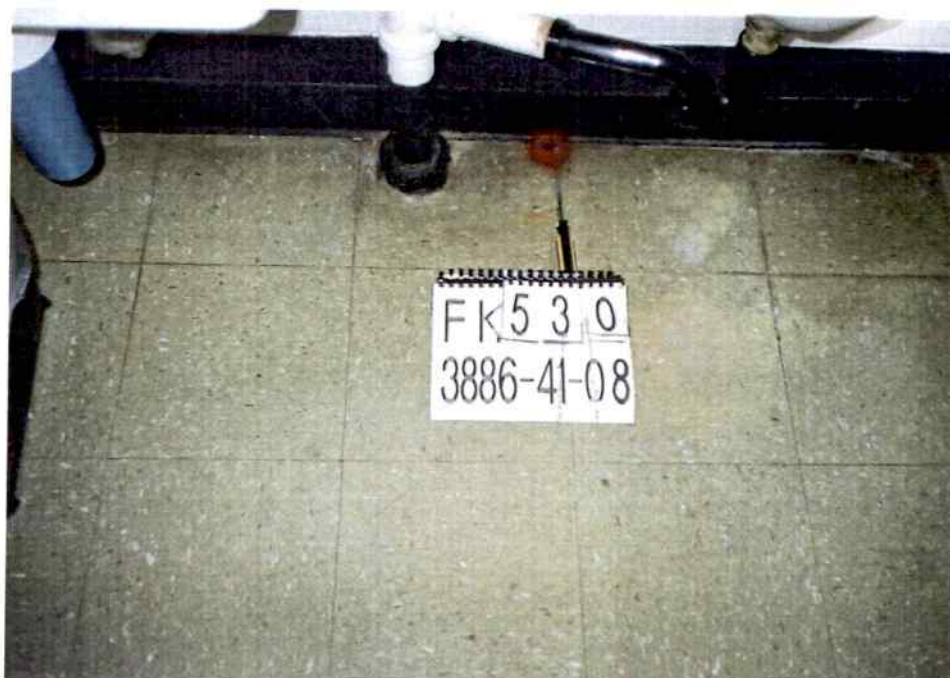
BLDG. 899

MEN'S/WOMEN'S LATRINES: (SAMPLE FK530) GRAY  
1' X 1' FLOOR TILE TESTED POSITIVE. GRAY  
1' X 1' FLOOR TILE IS ALSO PRESENT IN THE  
OPEN OFFICE AREA.

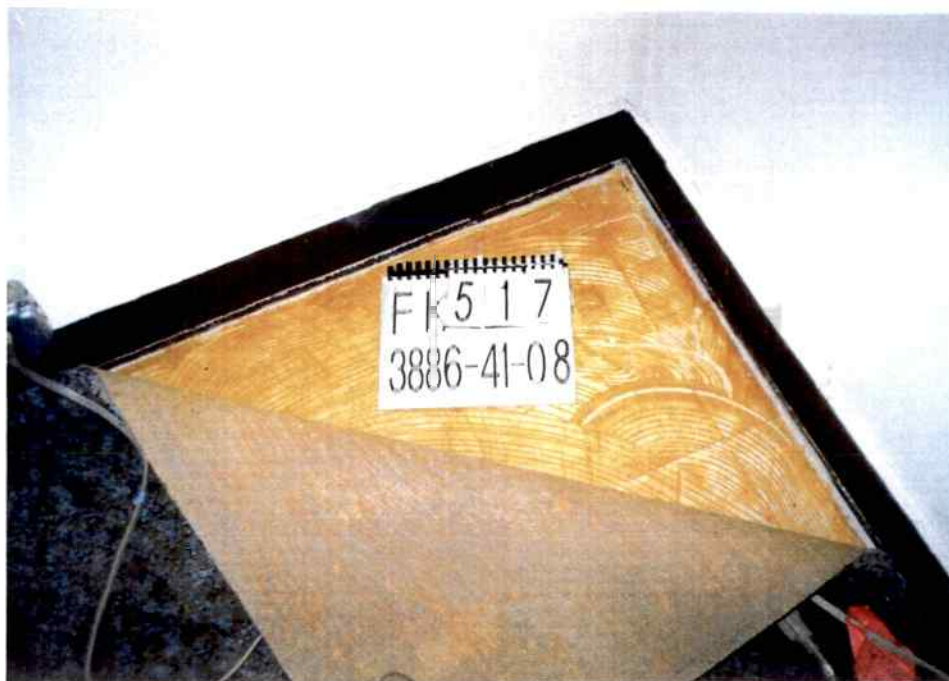
BLDG. 910

FIRST FLOOR: (SAMPLE FK517) WHITE 1' X 1' FLOOR TILE TESTED POSITIVE. WHITE 1' X 1' FLOOR TILE IS ALSO PRESENT ON ENTIRE SECOND FLOOR.

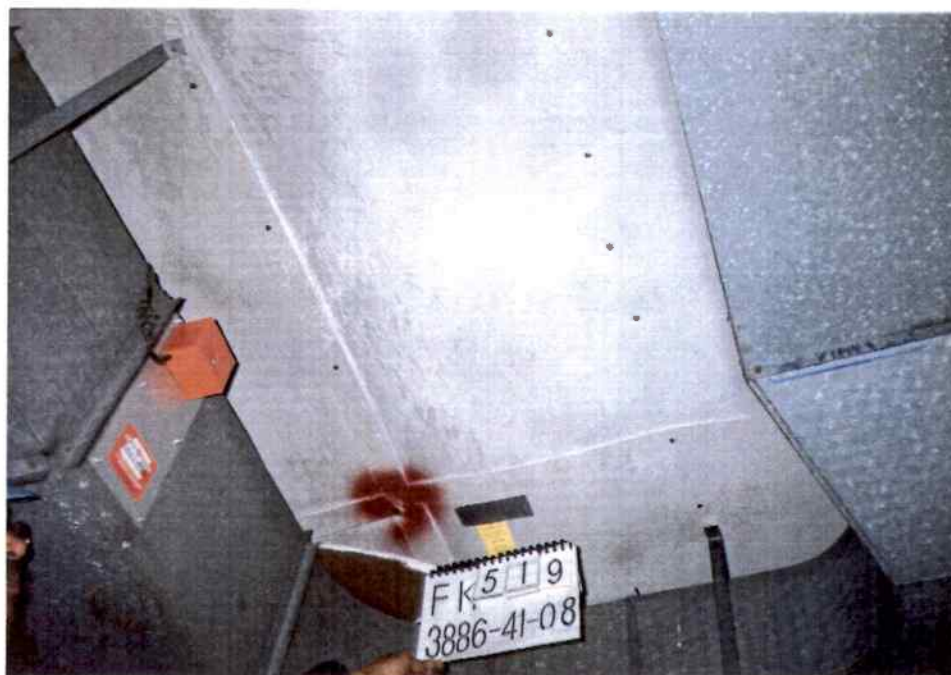
BLDG. 910

BOILER ROOM: (SAMPLE FK519) GRAY TRANSITE PANEL TESTED POSITIVE.

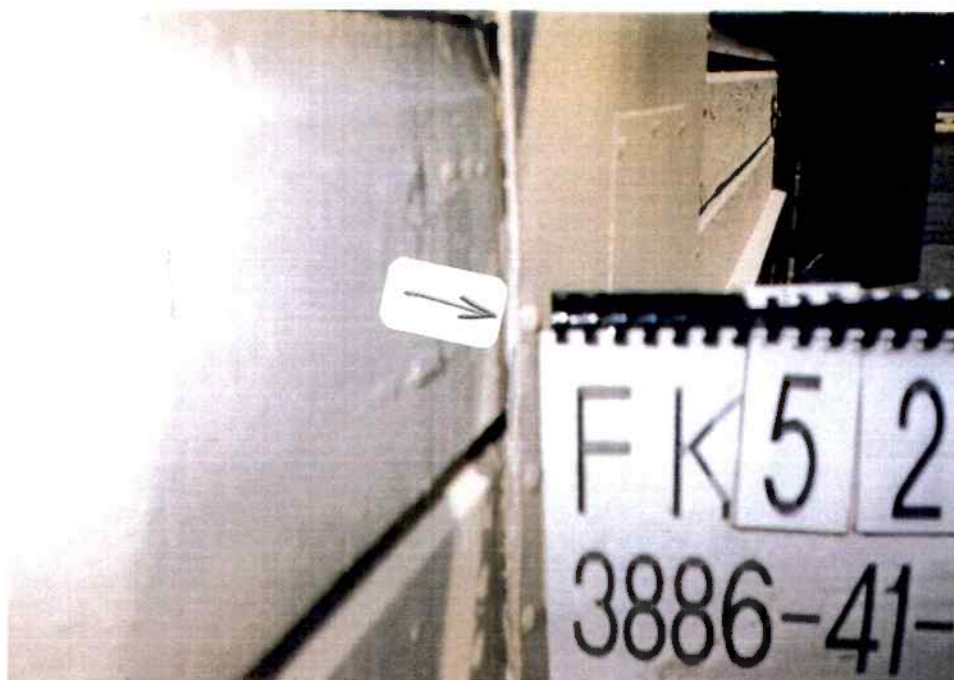
BLDG. 910

EXTERIOR WALL: (SAMPLE FK520) GRAY EXTERIOR  
SIDING TESTED POSITIVE.

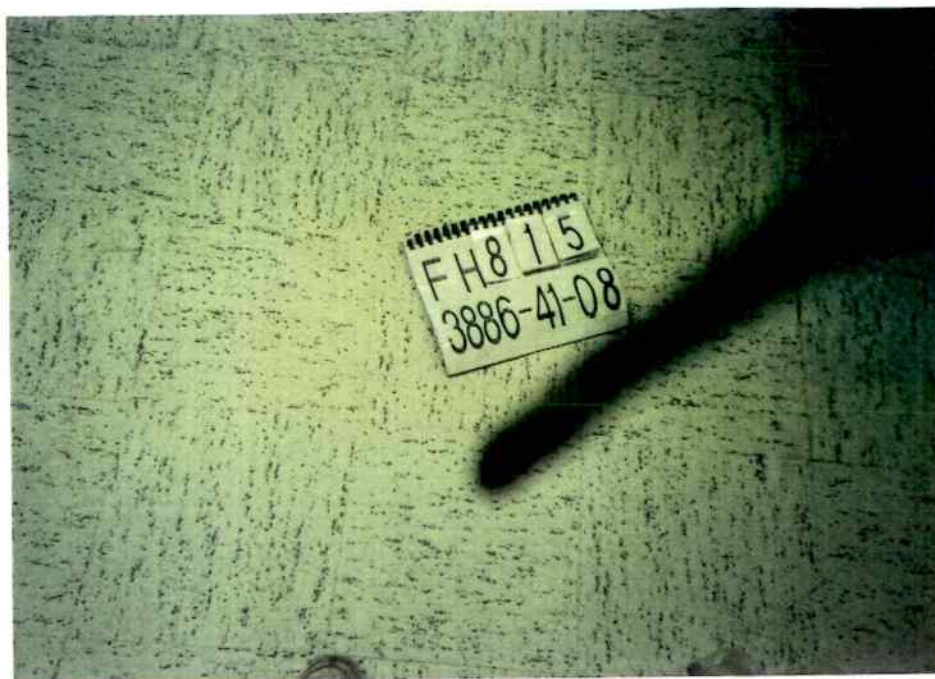
BLDG. 1004

EAM OFFICE: (SAMPLE FH815) WHITE 1' X 1' FLOOR TILE TESTED POSITIVE. THIS TILE IS ALSO PRESENT IN GENERAL/PURCHASING, AND THE EMPLOYEE BREAK AREA.

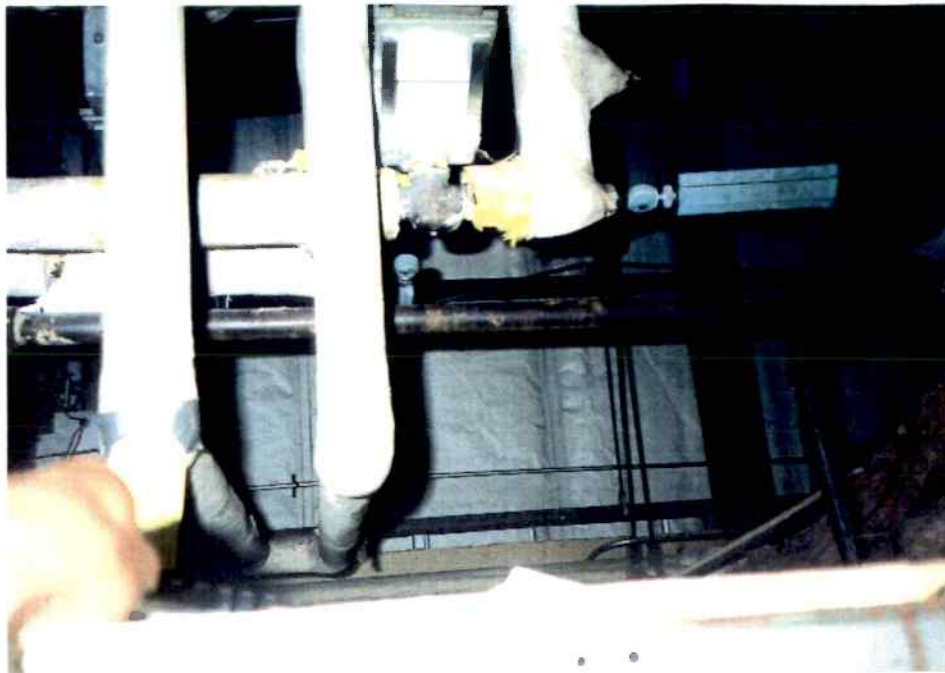
BLDG. 1004

PRODUCE PREP AREA: (SAMPLE FH821) GRAY LESS THAN 4" PIPE FITTING INSULATION TESTED POSITIVE.

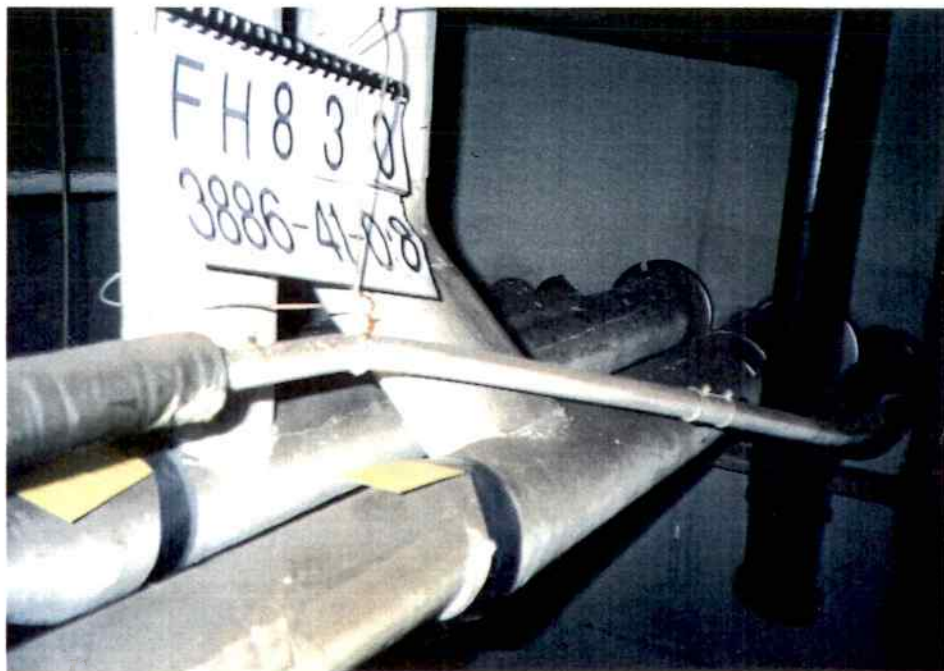
BLDG. 1004

WASHING AREA: (SAMPLES FH830 AND FH831) WHITE 4" TO 8" PIPE FITTING INSULATION TESTED POSITIVE.

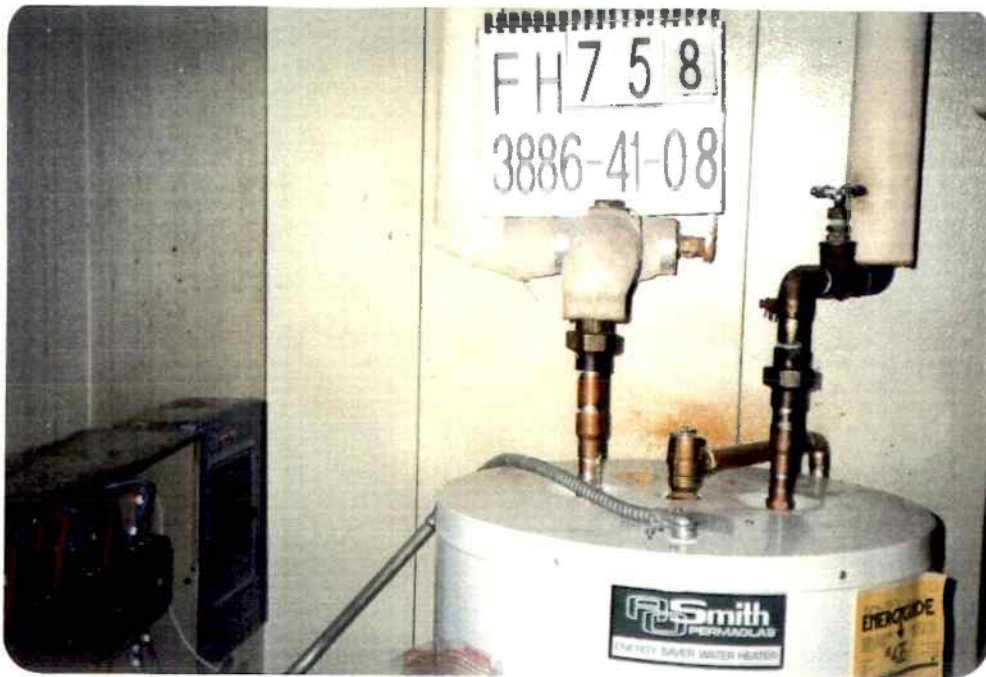
BLDG. 1214

MECHANICAL ROOM: (SAMPLE FH758)  
LESS THAN 4" PIPE FITTING INSULATION  
TESTED POSITIVE.

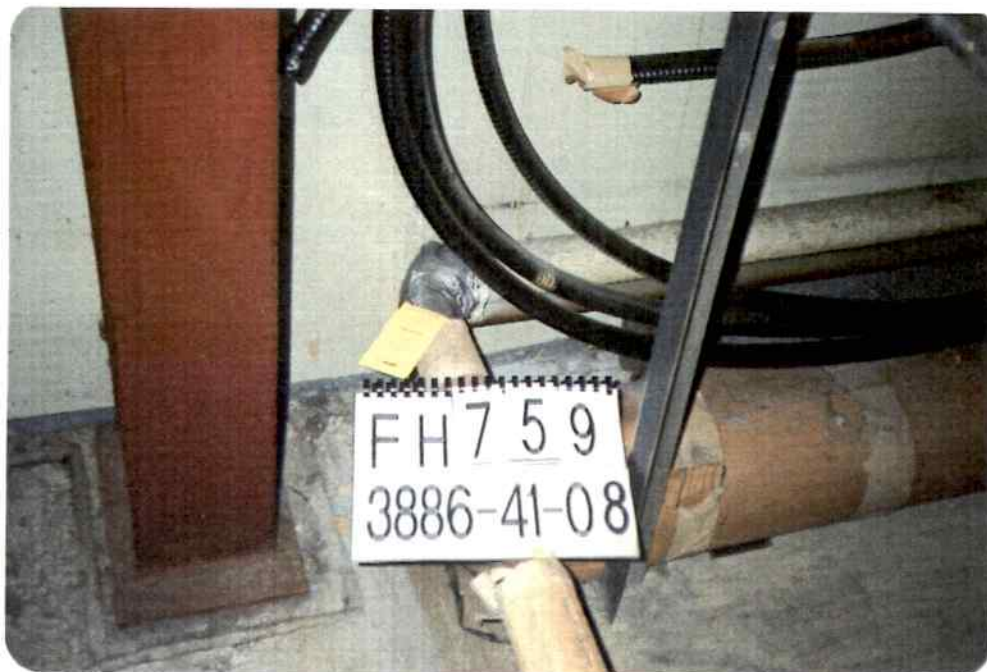
BLDG. 1214

MECHANICAL ROOM: (SAMPLE FH759)  
LESS THAN 4" PIPE FITTING INSULATION  
TESTED POSITIVE.

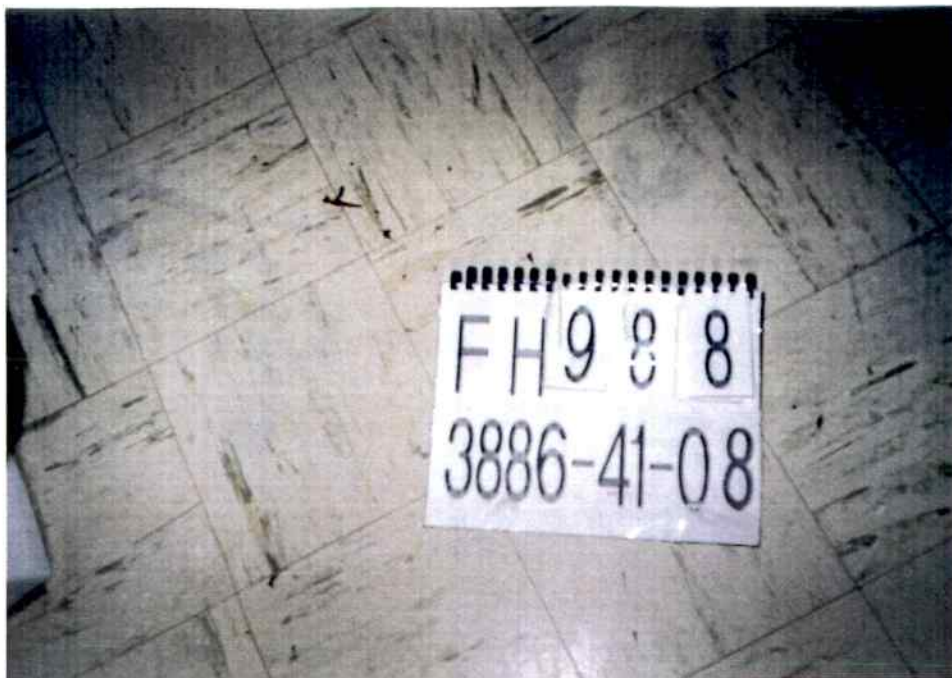
BLDG. 1215

PROJECTION ROOM-BATHROOM: (SAMPLE FH988)  
GRAY 9" X 9" FLOOR TILE TESTED POSITIVE.

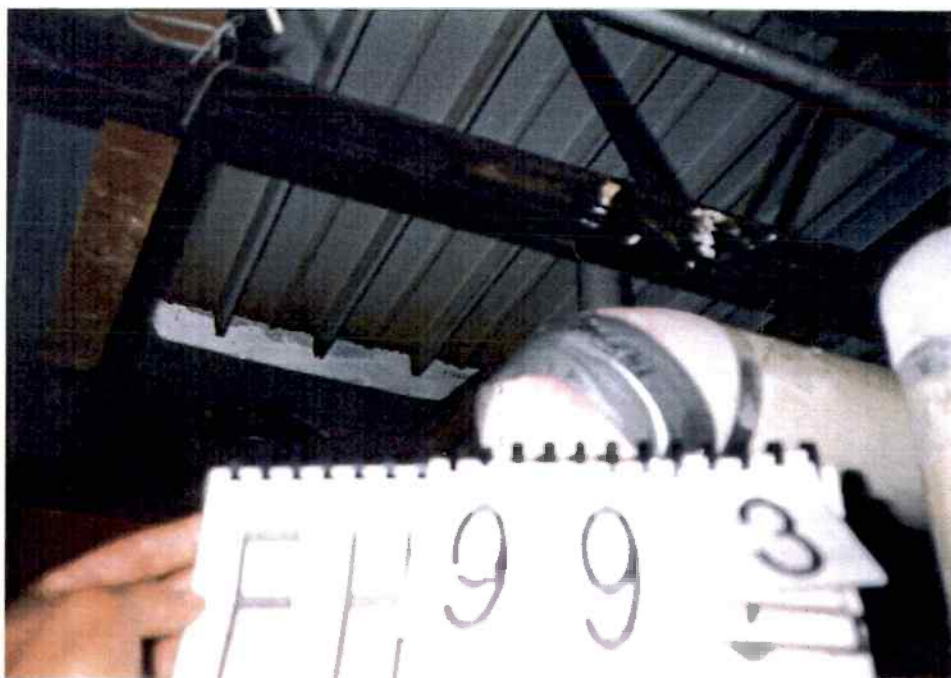
BLDG. 1215

THEATER ATTIC: (SAMPLE FH993) WHITE 4" TO 8"  
PIPE FITTING INSULATION TESTED POSITIVE. WHITE  
4" TO 8" PIPE FITTING INSULATION IS ALSO  
PRESENT IN THE BOILER ROOM AND A/C ROOM.

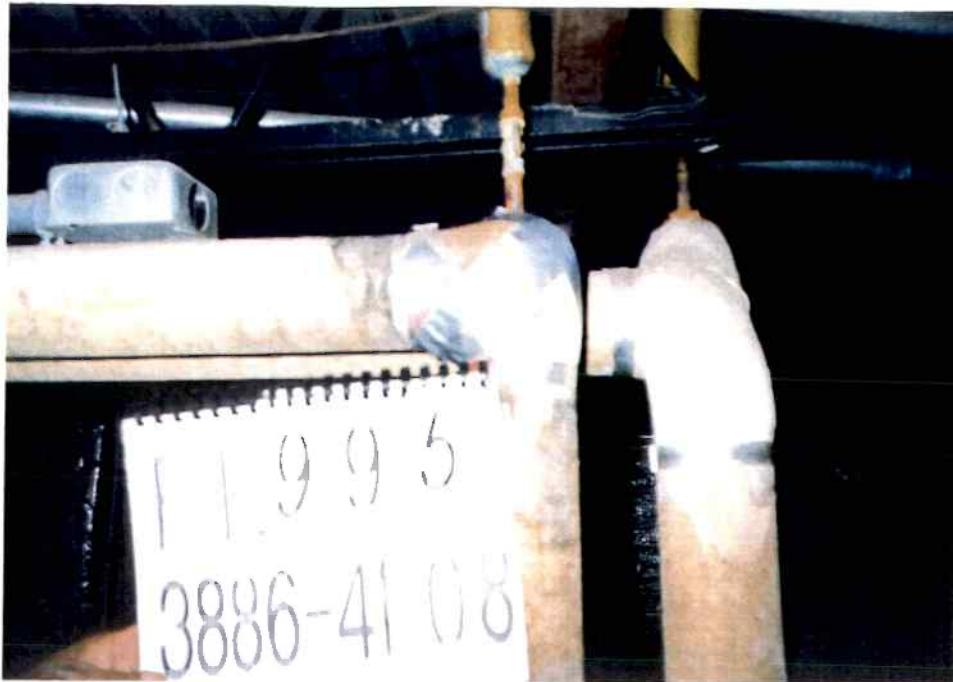
BLDG. 1215

THEATER ATTIC: (SAMPLE FH995) WHITE <4" PIPE FITTING INSULATION TESTED POSITIVE. WHITE <4" PIPE FITTING INSULATION IS ALSO PRESENT IN BOILER ROOM.

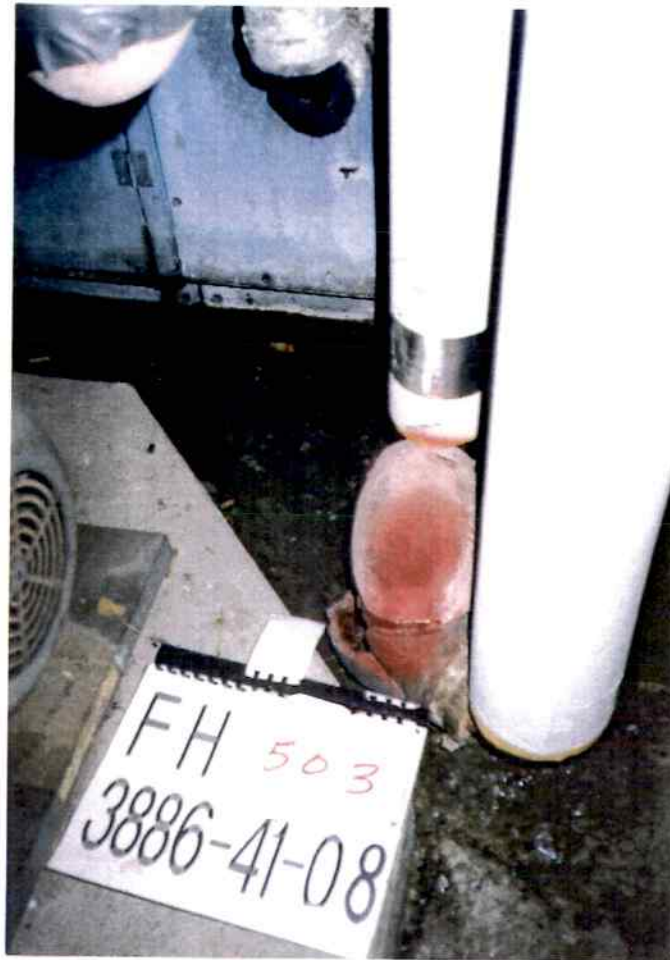
BLDG. 1215

A/C ROOM : (SAMPLE FH503) WHITE PIPE FITTING  
INSULATION TESTED POSITIVE.

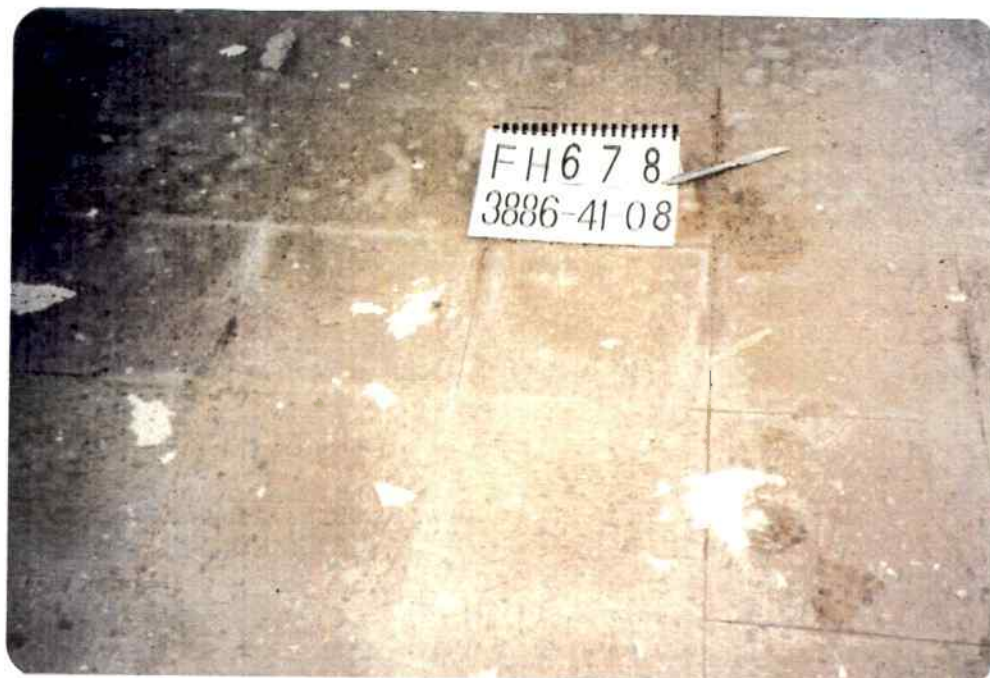
BLDG. 2337

SECOND FLOOR, PROJECTION ROOM : (SAMPLE FH678)  
TAN 12" X 12" FLOOR TILE TESTED POSITVE.

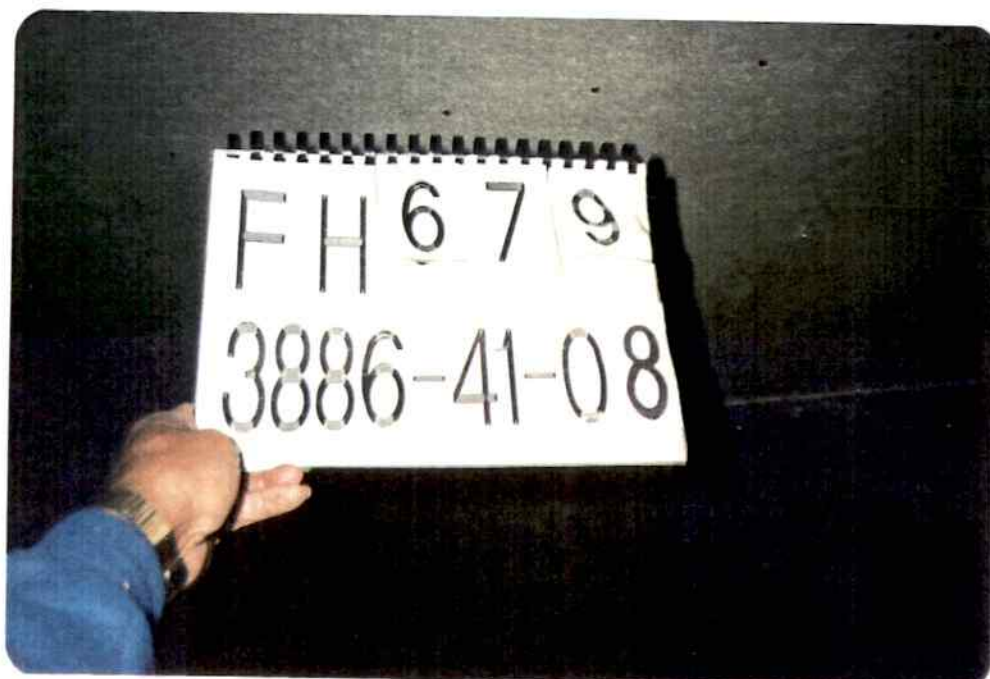
BLDG. 2337

SECOND FLOOR, PROJECTION ROOM: (SAMPLE FH679)  
TRANSITE PANEL BOARD TESTED POSITIVE.
