**U.S. Army Corps of Engineers  
Philadelphia District**

***Volume II - Building Reports for a  
Comprehensive Asbestos  
Survey in Various Buildings at  
Fort Monmouth, New Jersey***

**February 1992**

Roy F. Weston, Inc.  
West Chester,  
Pennsylvania 19380

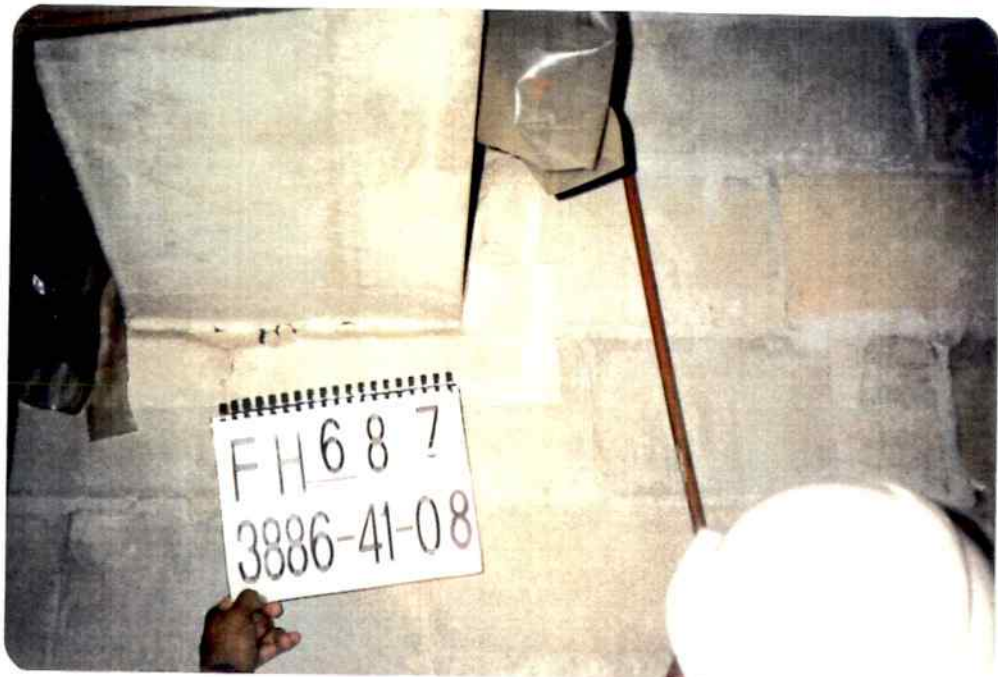
BLDG. 2337

FIRST FLOOR, JANITOR'S CLOSET: (SAMPLE FH687)  
AIR DUCT INSULATION TESTED POSITIVE.

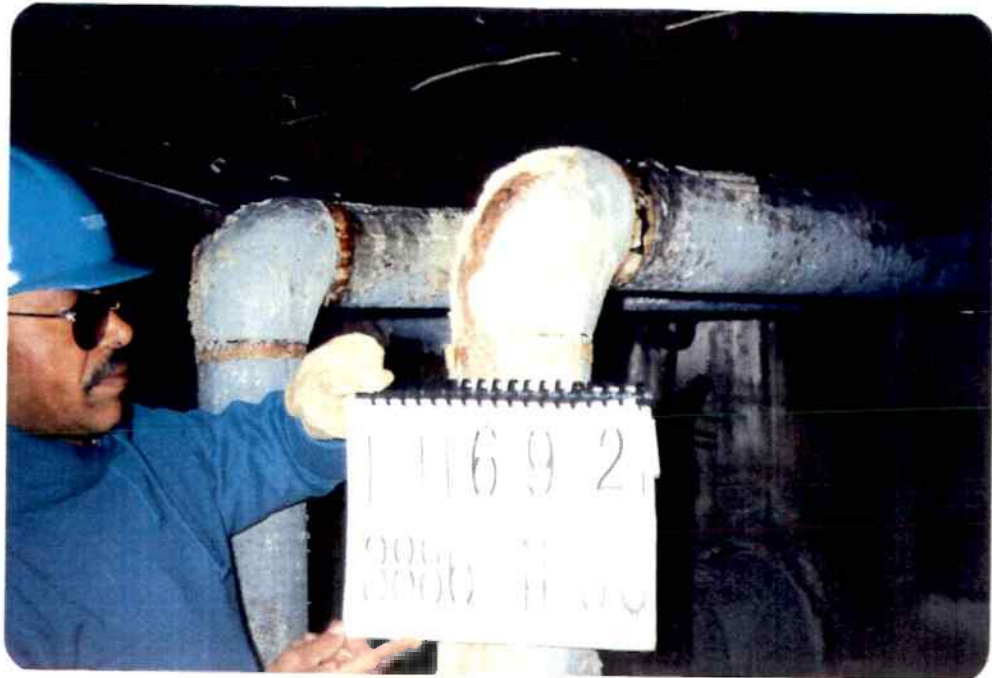
BLDG. 2337

MECHANICAL ROOM : (SAMPLE FH692)  
4"-8" PIPE FITTING INSULATION TESTED  
POSITIVE.

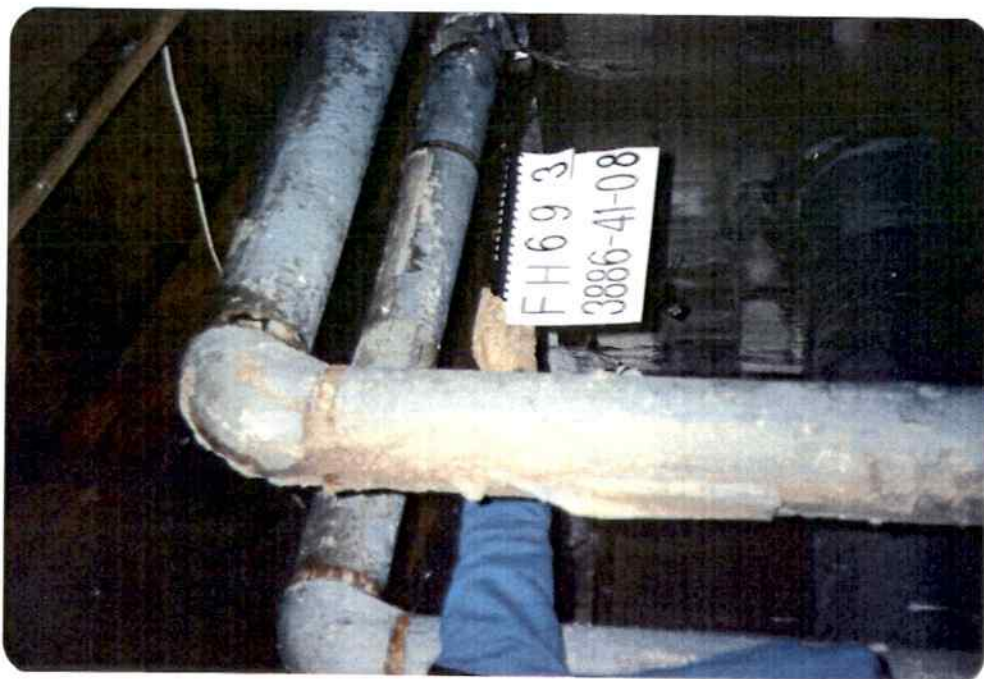
BLDG. 2337

MECHANICAL ROOM: (SAMPLE FH693)  
4"-8" PIPE RUN INSULATION TESTED  
POSITIVE.

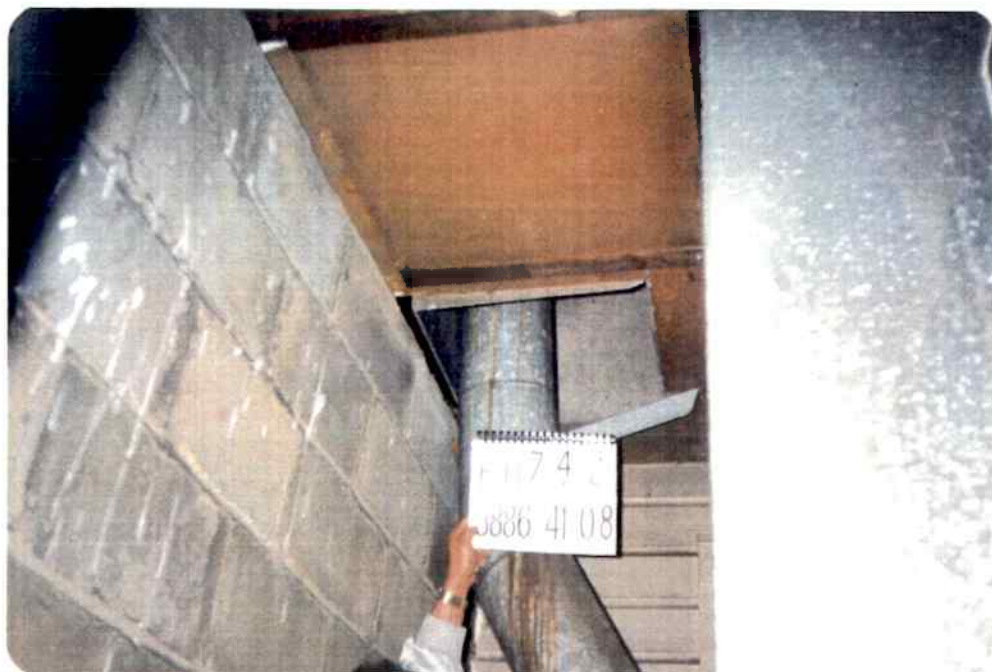
BLDG. 9379

MECHANICAL ROOM: (SAMPLE FH742)  
TRANSITE PANEL BOARD TESTED POSITIVE.

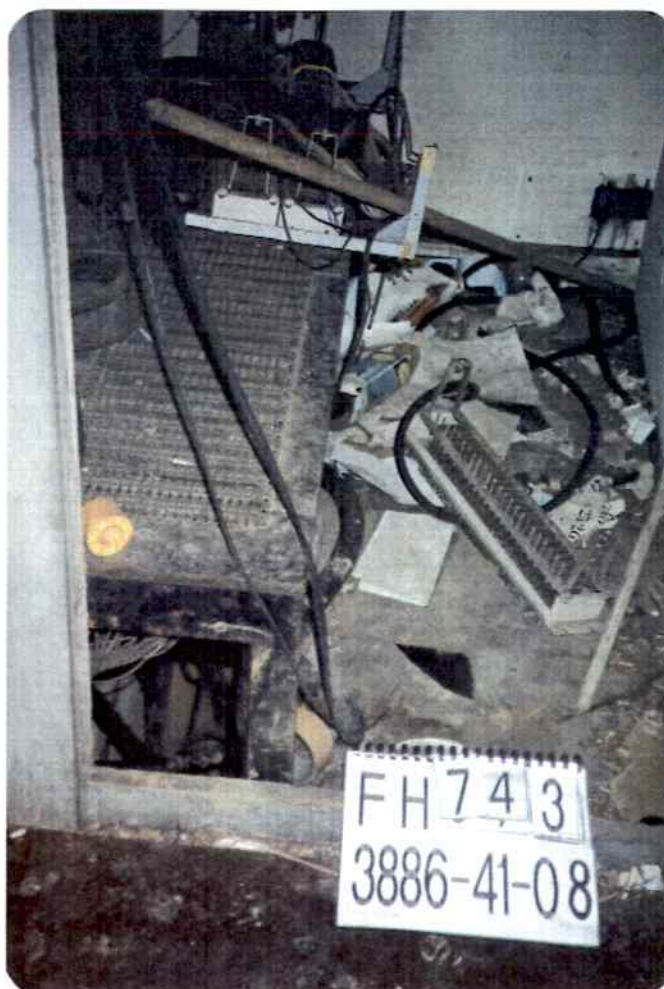
BLDG. 9379

ELECTRICAL CLOSET: (SAMPLE FH743)  
BROWN 9" X 9" FLOOR TILE TESTED POSITIVE.

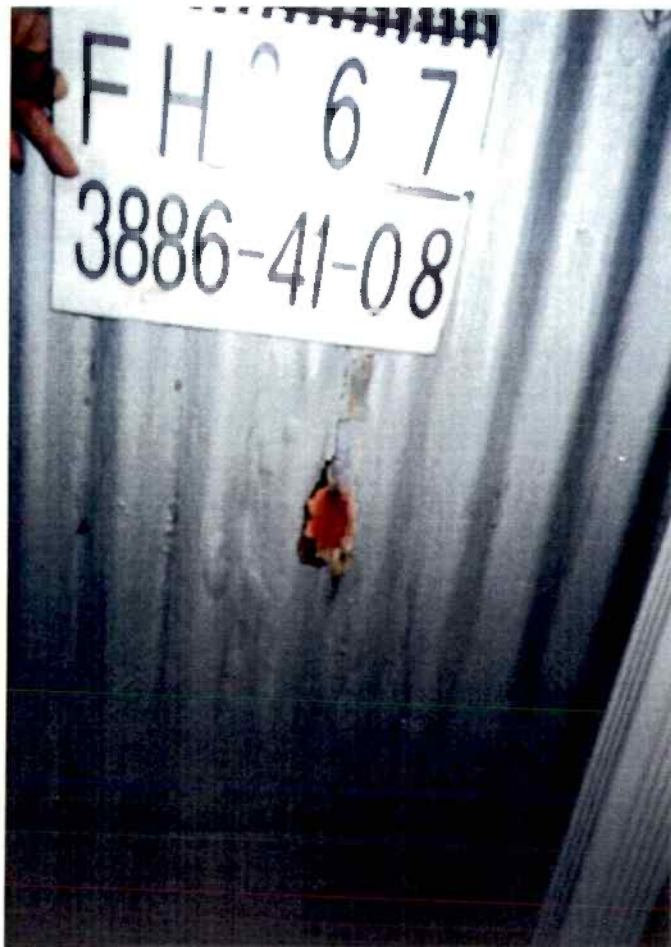
BLDG. 9392

EXTERIOR WALL: (SAMPLE FH867)  
BROWN EXTERIOR BUILDING PAPER  
TESTED POSITIVE.

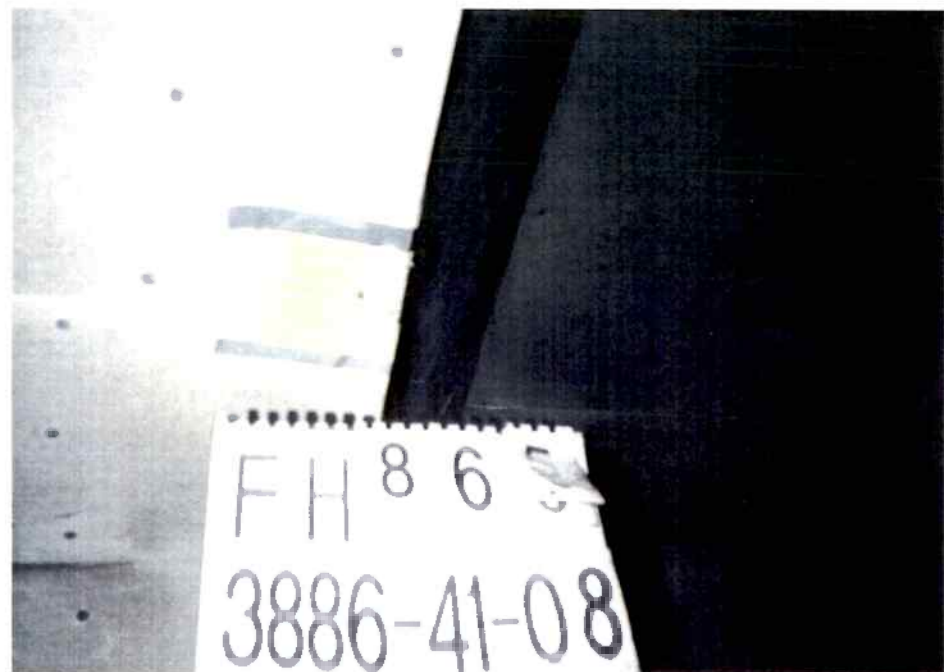
BLDG. 9392

BOILER ROOM: (SAMPLE FH865 AND FH866) TRANSITE  
PANELS TESTED POSITIVE.

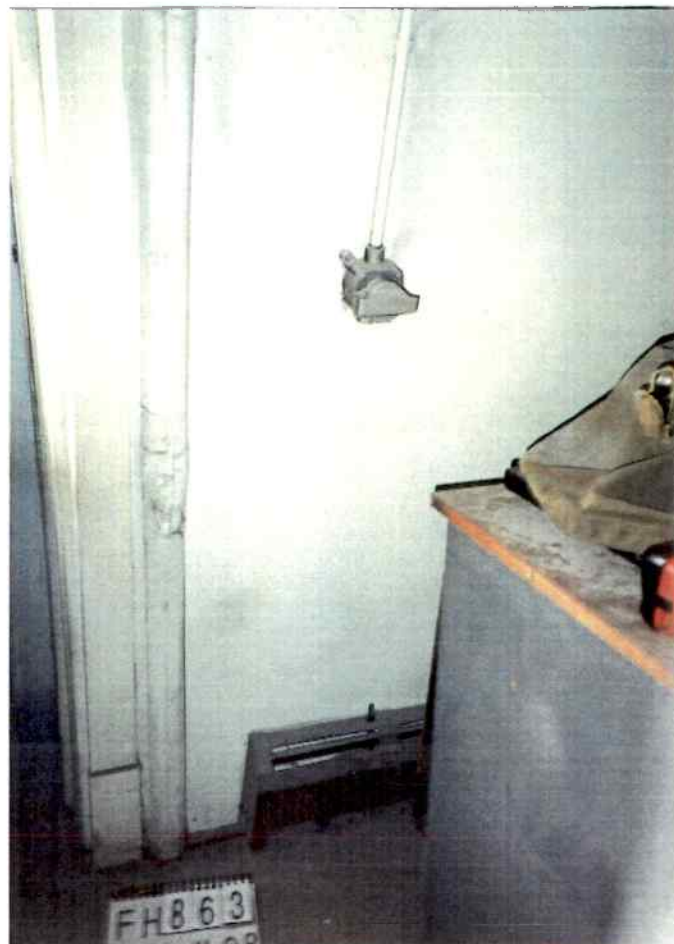
BLDG. 9392

PAINT SHOP: (SAMPLES FH862 AND FH863) < 4"  
PIPE RUN INSULATION TESTED POSTIVE.
