Volume I - Building Reports for a Comprehensive Asbestos Survey in Various Buildings at Fort Monmouth, New Jersey

February 1992

BUILDING REPORTS FOR A COMPREHENSIVE ASBESTOS SURVEY IN VARIOUS BUILDINGS AT FORT MONMOUTH, NEW JERSEY

VOLUME I

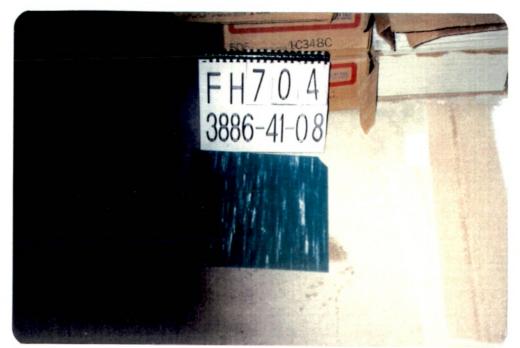
BLDG. 63

BAY 4: (SAMPLE FH704) GREEN 9" X 9" FLOOR TILE TESTED POSITIVE.

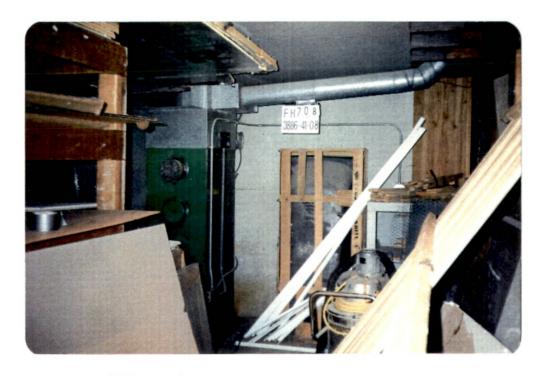
BLDG. 63

BAY 4: (SAMPLE FH708) TRANSITE PANEL BOARD TESTED POSITIVE. TRANSITE PANELS ARE ALSO PRESENT IN BAYS 2 & 6.

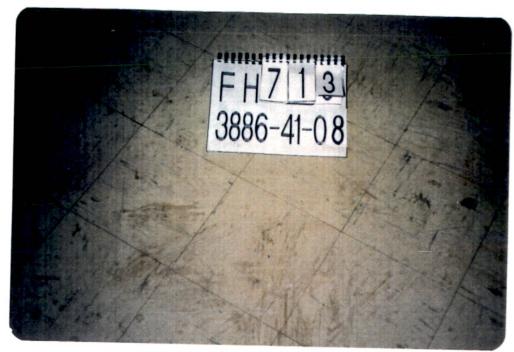
BLDG. 80

WAREHOUSE OFFICE: (SAMPLE FH713)
TAN 9" X 9" FLOOR TILE TESTED POSITIVE.

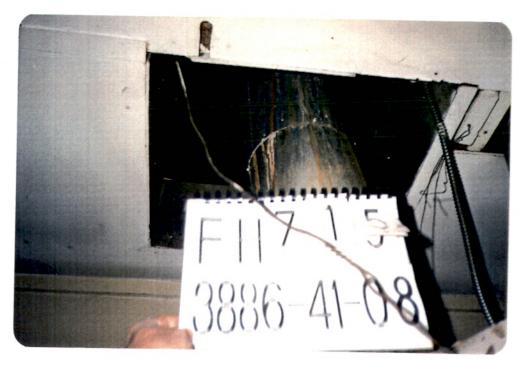
BLDG. 80

HEATER ROOM: (SAMPLE FH715)
TRANSITE PANEL BOARD TESTED POSITIVE.

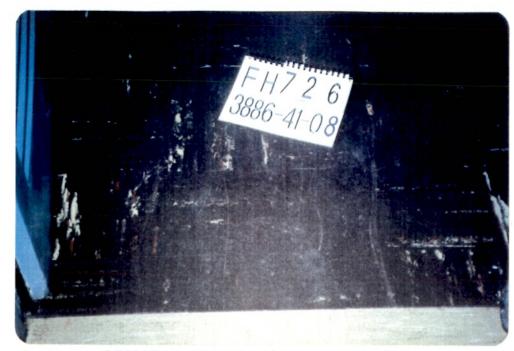
BLDG. 108

DISPATCH OFFICE: (SAMPLE FH726) BROWN 9" X 9" FLOOR TILE TESTED POSITIVE.

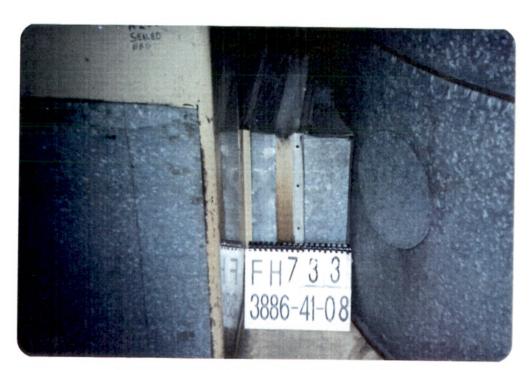
BLDG. 108

MECHANICAL ROOM: (SAMPLE FH733) EXPANSION JOINT TESTED POSITIVE.

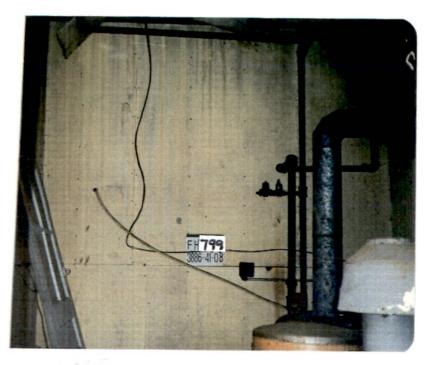
BLDG. 198

MECHANICAL ROOM: (SAMPLE FH799) TRANSITE PANEL BOARD TESTED POSITIVE.

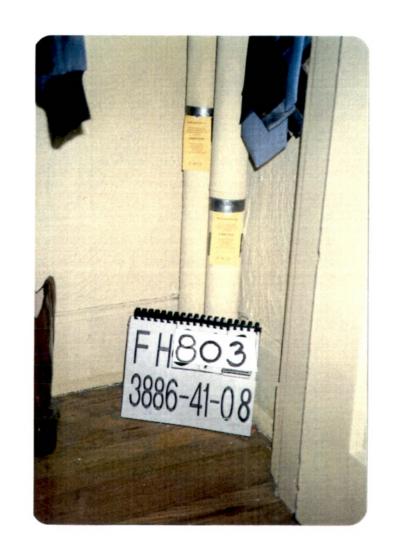
BLDG. 265

SECOND FLOOR, BEDROOM #1: (SAMPLE FH803) <4" PIPE RUN INSULATION TESTED POSITIVE.

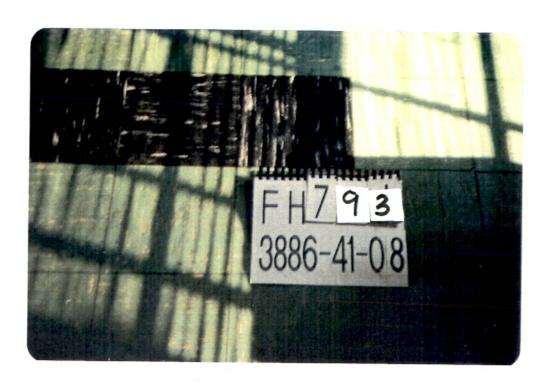
BLDG. 279

OFFICE AREA: BLACK AND GREEN 9" X 9" FLOOR TILES TESTED POSITIVE. (SAMPLES FH793 AND FH794).

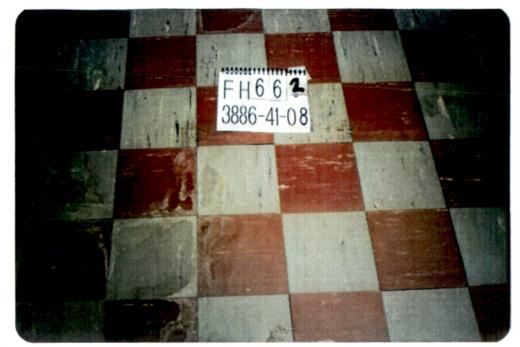
BLDG. 482

LOCKER ROOM/TOILET: (SAMPLE FH662) RED 9" X 9" FLOOR TILE TESTED POSITIVE. GRAY 9" X 9" FLOOR TILE (SAMPLE FH761) ALSO TESTED POSITIVE.

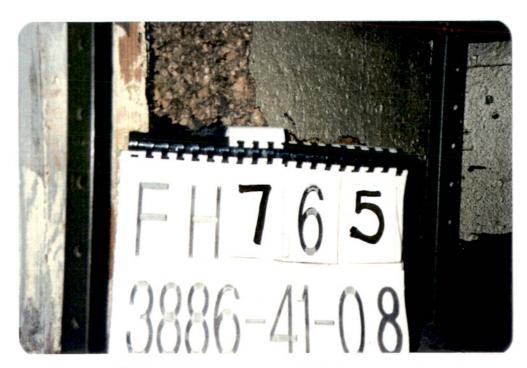
BLDG. 482

WOOD WORKING SHOP: (SAMPLE FH765) CORK INSULATION TESTED POSITIVE. CORK INSULATION IS PRESENT ON WALLS AND CEILINGS OF THE ENTIRE BUILDING.

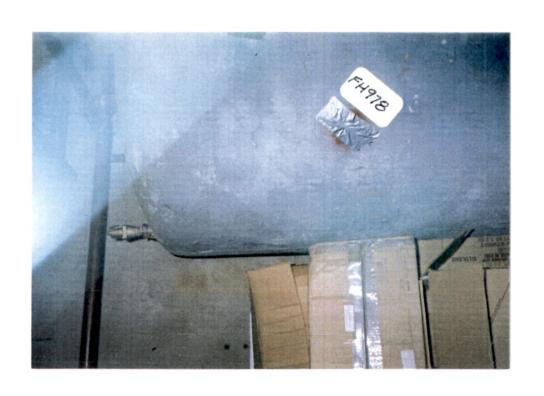
BLDG. 490 (SAMPLE FH978) GRAY TANK INSULATION TESTED POSITIVE.

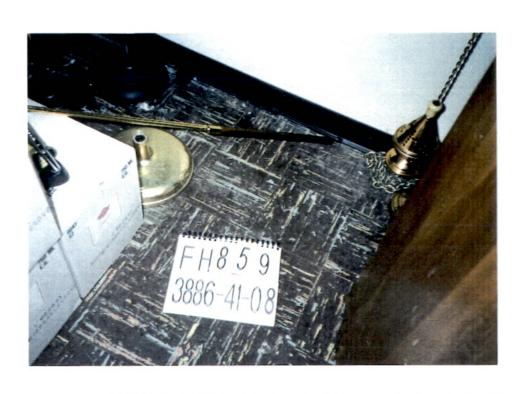
BLDG. 500

SACRISTY CLOSET: (SAMPLE FH859) BROWN 9" X 9" FLOOR TILE TESTED POSITIVE.

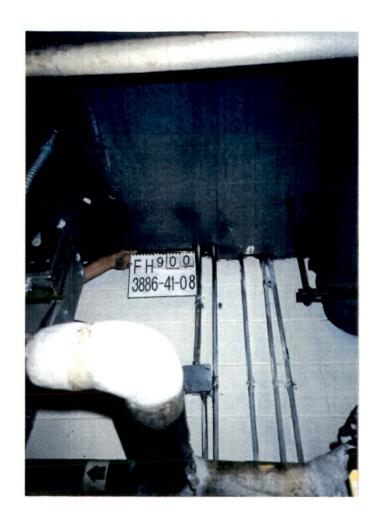
BLDG. 501

MECHANICAL ROOM: (SAMPLE FH900) GRAY TRANSITE PANEL BOARD TESTED POSITIVE.

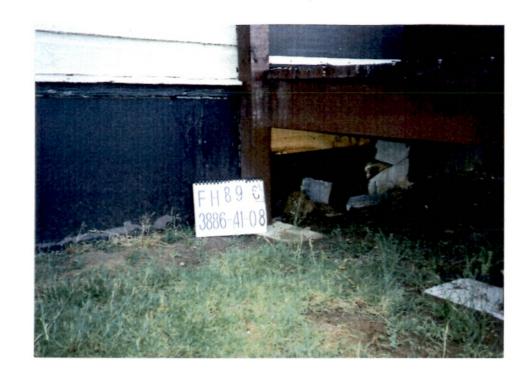
BLDG 605

EXTERIOR WALL: (SAMPLE FH896) GRAY TRANSITE PANEL BOARD TESTED POSITIVE.

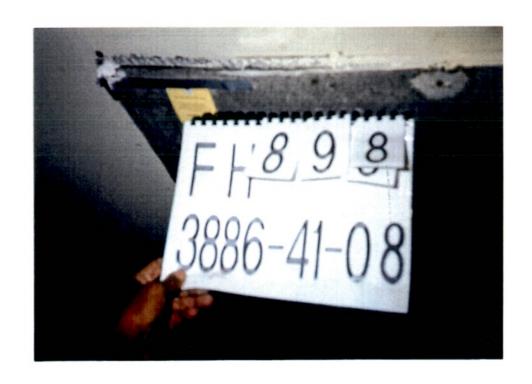
BLDG. 605 MECHANICAL ROOM: (SAMPLE FH898) GRAY TRANSITE PANEL TESTED POSITIVE.

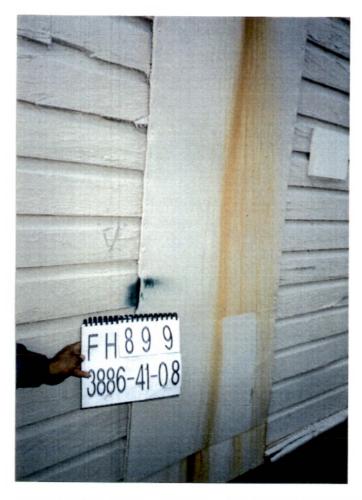
BLDG. 605

EXTERIOR WALL PATCH: (SAMPLE FH899)
TRANSITE PANEL BOARD TESTED POSITIVE.

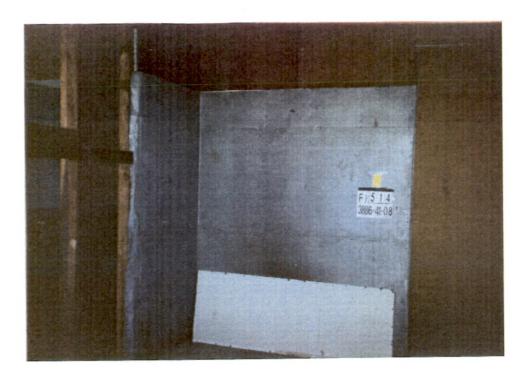
BLDG. 623

PCB STOREHOUSE: (SAMPLE FK514) GRAY FIREPROOFING WALL INSULATION TESTED POSITIVE.

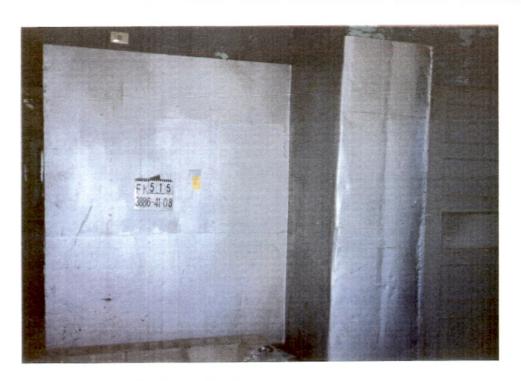
BLDG.623

PCB STOREHOUSE: (SAMPLE FK515) GRAY FIREPROOFING INSULATION LOCATED BEHIND SHEET METAL TESTED POSITIVE.

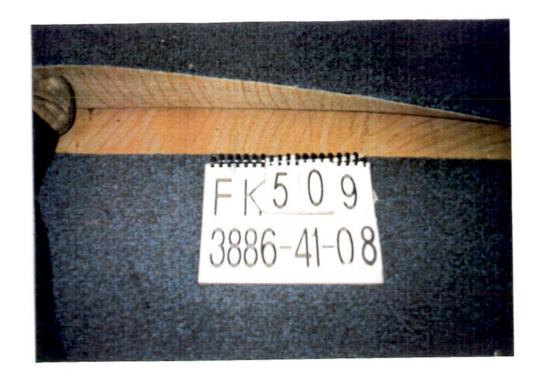
BLDG. 668

OPEN OFFICE: (SAMPLE FK509) TAN 9" X 9" FLOOR TILE TESTED POSITIVE.

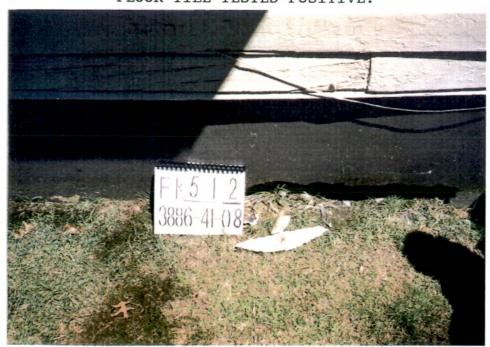
BLDG. 668

EXTERIOR WALL: (SAMPLE FK512) GRAY TRANSITE SKIRT, (PAINTED BROWN), TESTED POSITIVE.
