**U.S. Army Corps of Engineers  
Philadelphia District**

***Volume III - Building Reports for a  
Comprehensive Asbestos  
Survey in Various Buildings at  
Fort Monmouth, New Jersey***

Contract Number DACA61-89-D-0013

**June 1991**

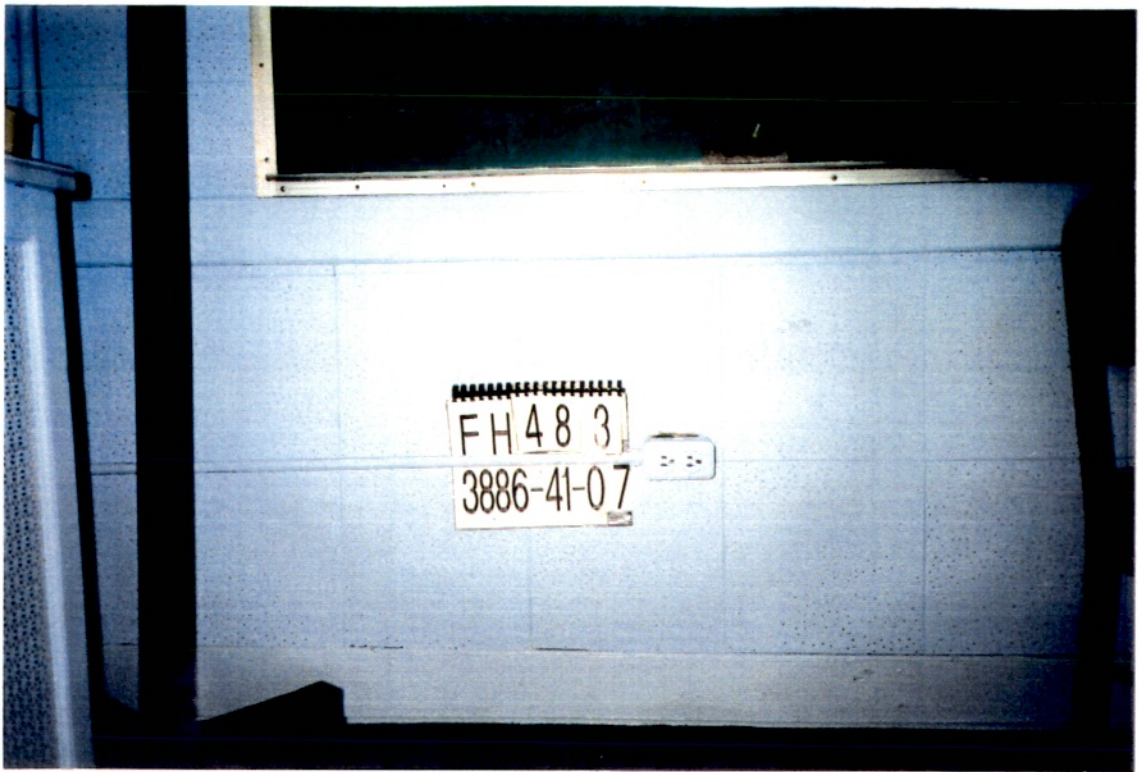
Bldg. 2525 Room 2106: Sample FH483, 12 x 12" acoustical wall tiles tested positive.

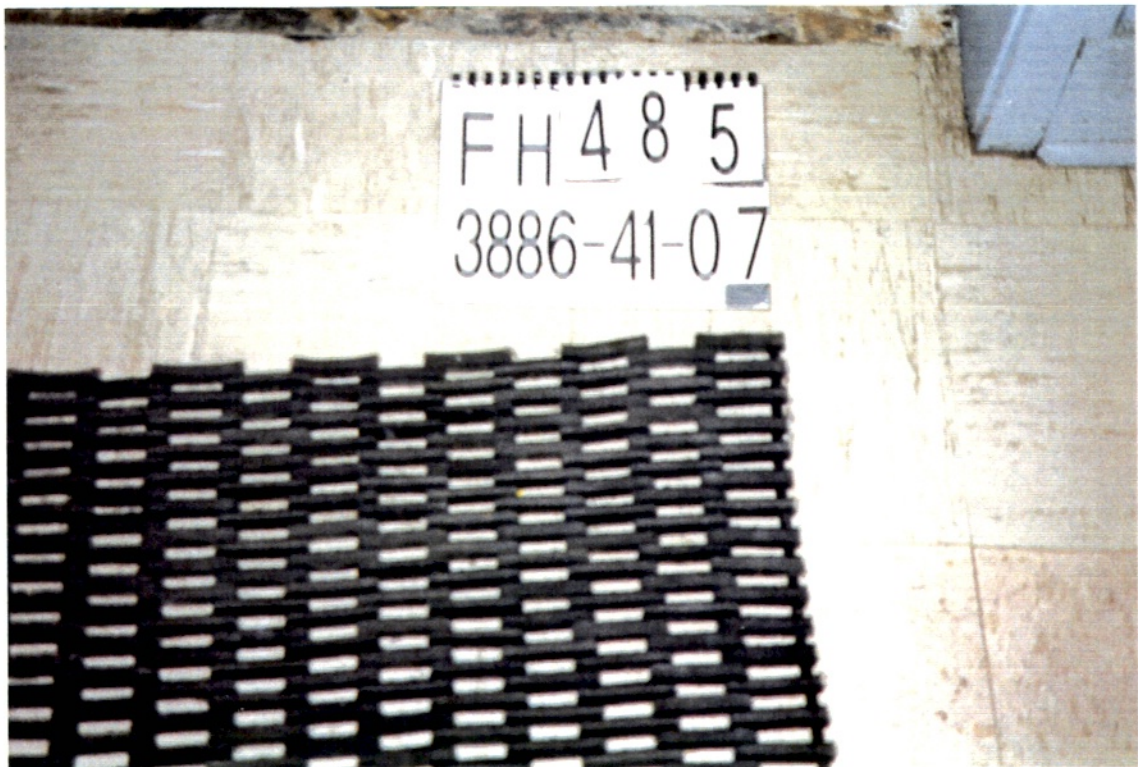
Bldg. 2525 Corridor 21A: Sample FH485, 12 x 12" tan floor tiles tested positive.

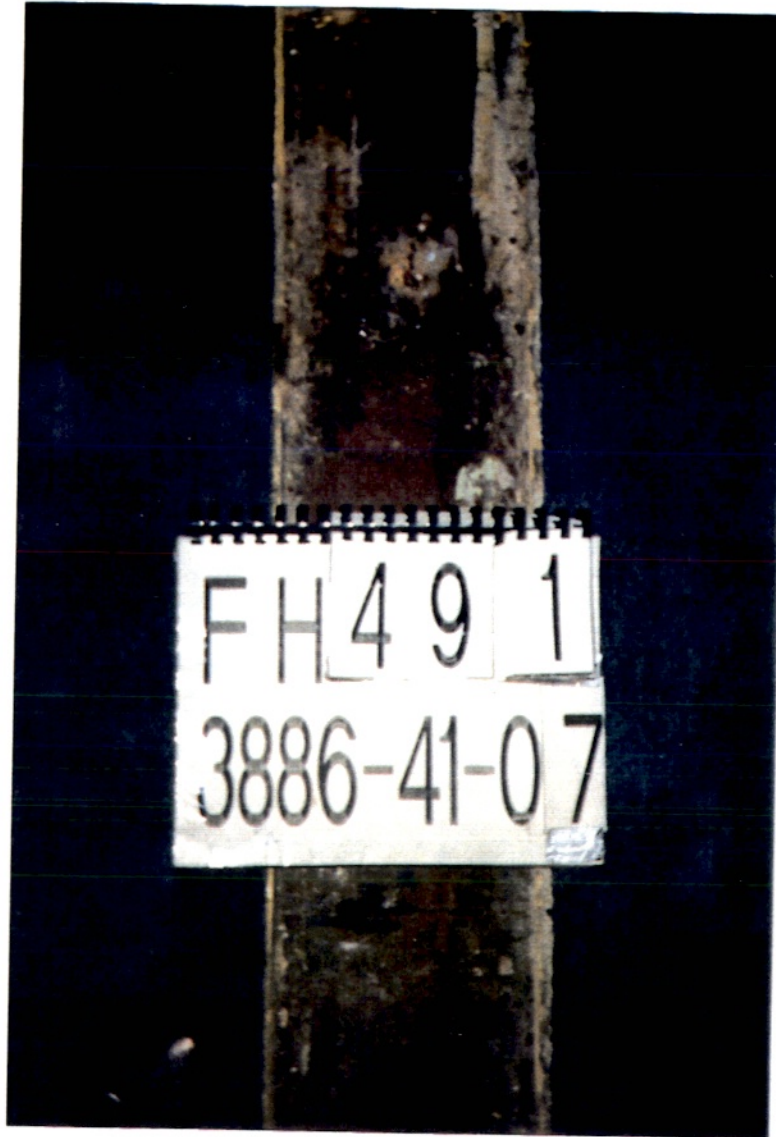
Bldg. 2525 Room 2110A; Sample No. FH491, 9 x 9" brown floor tiles under carpet and 12 x 12" tan floor tiles tested positive; sample FH492, 12 x 12" tan floor tiles also tested positive.

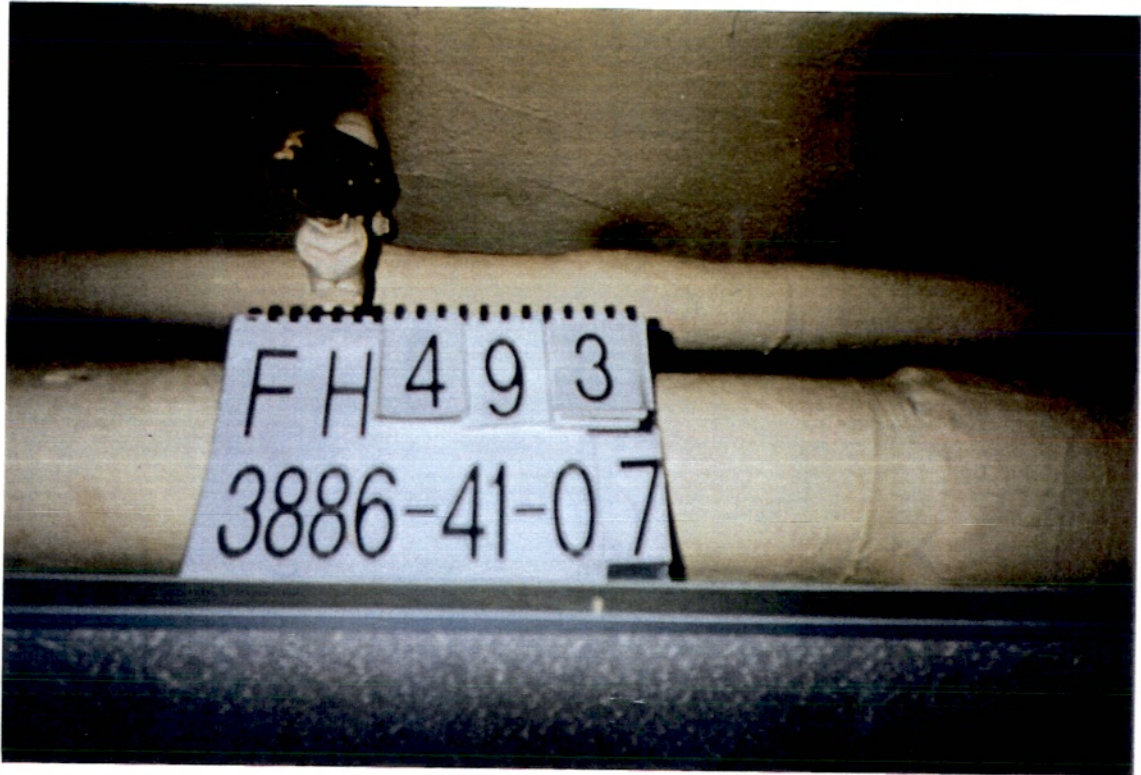
Bldg. 2525 Room 3110:

Sample FH493, < 4" pipe run tested positive. Sample FH494 (not shown) < 4" mud fitting tested positive; sample FH495 (not shown) < 4" pipe run also tested positive.

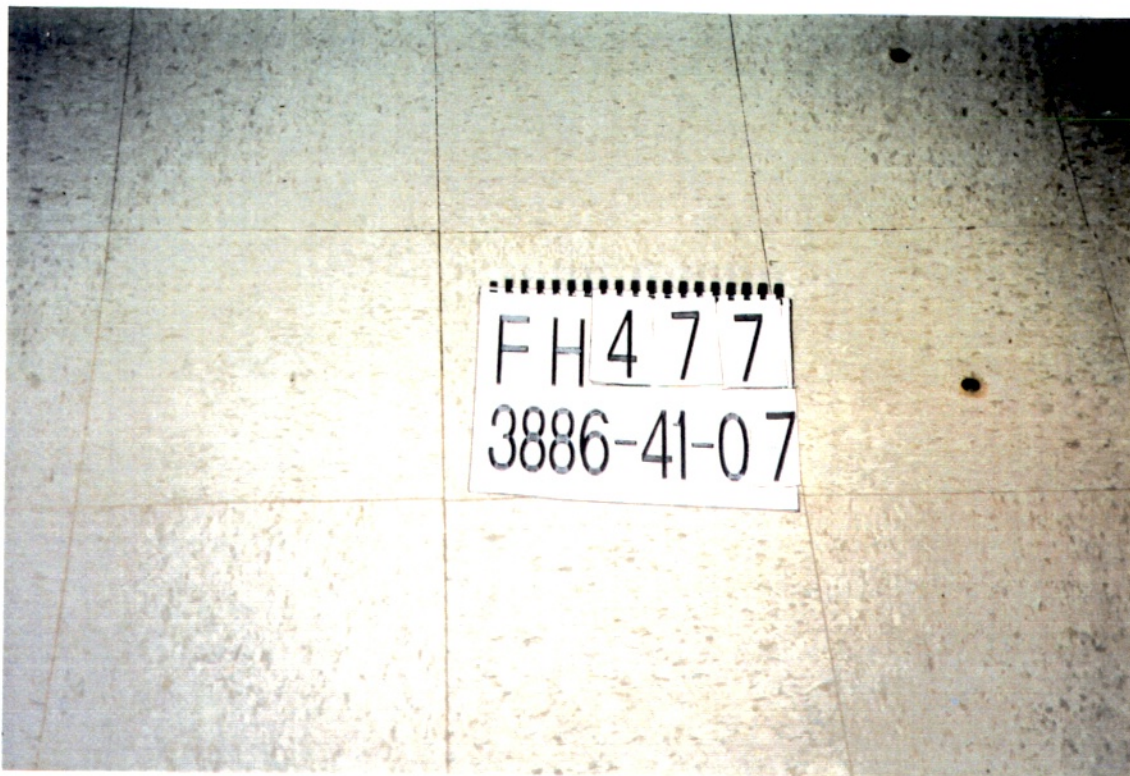
Bldg. 2525 Room 2101: Sample FH477, 12 x 12" tan floor tiles tested positive.

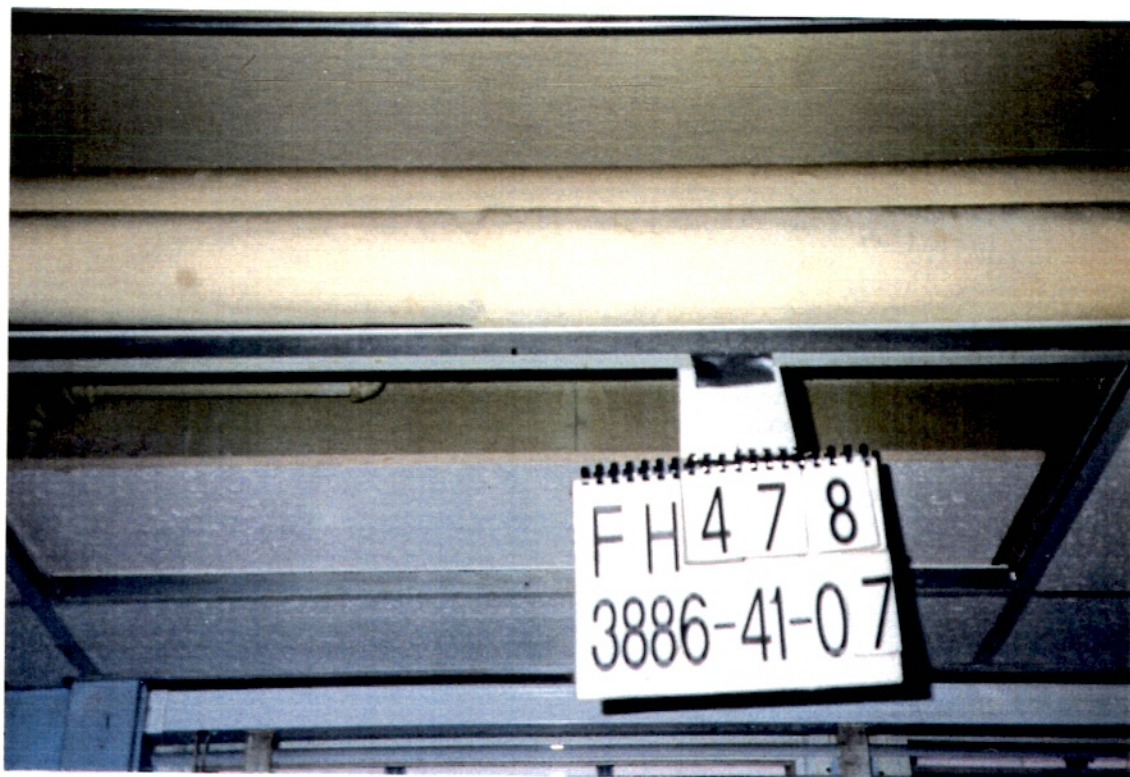
Bldg. 2525 Room 2101: Sample FH478, 4 - 8" pipe run tested positive; sample FH480 (not shown) 4 - 8" pipe run also tested positive.

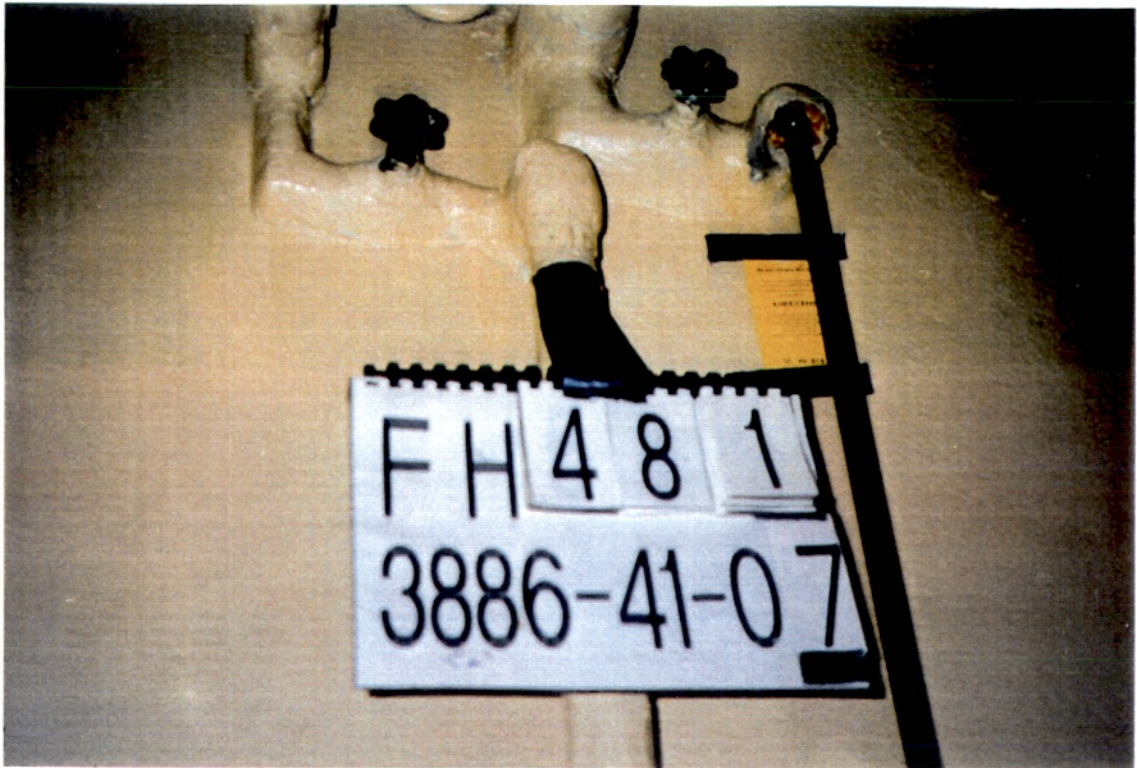
Bldg. 2525 Room 2102A: Sample FH481, < 4" mud fitting tested positive.

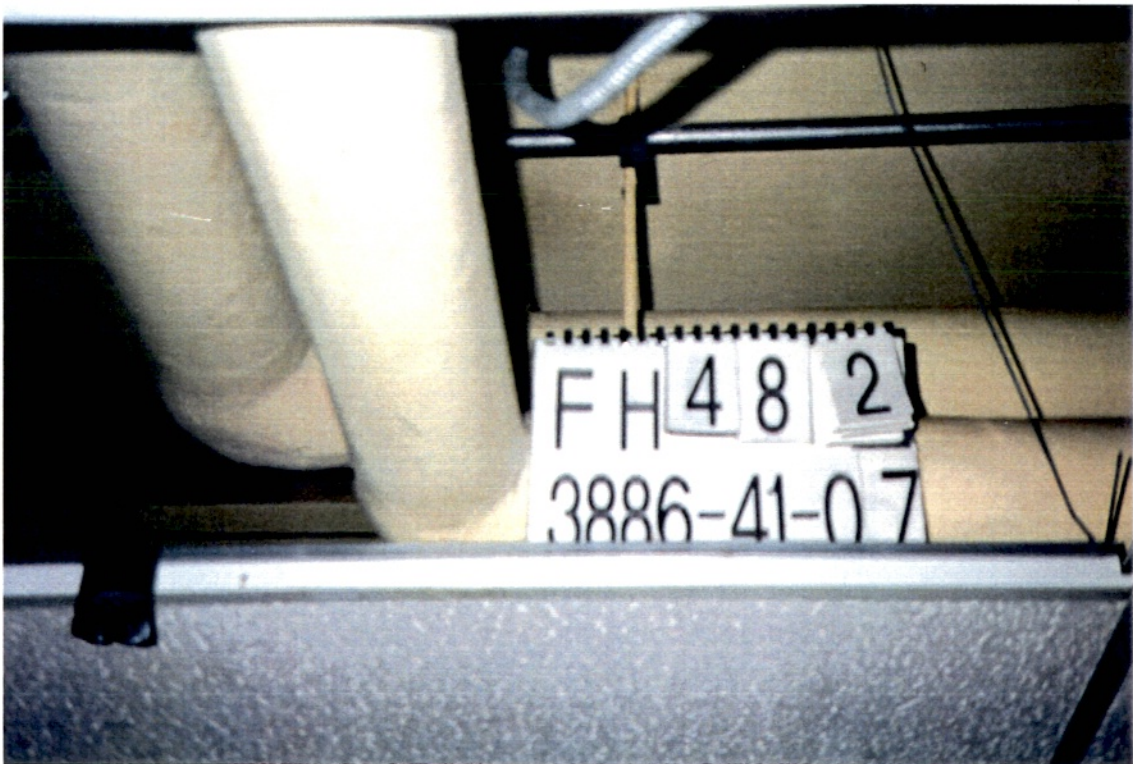
Bldg. 2525 Room 2105A: Sample FH482, 4 - 8" mud fitting tested positive. Samples FH484 (not shown) 4 - 8" mud fitting tested positive.

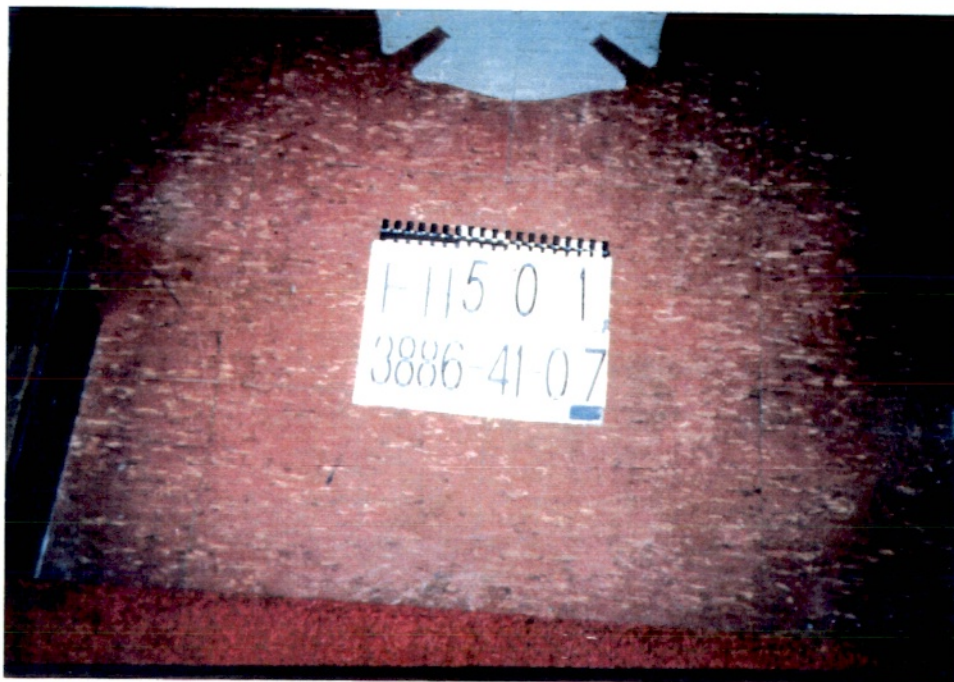
Bldg. 2536 - Fire Station, Hallway:

12 x 12" red floor tiles  
tested positive.

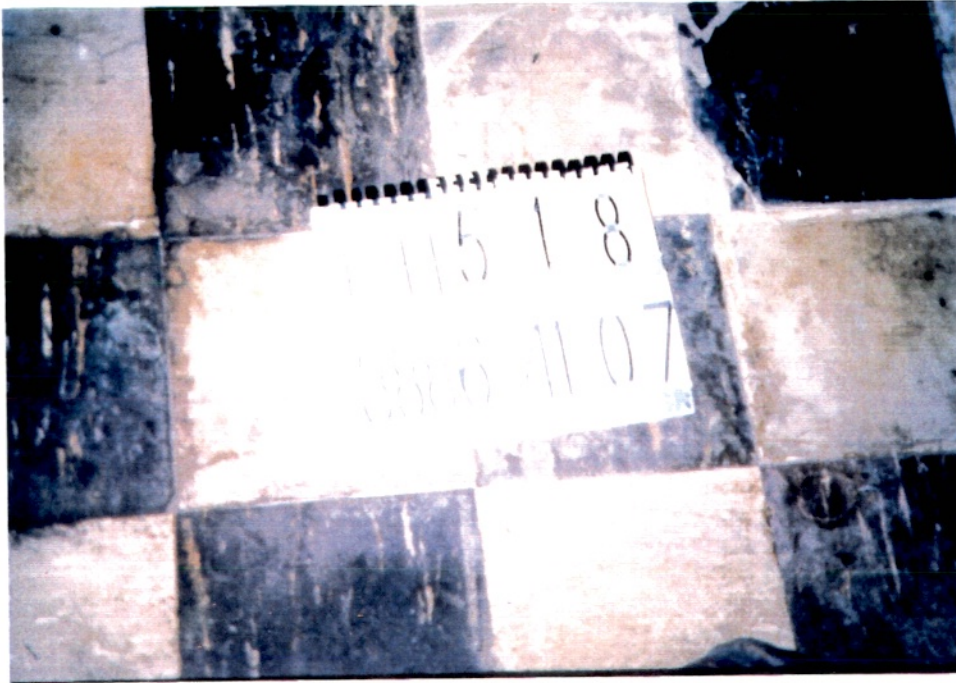
Bldg. 2704 - Test Chamber, Mechanical Room: 9 x 9" floor tiles tested positive. Samples FH516; FH517; FH519 and FH520, floor tiles (not shown) all tested positive.

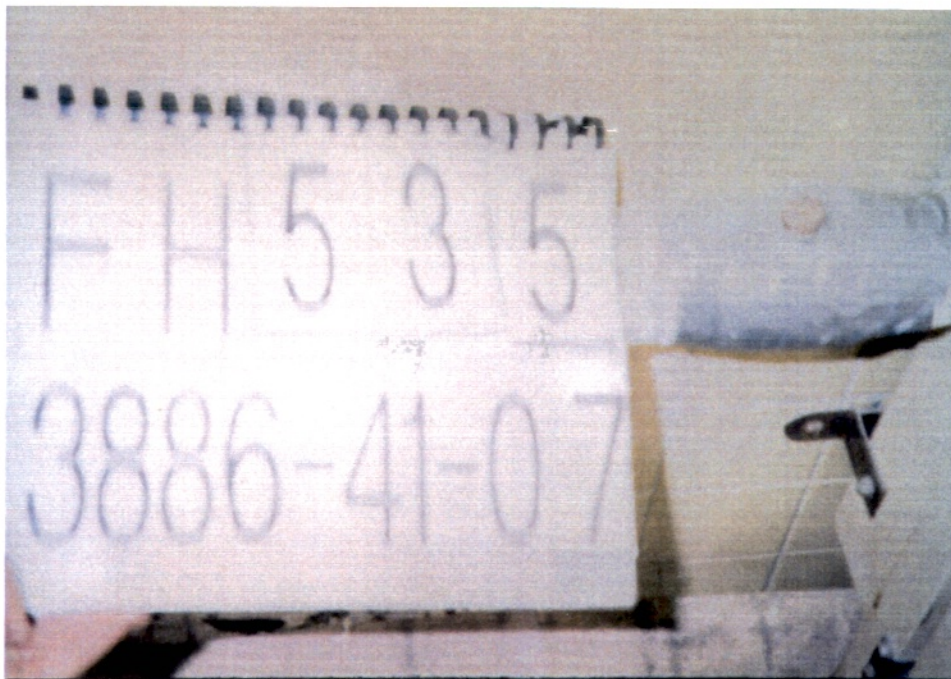
Bldg. 2704 - Test Chamber: < 4" mud fitting (Ladies Room) sample FH535 tested positive. Sample FH533 (not shown) also tested positive.

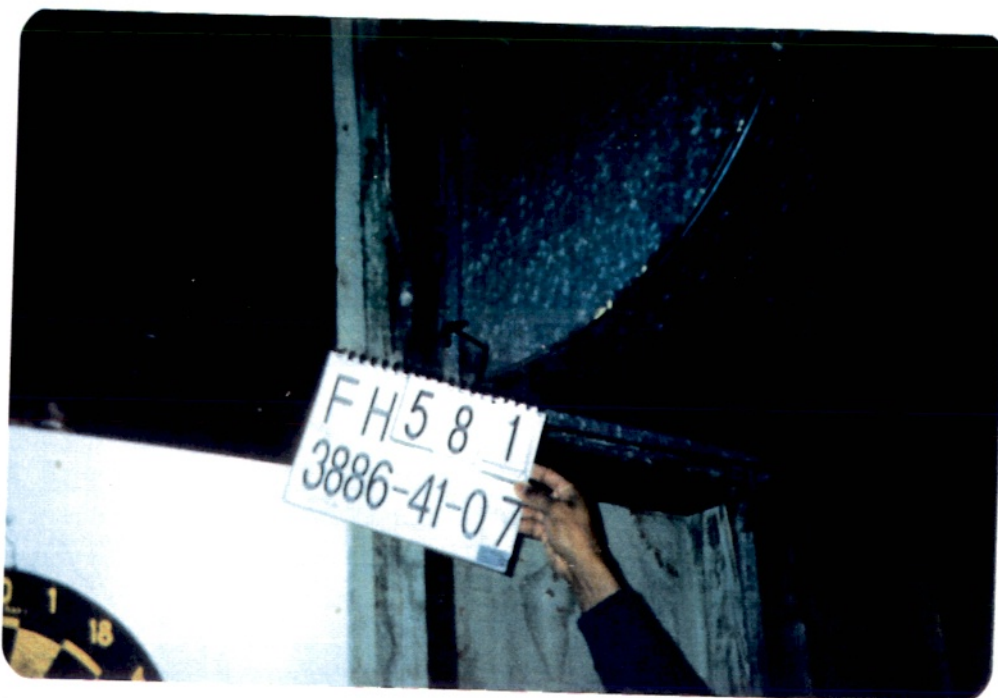
Bldg. 9009 - Serv-Air Garage/Shop: Expansion joing around metal duct, sample FH581 tested positive.

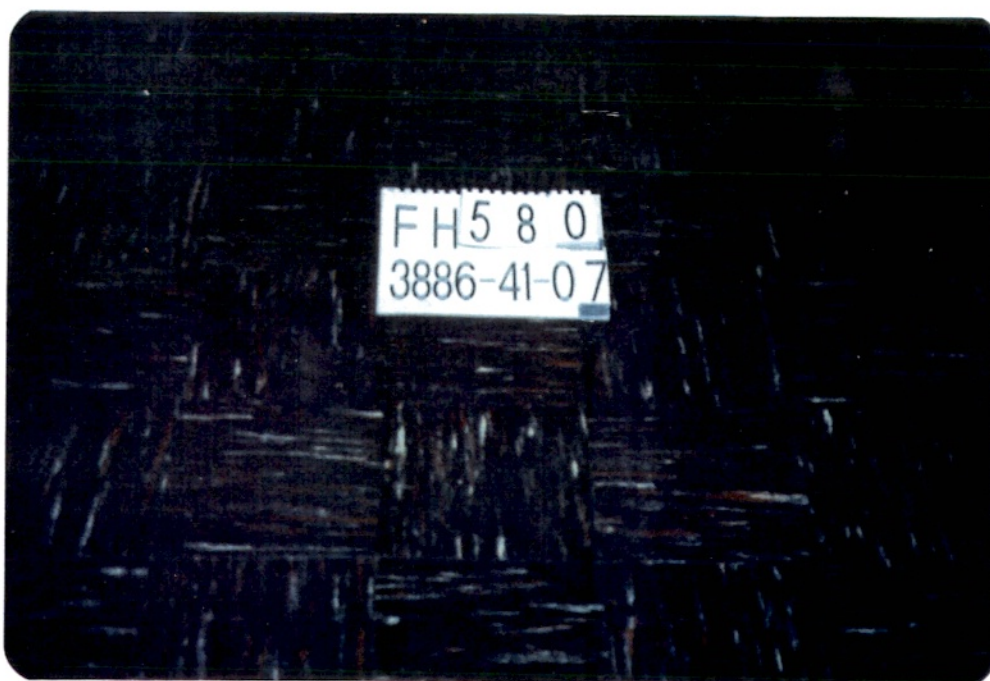
Bldg. 9009 - Serv-Air Garage/Shop: 9 x 9" floor tiles sample FH580 tested positive.

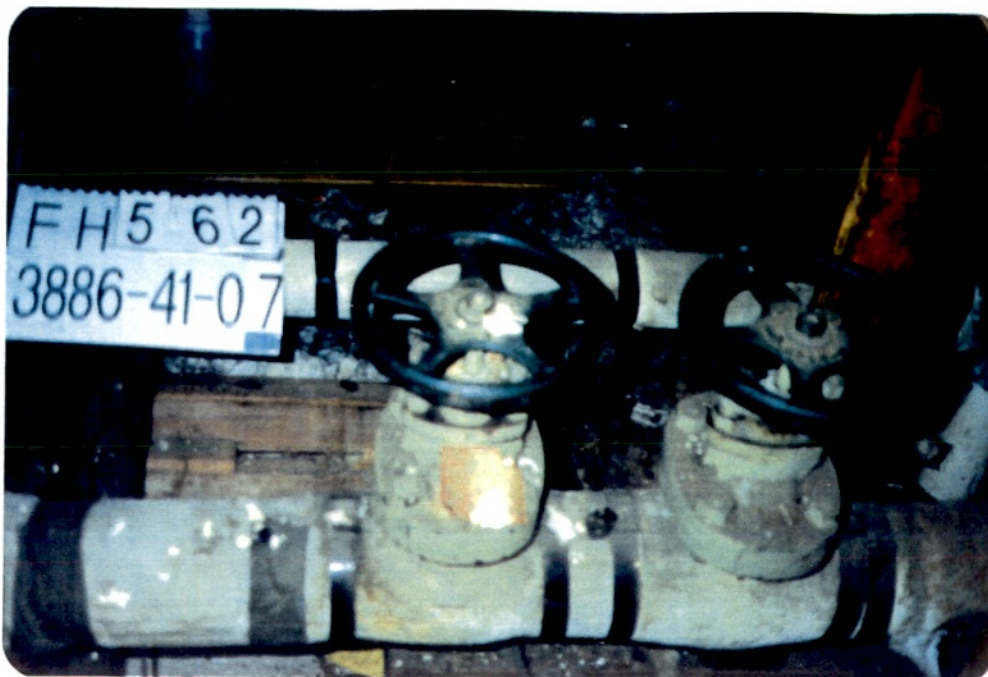
Bldg. 9011A - Attic Area: < 4" steam fitting FH562 tested positive. Sample FH563 < 4" pipe run (not shown) also tested positive.

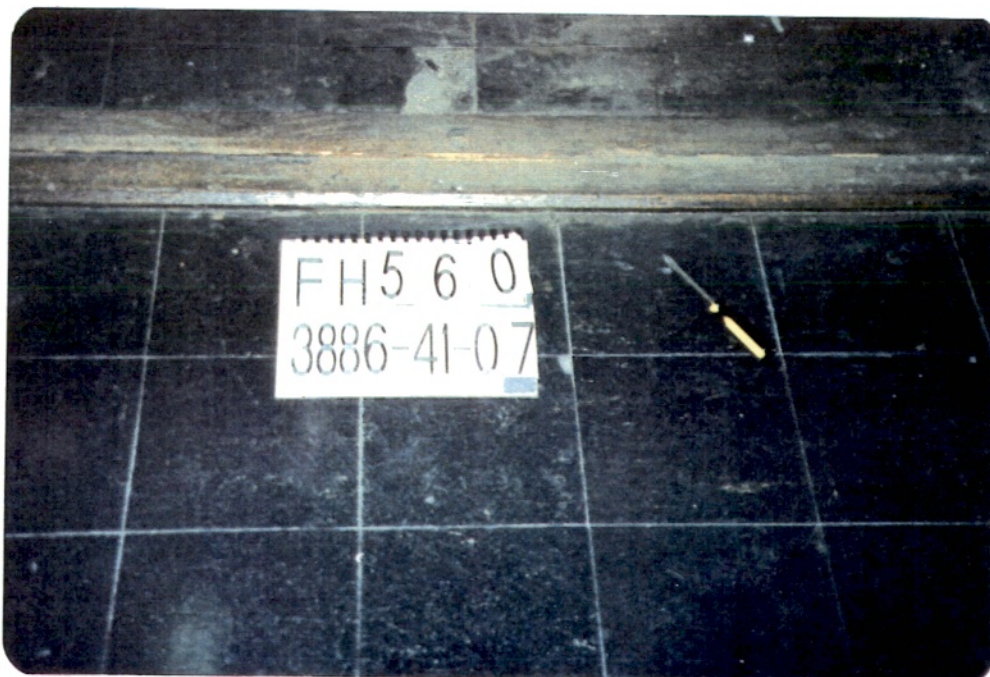
Bldg. 9011A - Mechanical Room: 9 x 9" black floor tiles FH560 tested positive, Office 1A; 9 x 9" black floor tiles FH559 also tested positive. Metal shop storage 9 x 9" black floor tiles FH558 also tested positive.

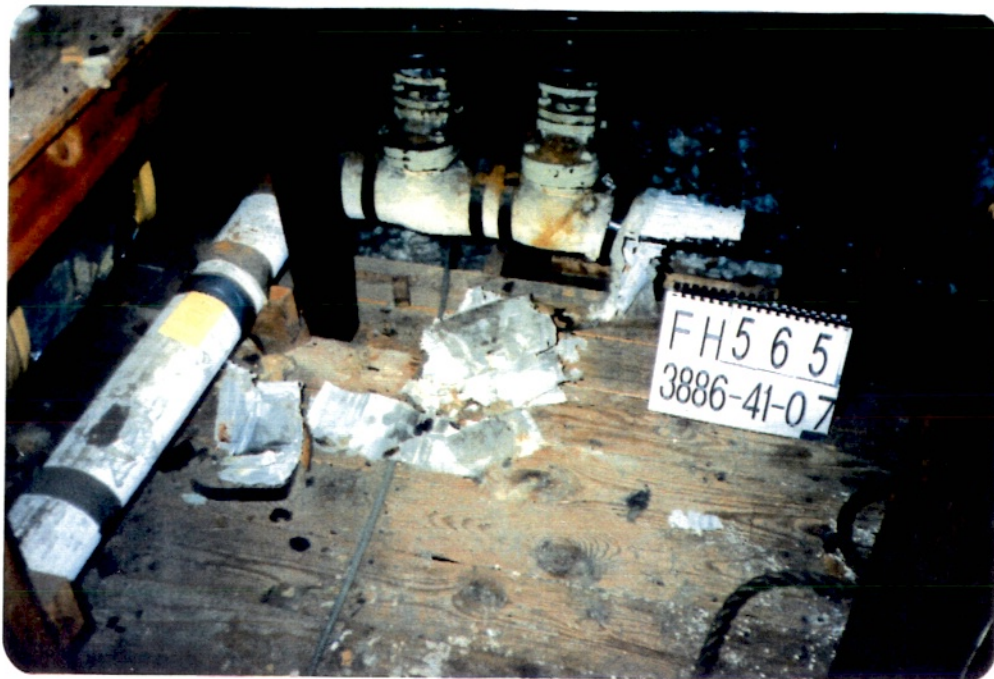
Bldg. 9011A - Attic Area: 4 - 8" steam pipe insulation sample FH565 tested positive.

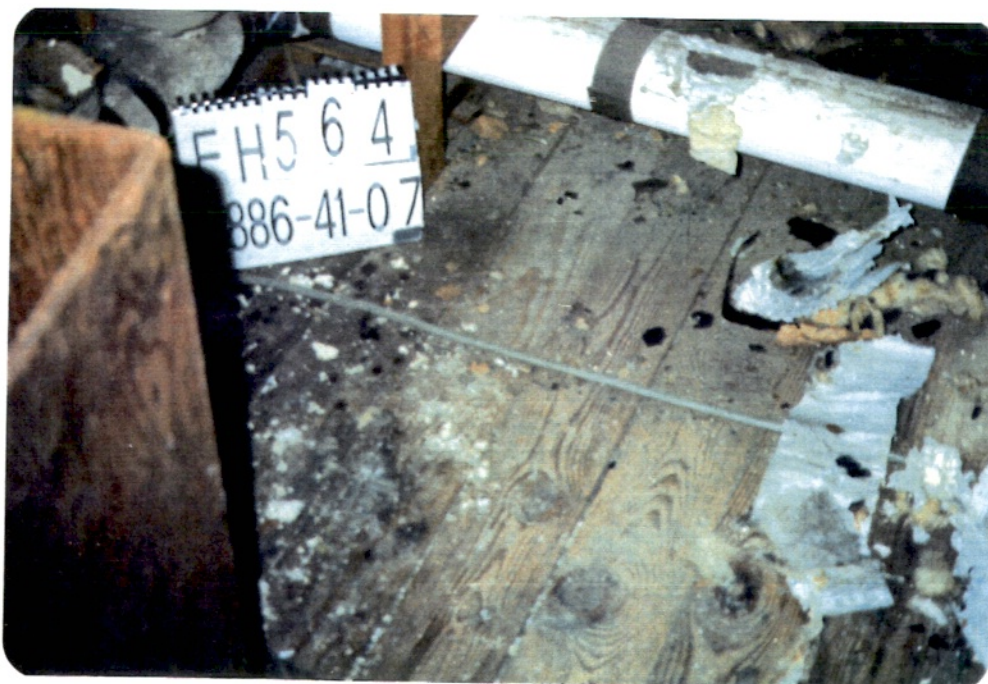
Bldg. 9011A - Attic Area: 4 - 8" mud fitting sample FH564 tested positive.

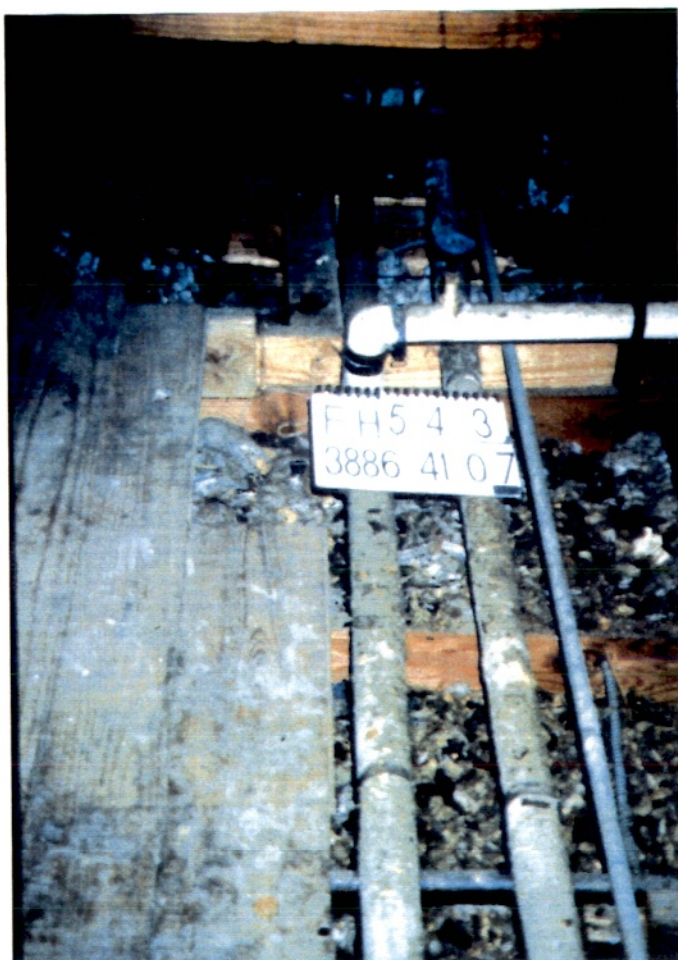
Bldg. 9011D - Attic: < 4" mud fitting sample FH543 tested positive; samples FH545 (not shown) 4 - 8" mud fitting tested positive; sample FH547 < 4" mud fitting tested positive (not shown); also sample FH549 (not shown), 4 - 8" mud fitting tested positive.

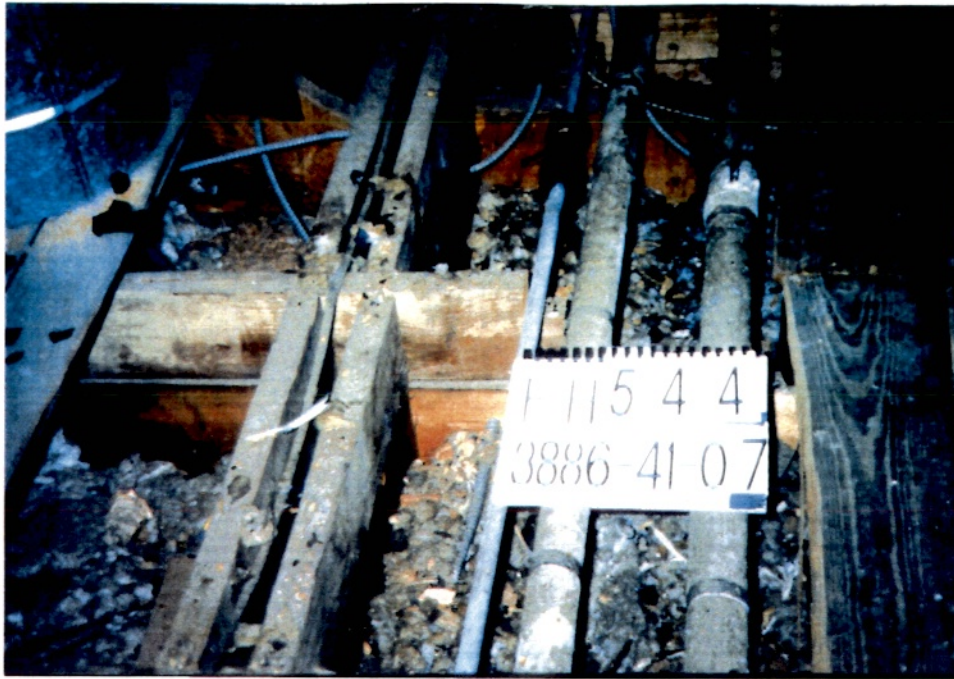
Bldg. 9011D - Attic: < 4" pipe run sample FH544 tested positive, also testing positive and not shown are samples FH546 4 - 8" pipe run; sample FH548 < 4" pipe run; sample FH550 4 - 8" pipe run.

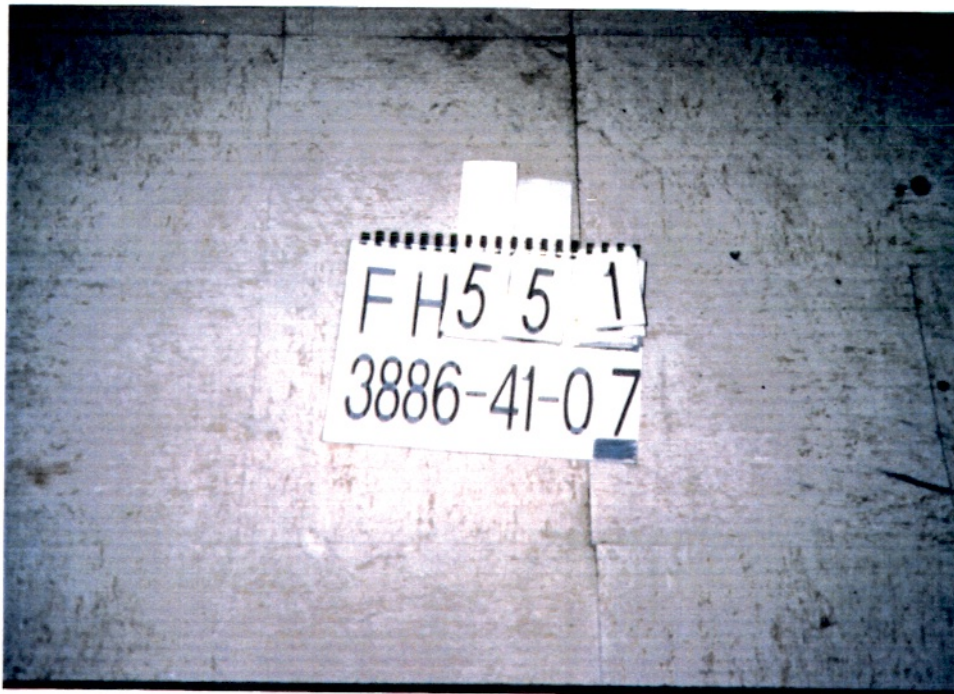
Bldg. 9011D - Corridor D: Sample FH551 12 x 12" tan floor tiles tested positive; sample FH552 (not shown) 9 x 9" red floor tiles also tested positive. Following floor tile samples tested positive (not shown) are: FH557, 12 x 12" tan; FH558, 9 x 9" black, FH559 and FH560 also 9 x 9" black.

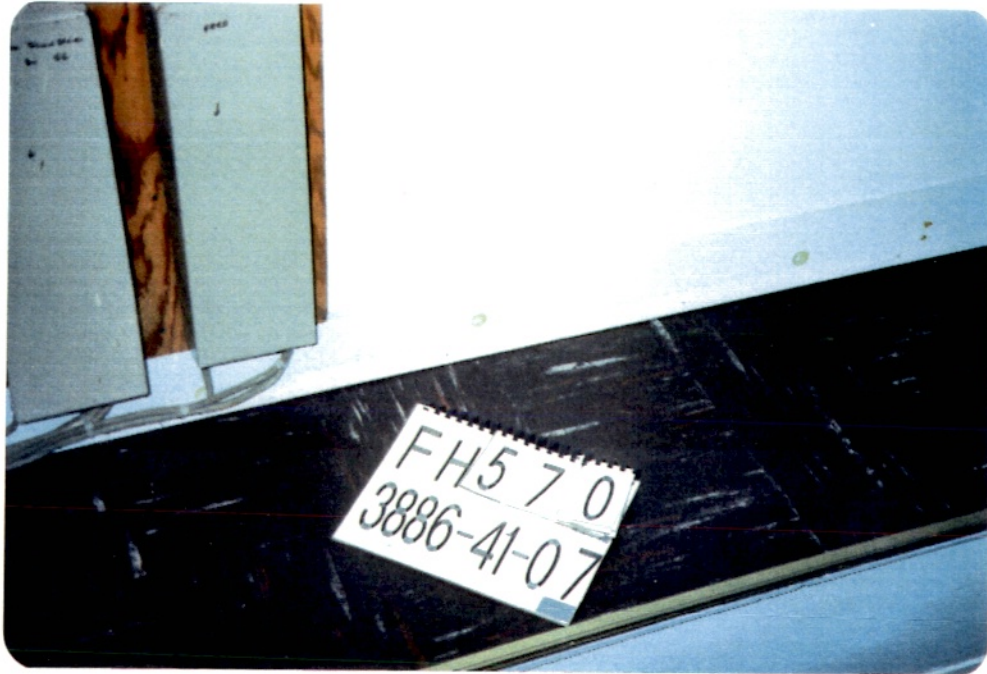
Bldg. 9015 - EW RSTA: 9 x 9" brown floor tiles FH570 tested positive.

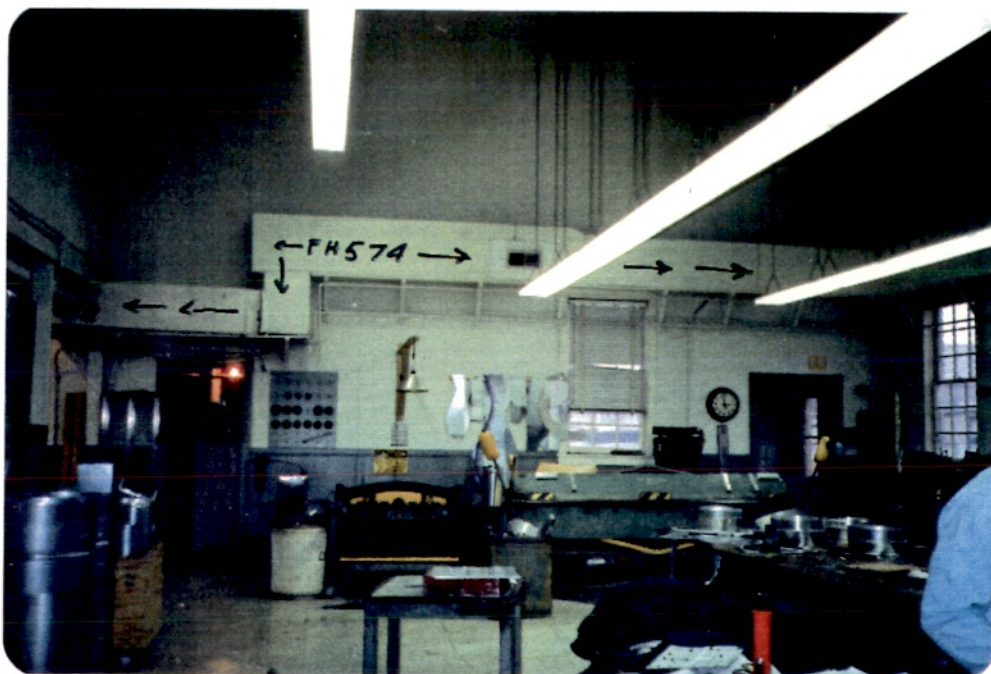
Bldg. 9023 - Metal Shop: Duct insulation sample FH574 tested positive; also sample FH572, 12 x 12" tan floor tiles in shop area tested positive. Sample FH573, 12 x 12" tan floor tiles upstairs offices (FH572 and FH573 not shown).

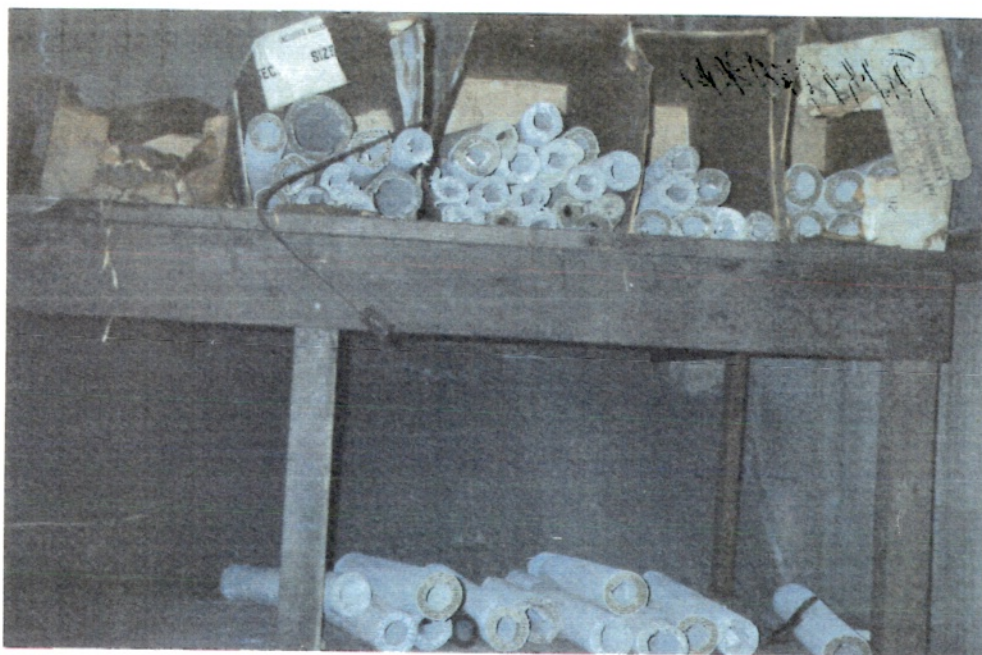
Bldg. 9041 - Basement:   Aircell-type pipe insulation tested positive.

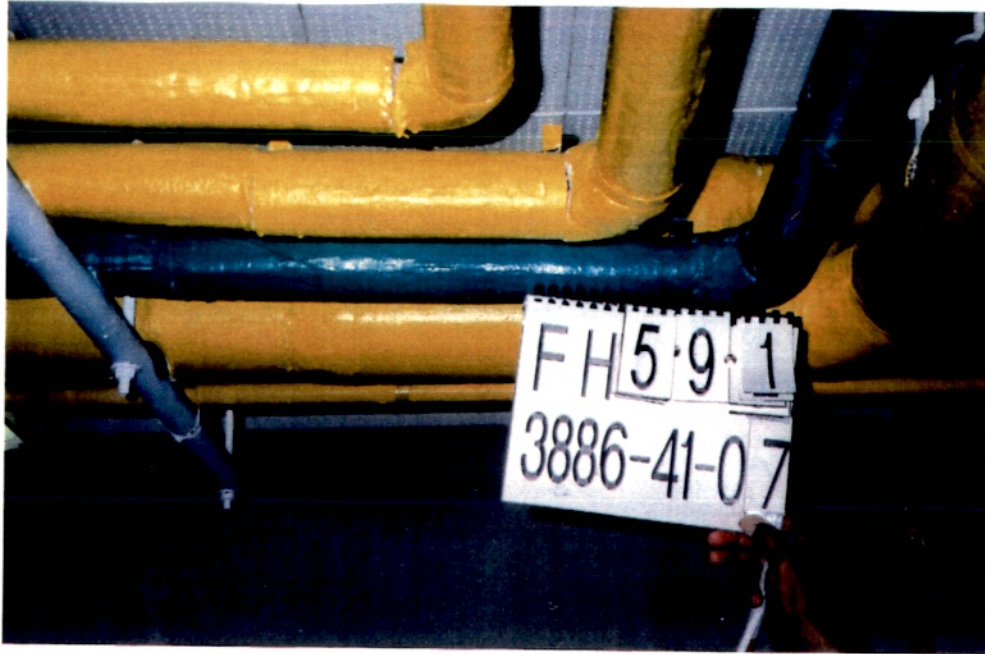
Bldg. 9042 - Basement: Sample FH591 < 4" mud fitting tested positive. Samples FH592 < 4" pipe run; sample FH593, 4 - 8" mud fitting; and sample FH594, 4 - 8" pipe run all tested positive.

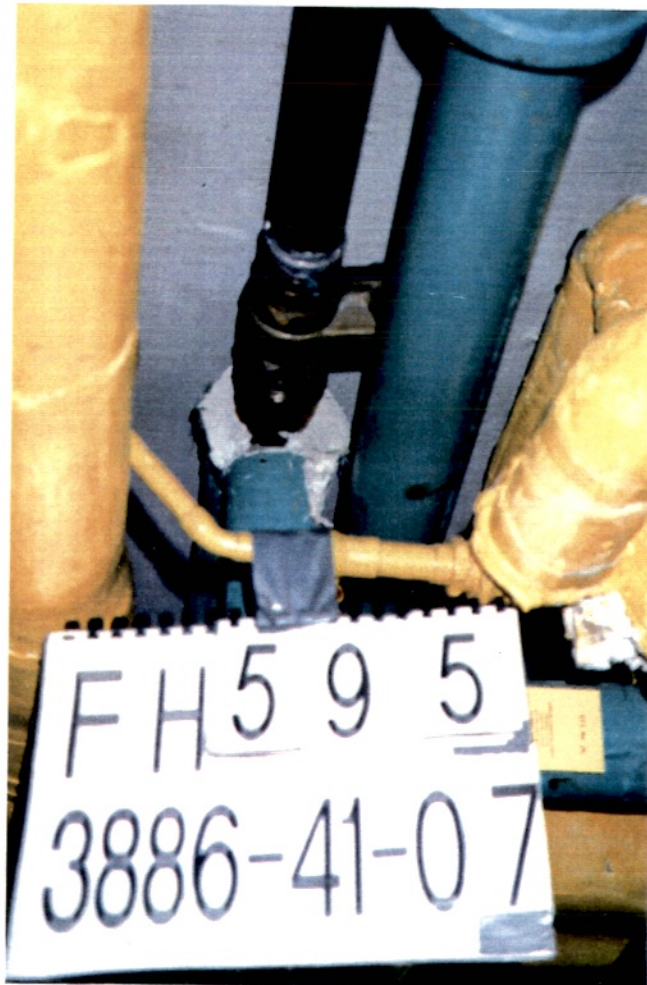
Bldg. 9042 - Basement: Sample FH595 < 4" mud fitting tested positive.

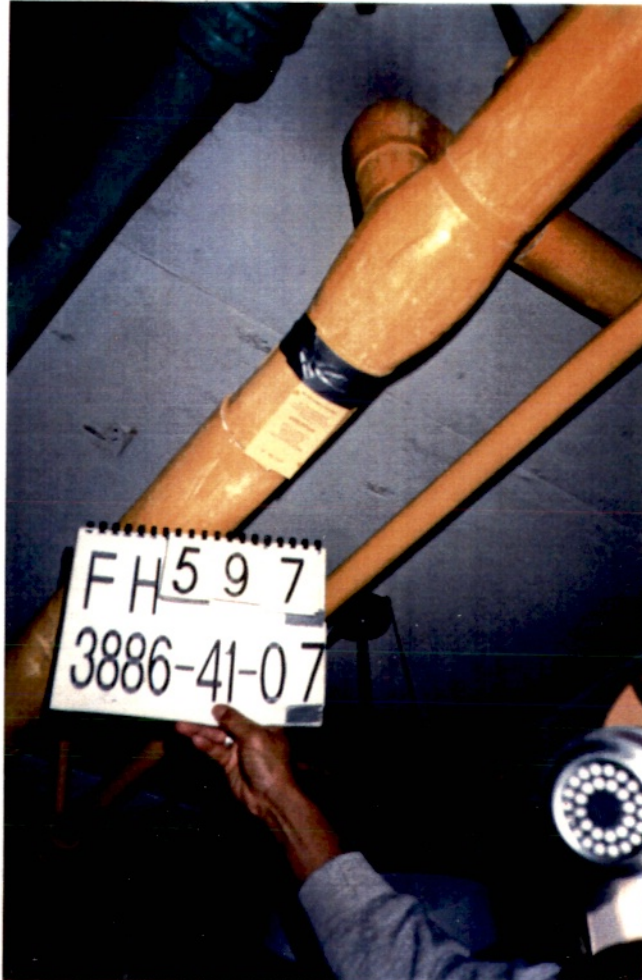
Bldg. 9042 - Basement: Sample FH596 (not shown) < 4" pipe insulation tested positive; sample FH597, 4 - 8" mud fitting tested positive; sample FH598, 4 - 8" pipe insulation (not shown) also tested positive.

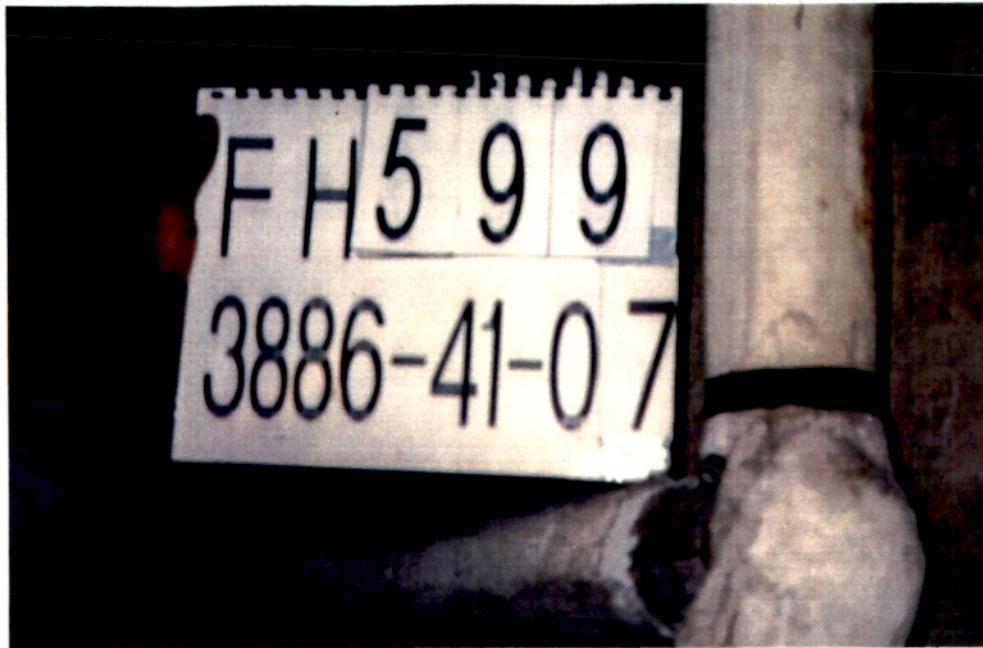
Bldg. 9042 - Basement, Corridor leading to Pipe Tunnel: Sample FH599 < 4" mud fitting tested positive; sample FH600 < 4" pipe insulation also tested positive.

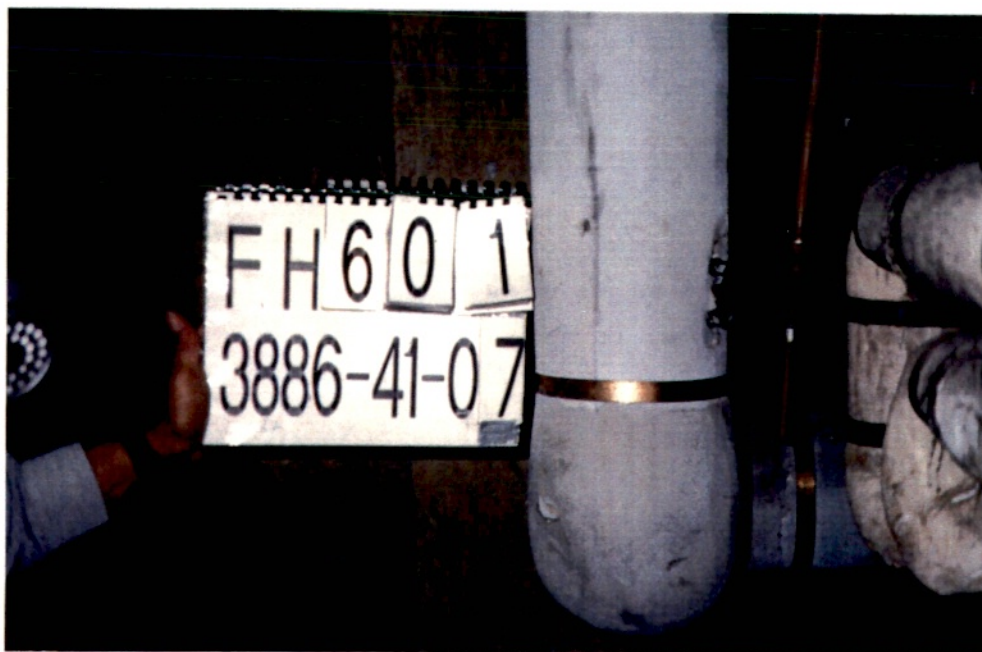
Bldg. 9042 - Basement, Corridor leading to Pipe Tunnel: Sample FH601, 4 - 8" mud fitting tested positive. Sample FH602 (not shown), 4 - 8" pipe run also tested positive.

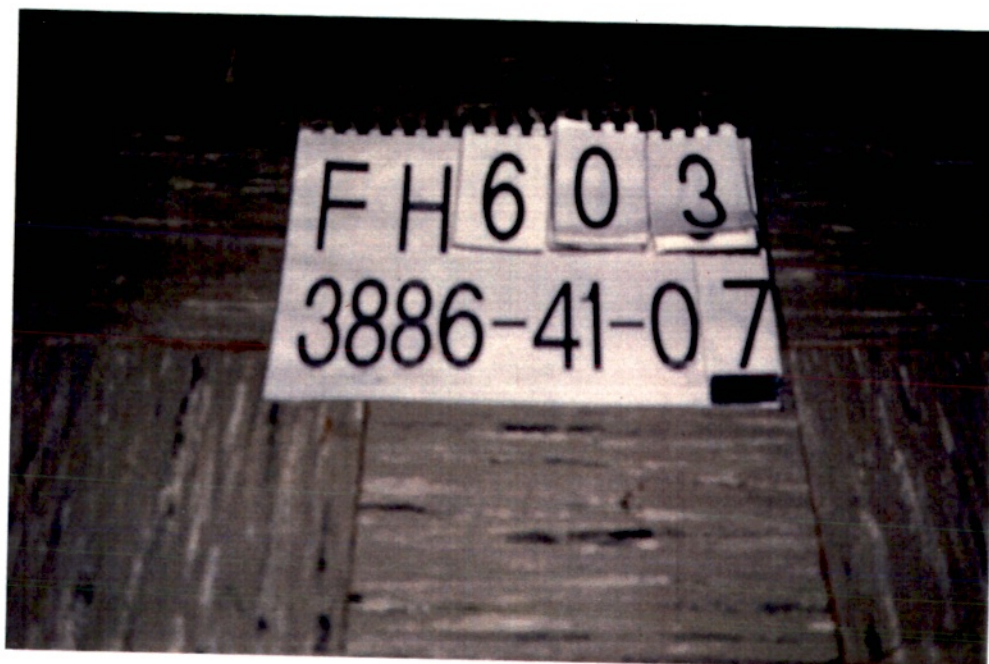
Bldg. 9042 - First Floor: Sample FH603, 9 x 9" gray floor tiles tested positive; sample FH604 9 x 9" gray floor tiles (not shown) also tested positive.

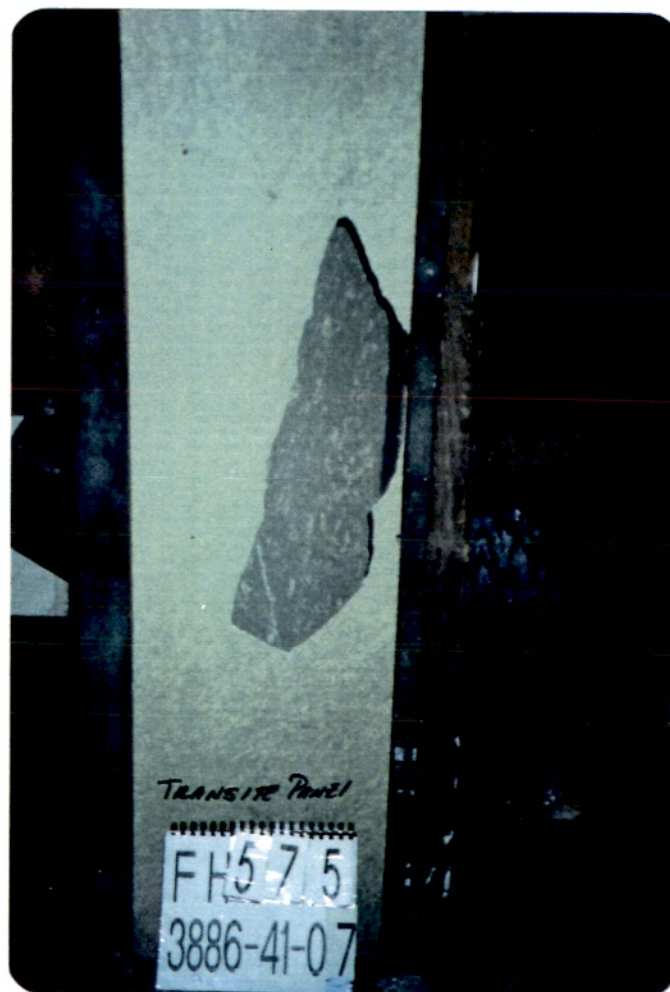
Bldg. 9061 - Carpenter Shop/Metal Shop, Attic: Transite panels sample FH575 tested positive; FH576, 9 x 9" black floor tiles also tested positive; sample FH579 gasket material debris in attic area (not shown) tested positive.
