**U.S. Army Corps of Engineers  
Philadelphia District**

***Volume III - Building Reports for a  
Comprehensive Asbestos  
Survey in Various Buildings at  
Fort Monmouth, New Jersey***

Contract Number DACA61-89-D-0013

**June 1991**

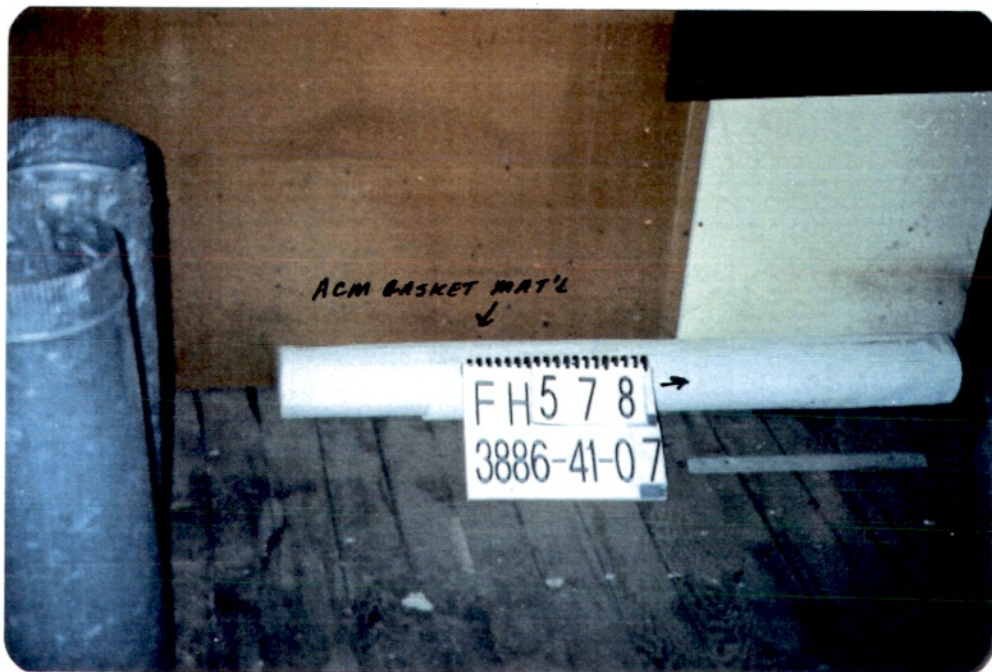
Bldg. 9061 - Carpenter Shop/Metal Shop, Attic: Roll of gasket material sample FH578 tested positive; sample FH577 9 x 9" white floor tile also tested positive (not shown).
