***Volume I - Building Reports for a  
Comprehensive Asbestos  
Survey in Various Buildings at  
Fort Monmouth, New Jersey***

Contract Number DACA61-89-D-0013

**June 1991**

Roy F. Weston, Inc.  
West Chester,  
Pennsylvania 19380

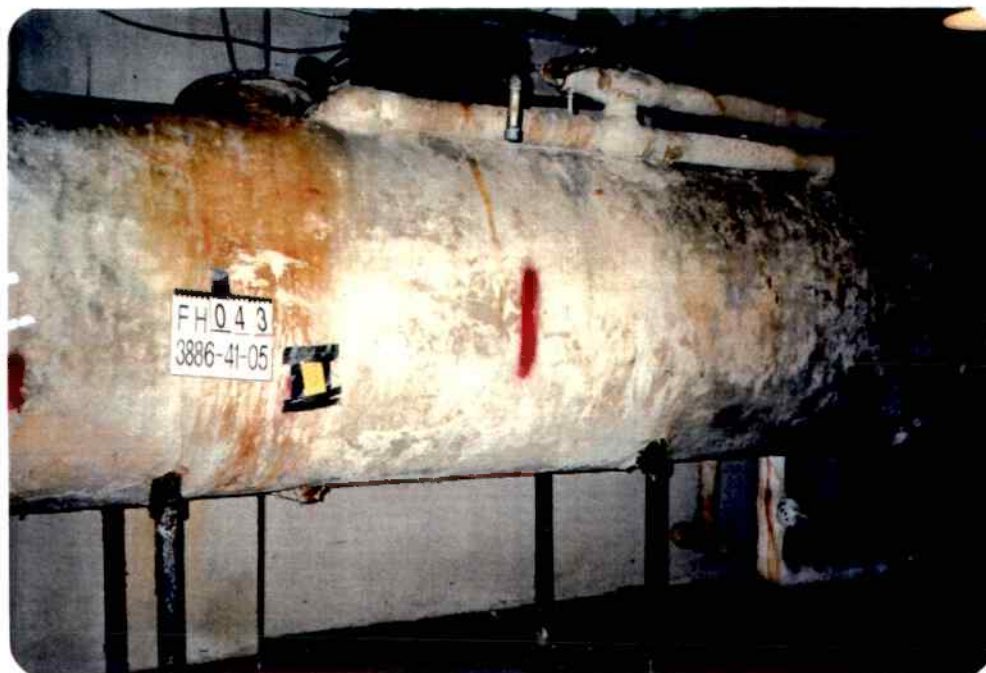
Bldg. 205

Mechanical Room: (Sample FH043)  
Storage Tank Insulation Tested Positive. Tank  
Insulation Is Extremely Damaged.

- The mechanical room and the 2nd floor men's latrine in Building 205 qualify for the Army Asbestos Deficiency Abatement Project.
- Other asbestos-containing materials should be labeled under the O&M Program.

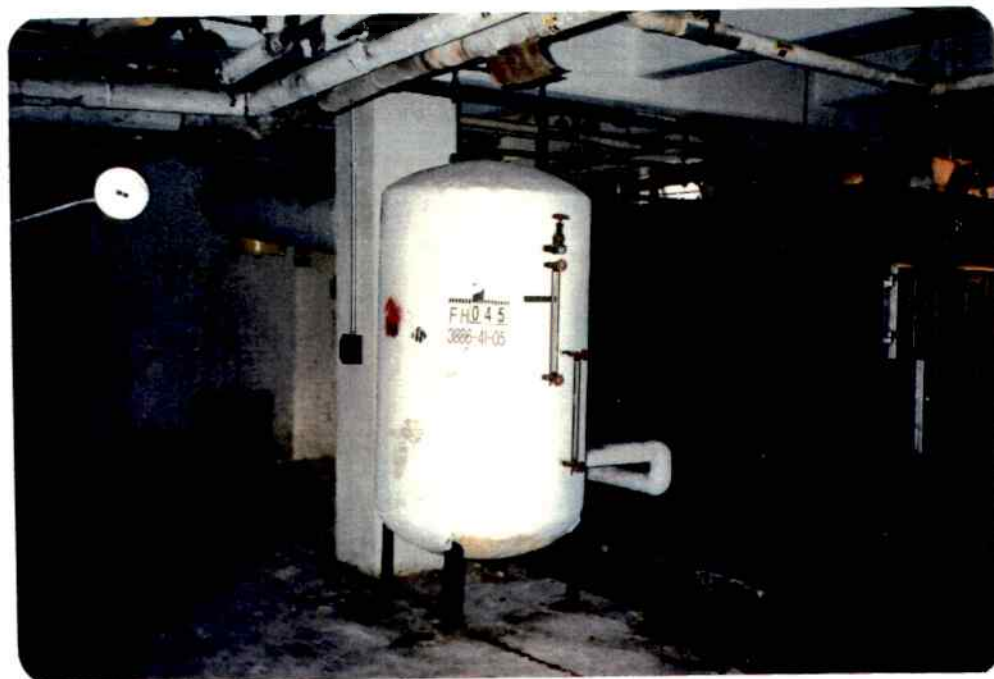
Bldg. 205

Mechanical Room: (Sample FH045)  
Storage Tank Insulation Tested Positive.

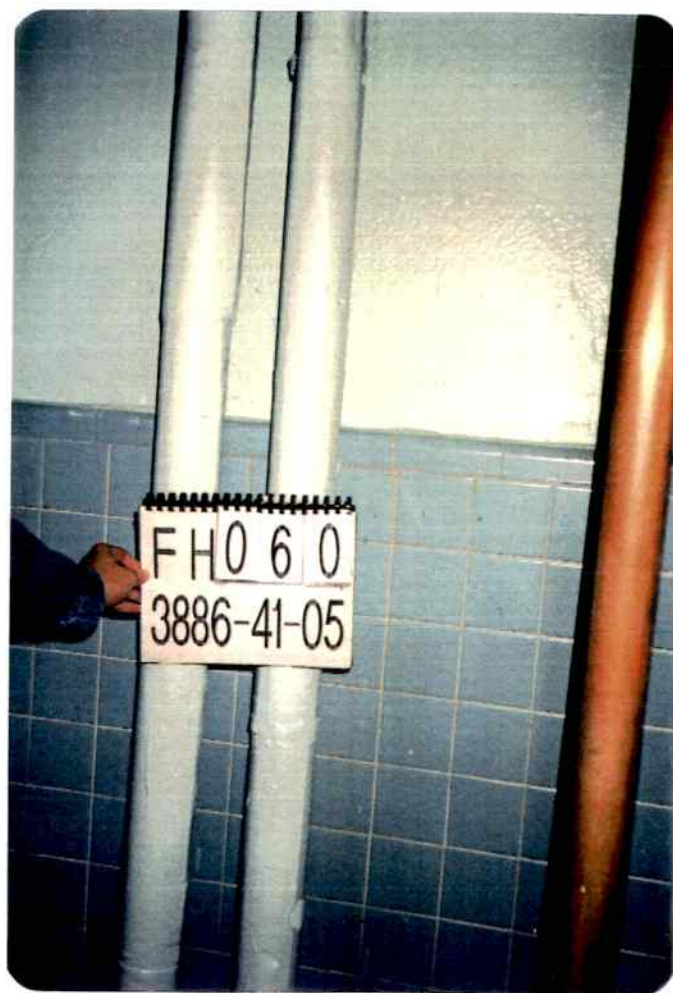
Bldg. 205

Second Floor Men's Latrine: (Sample FH060) Pipe  
Insulation (Less than 4 in.) Tested Positive.

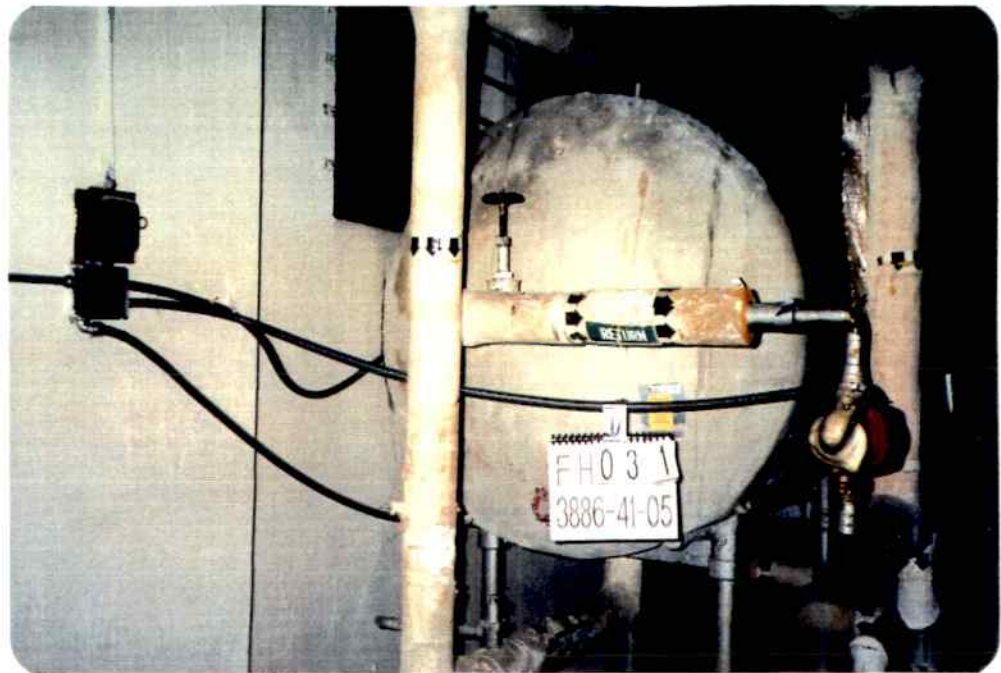
Bldg. 207

Mechanical Room: (Sample FH031)  
Storage Tank Insulation Tested Positive.

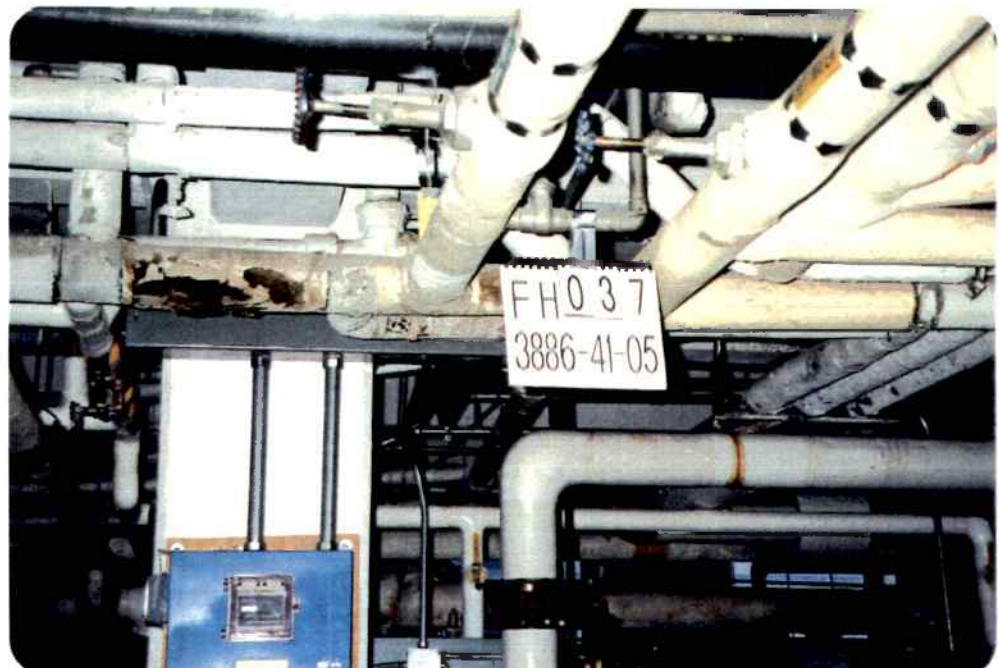
Bldg. 207

Mechanical Room: (Sample FH037)  
Pipe Insulation (Less Than 4 In.) Tested Positive.  
Pipe Fitting Insulation Also Tested Positive. Pipe  
and Fitting Insulation Are Extremely Damaged.

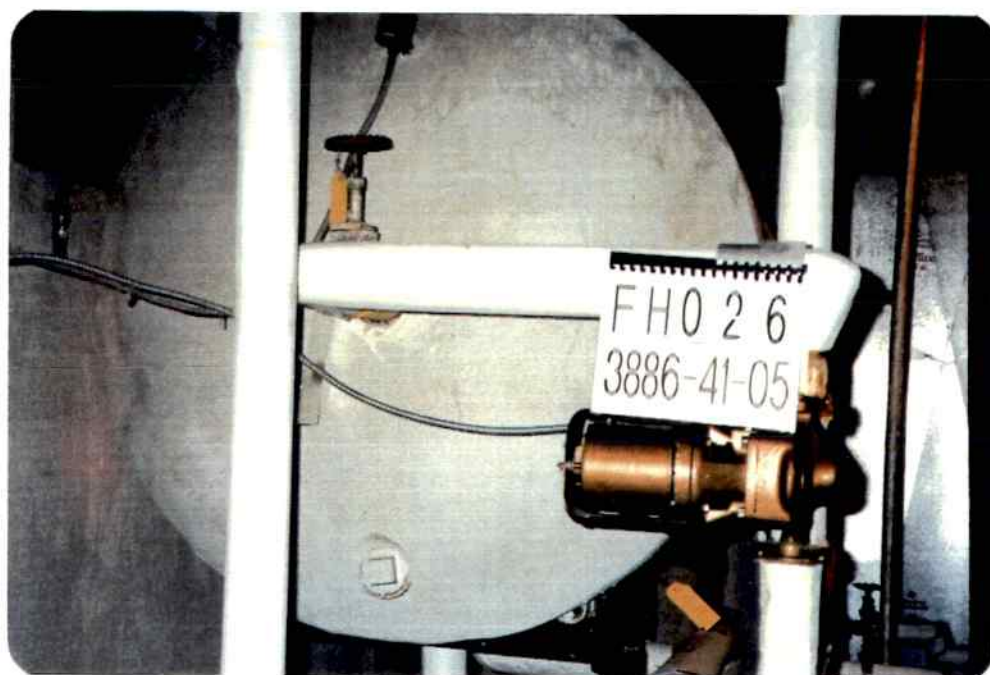
Bldg. 208

Mechanical Room: (Sample FH026)  
Storage Tank Insulation Tested Positive.

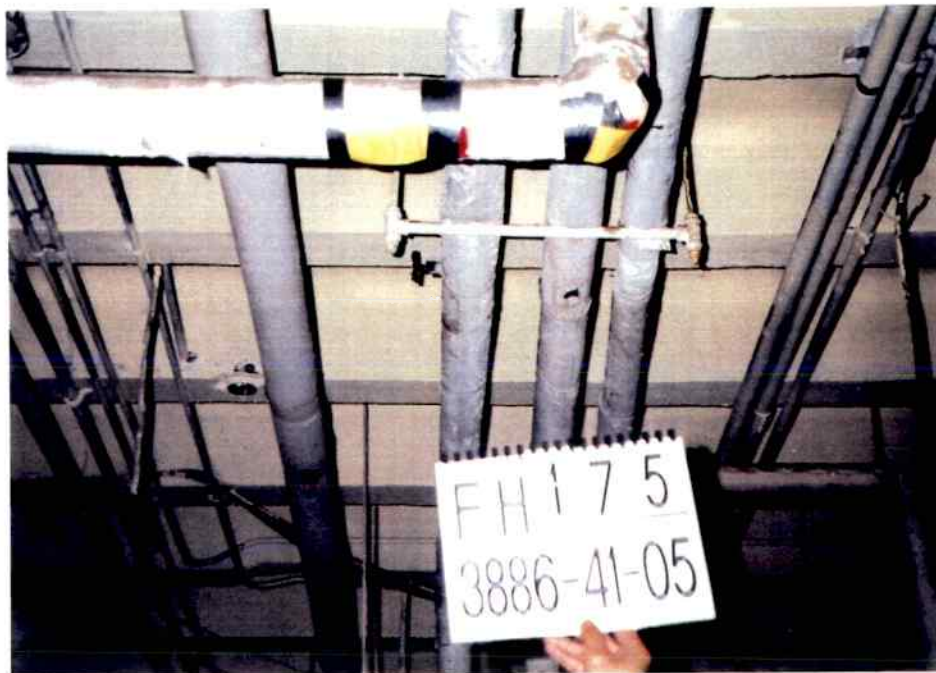
Bldg. 209

Mechanical Room: (Sample FH175)  
(Less Than 4 In.) Pipe Fitting Insulation Tested  
Positive. Pipe Run Insulation Also Tested Positive  
(Sample FH176).

- The mechanical room in Building 209 qualifies for the Army Asbestos Deficiency Abatement Project.
- Other asbestos-containing materials should be labeled under the O&M Program.

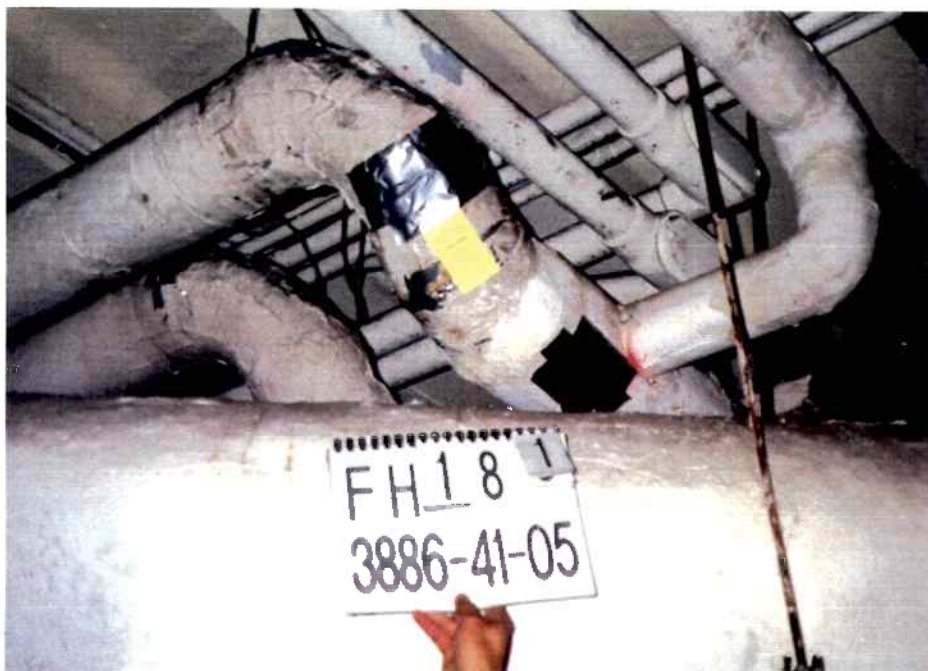
Bldg. 209

Mechanical Room: (Sample FH181)  
(4 In. - 8 In.) Pipe Fitting Insulation Tested  
Positive. Pipe Run Insulation Is Fiberglass.

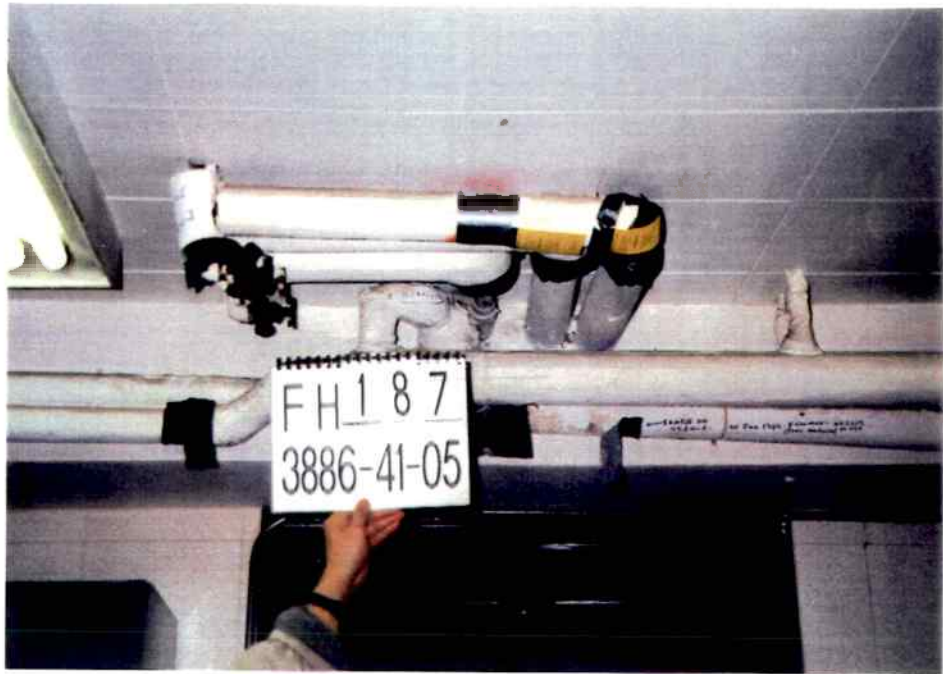
Bldg. 209

Basement, Room 27 (North End): (Sample FH187)  
(Less Than 4 In.) Pipe Fitting Insulation Tested  
Positive. Pipe Run Insulation Is Also Tested  
Positive (Sample FH186).

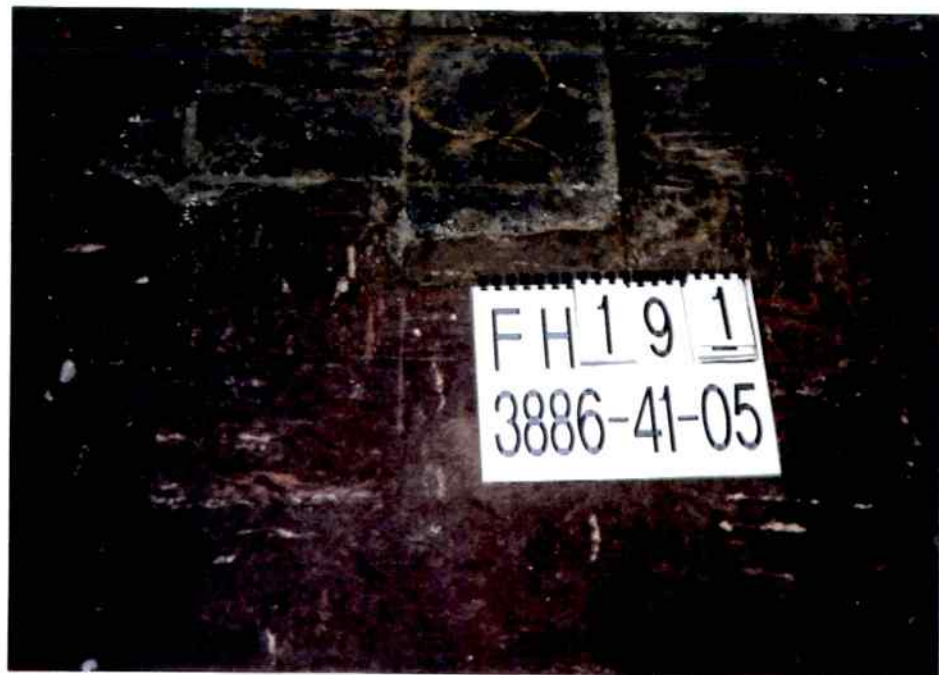
Bldg. 209

Basement, Store Room (North End): (Sample FH191)  
(9 In. x 9 In.) Red Floor Tile Tested Positive.

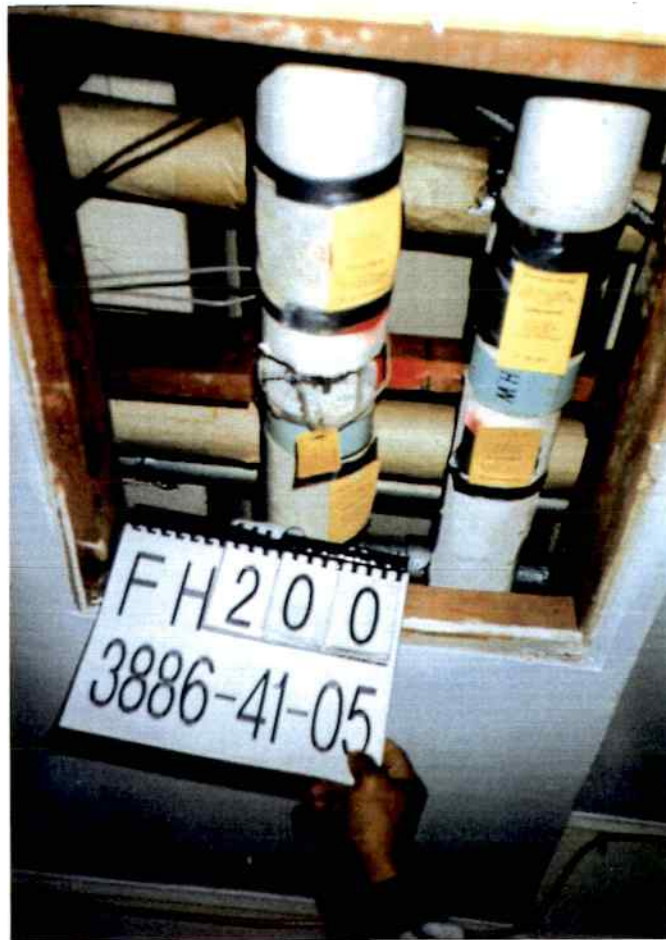
Bldg. 209

Basement, West Hallway: (Less Than 4 In.) Pipe Run Insulation Located Above Hallway Ceiling Tested Positive (Sample FH201). Pipe Fitting Insulation, (Sample FH200), Tested Negative.

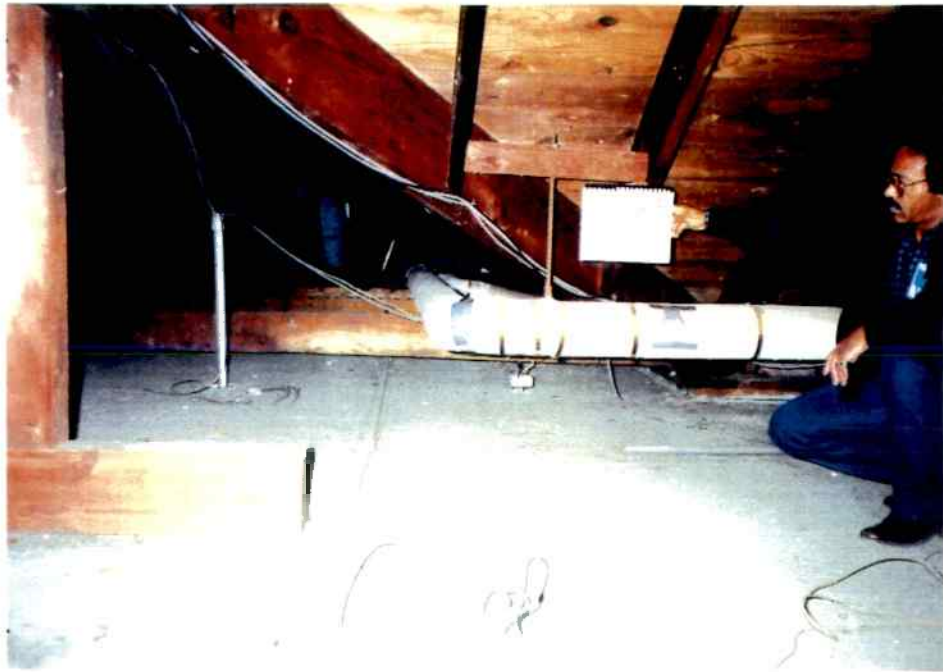
Bldg. 209

Attic: (Sample FH225) (4 In. - 8 In.) Pipe Fitting  
Insulation Tested Positive.

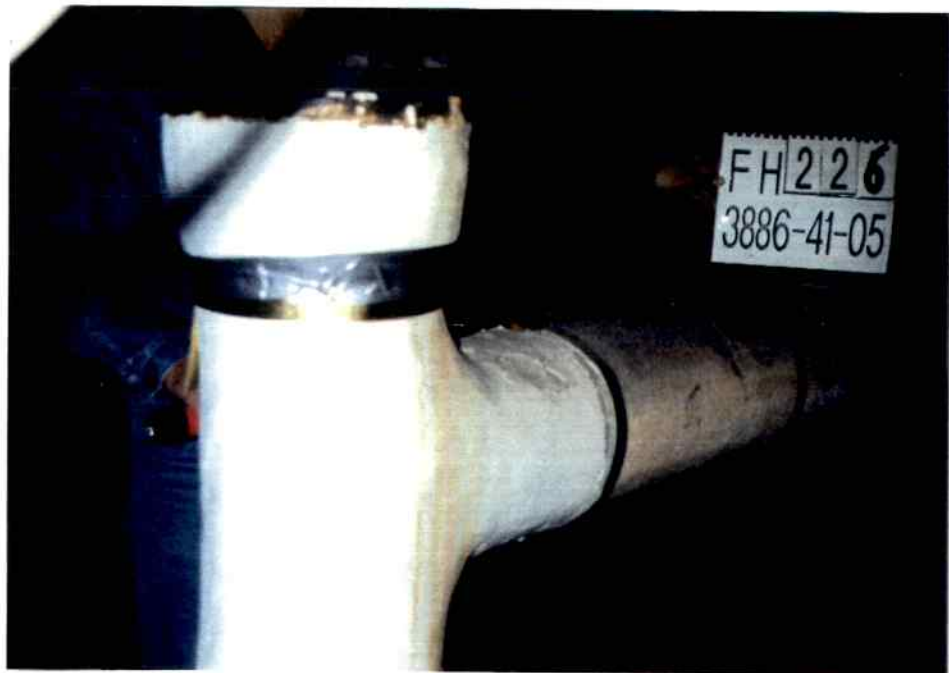
Bldg. 209

Attic: (Sample FH226) (4 In. - 8 In.) Pipe Run  
Insulation Tested Positive.

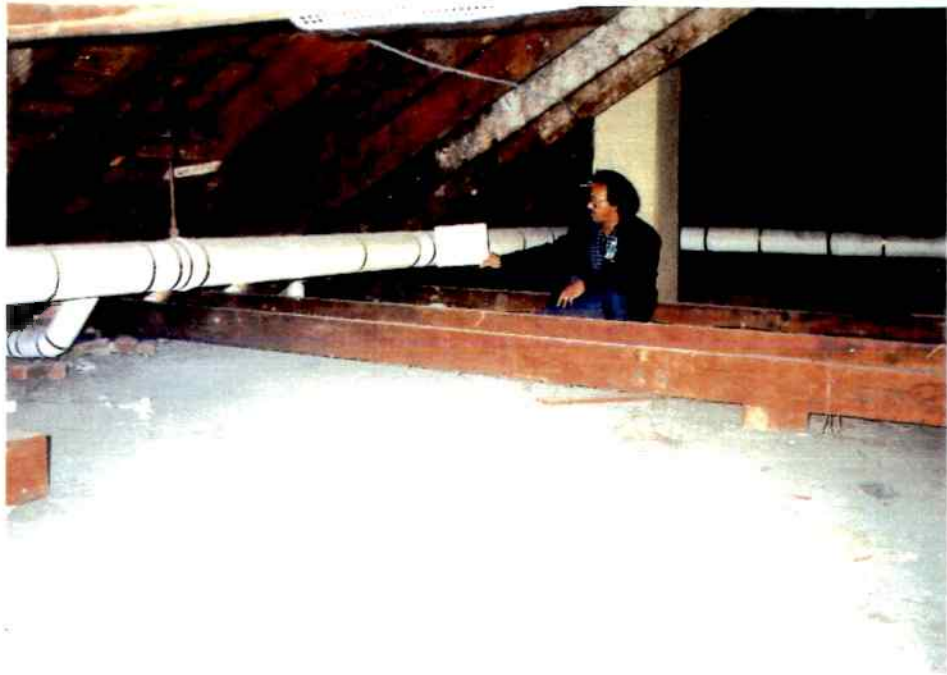
Bldg. 209

Attic: (Sample FH228) (Less Than 4 In.) Pipe Run  
Insulation Tested Positive.

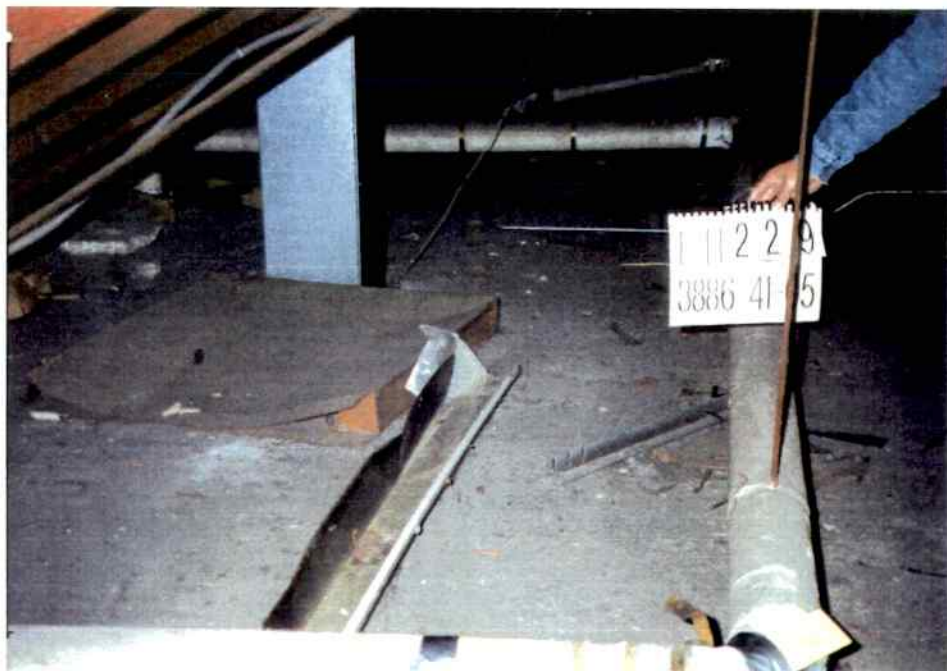
Bldg. 209

Attic: (Sample FH229) (Less Than 4 In.) Pipe  
Fitting Insulation Tested Positive.

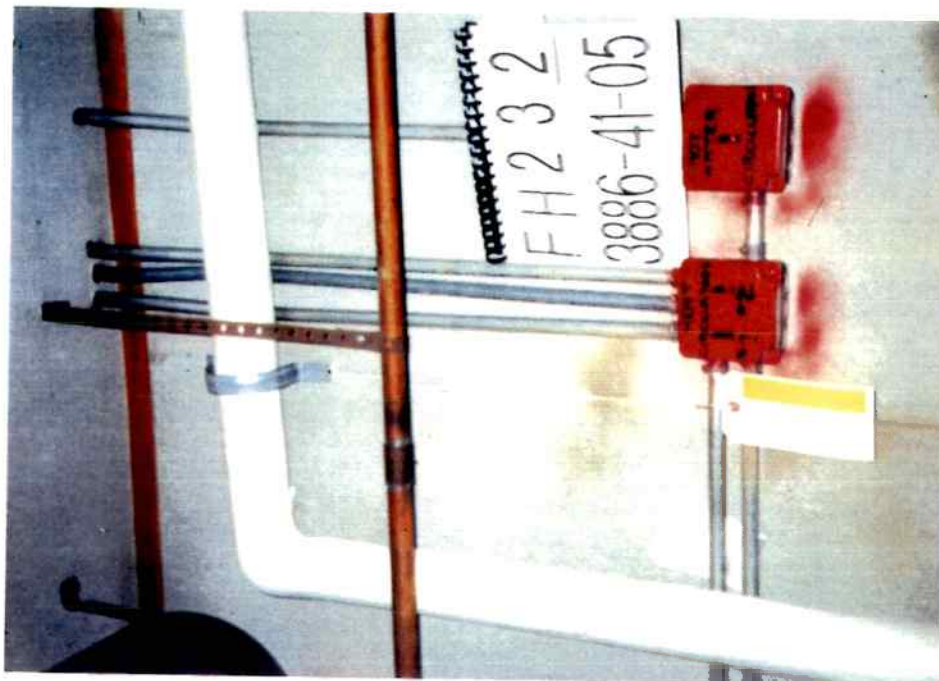
Bldg. 259

Mechanical Room: (Sample FH232) Transite Panels  
(Ceiling and Walls) Tested Positive.

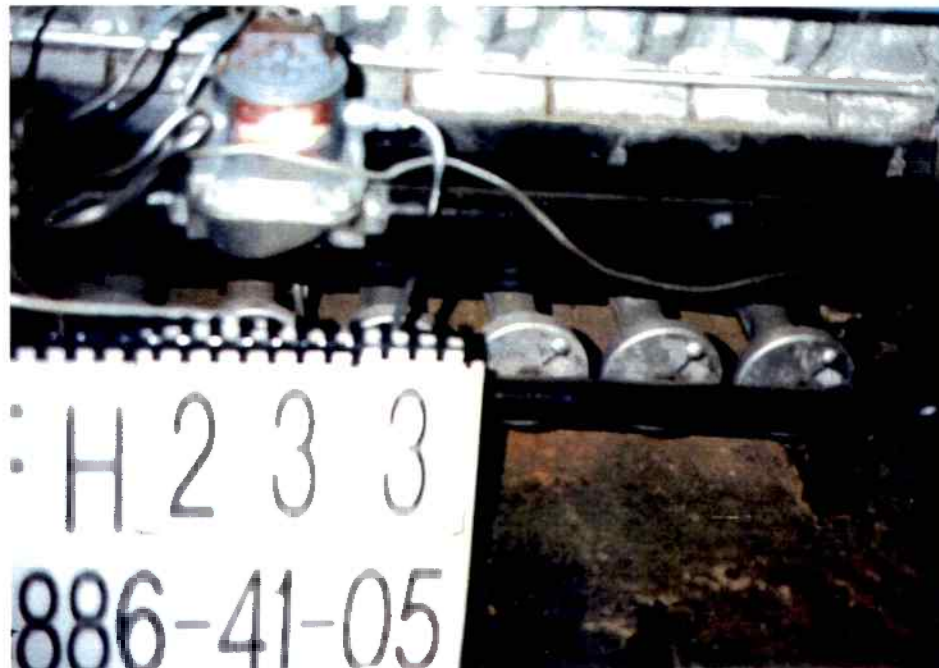
Bldg. 259

Mechanical Room: (Sample FH233) Furnace Insulation  
Tested Positive.

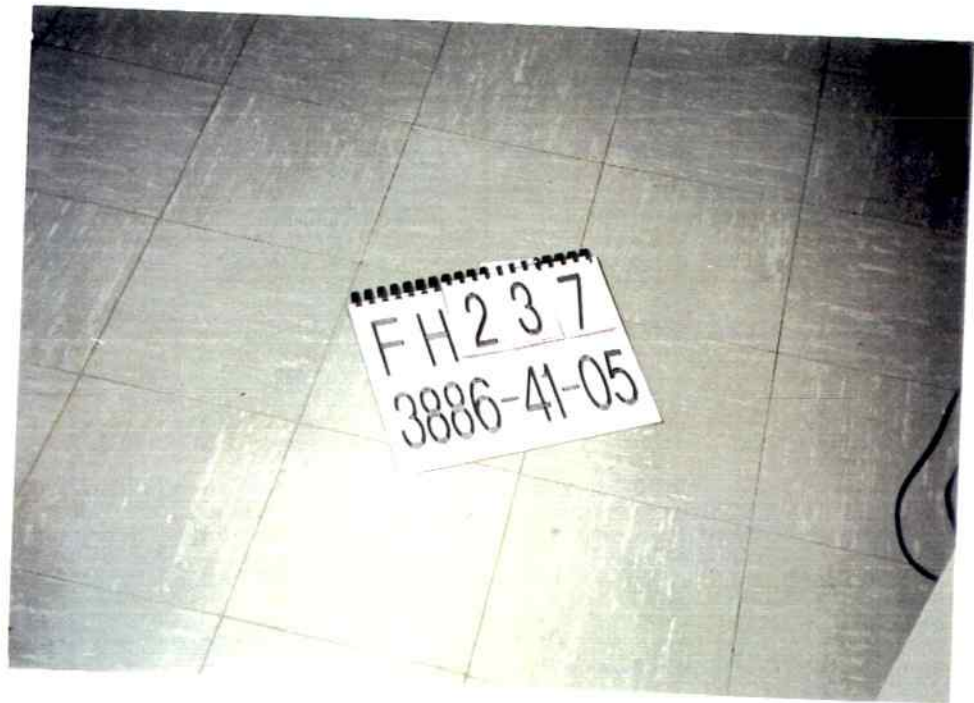
Bldg. 259

Entire First Floor Area: (Sample FH237) (9 In. x 9 In.) Gray Floor Tile Tested Positive.

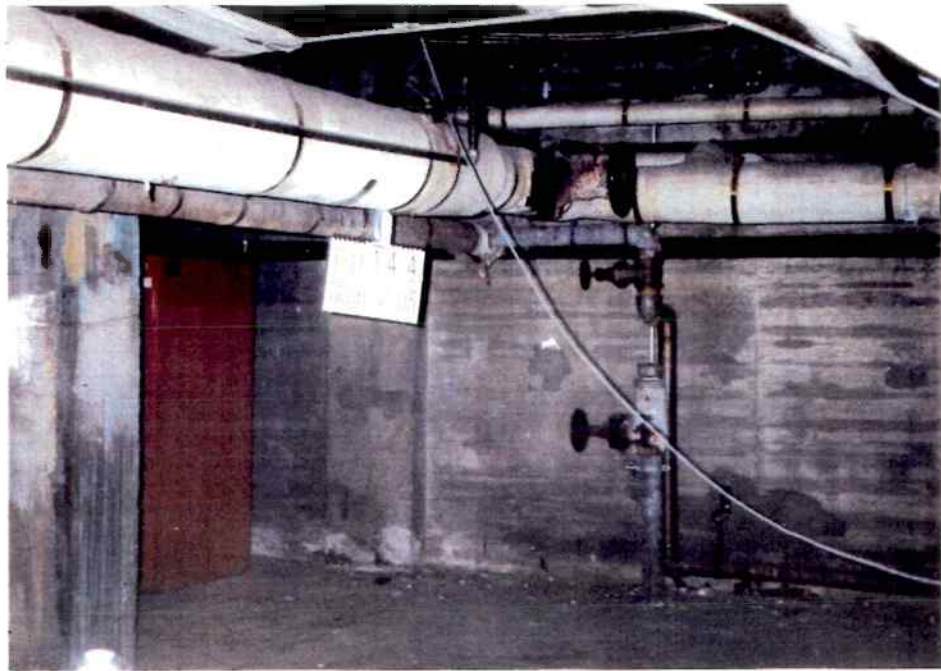
Bldg. 270

Basement: (Sample FH144) Pipe Insulation (4 In. - 8 In.) Tested Positive. Pipe Insulation In Some Sections Are Extremely Damaged.

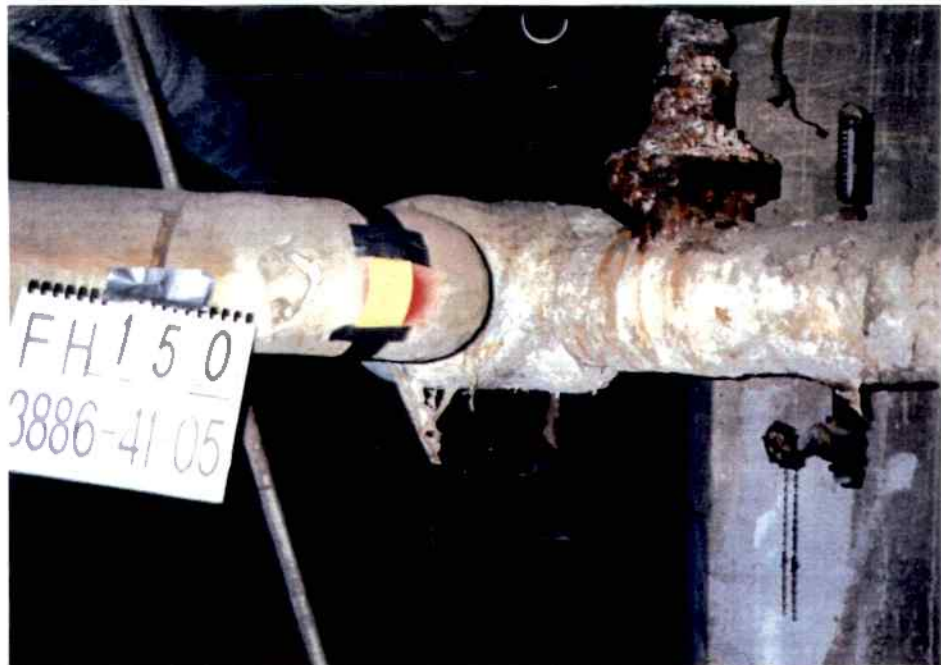
Bldg. 270

Basement: (Sample FH150) Pipe Fitting Insulation (4 In. - 8 In.) Tested Positive. Pipe Fitting Insulation are Extremely Damages.

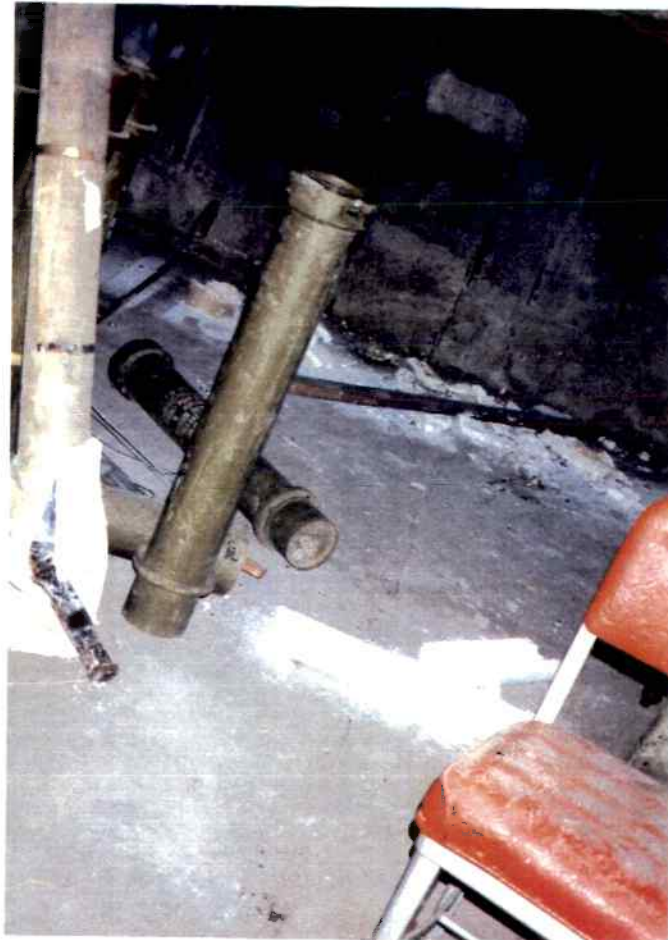
Bldg. 270

Basement: Pipe Insulation Debris (Tested Positive)  
are Present in The Middle Section Of The Basement.

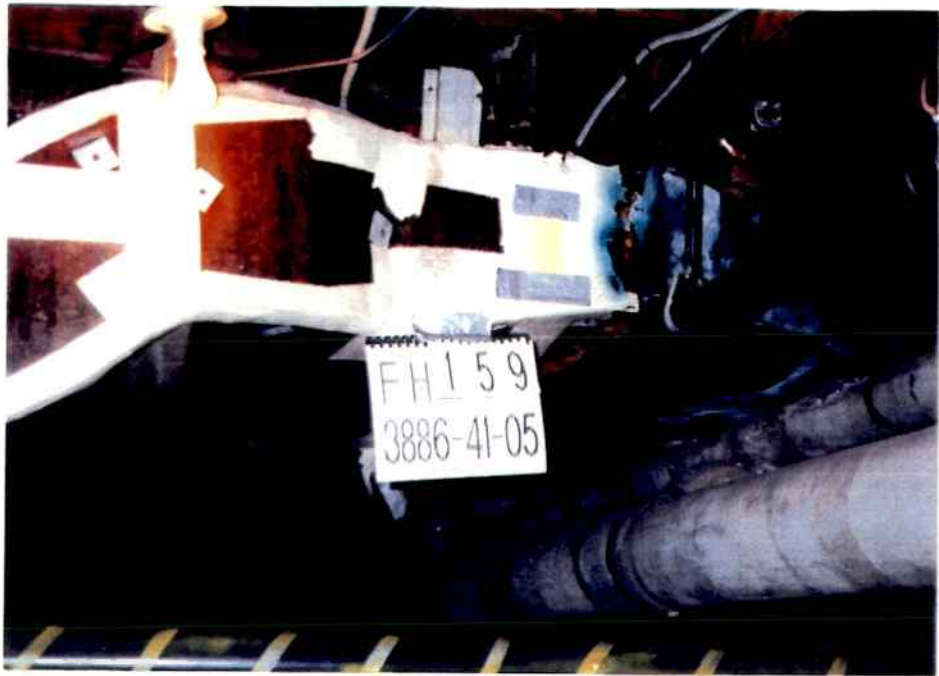
Bldg. 270

Basement: (Sample FH159) Air Duct Tape Tested Positive. Duct Tape In Some Sections Of The Duct Is Extremely Damaged.

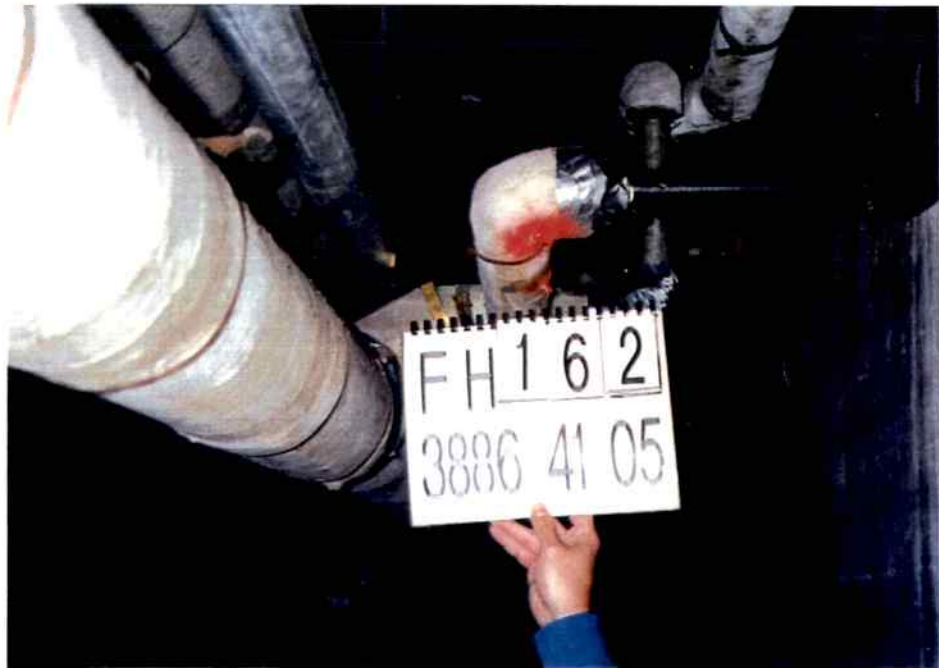
Bldg. 270

Basement: (Sample FH162) Pipe Fitting Insulation (Less Than 4 In.) Tested Positive. Pipe Insulation (Less Than 4 In.) Is Also Tested Positive.

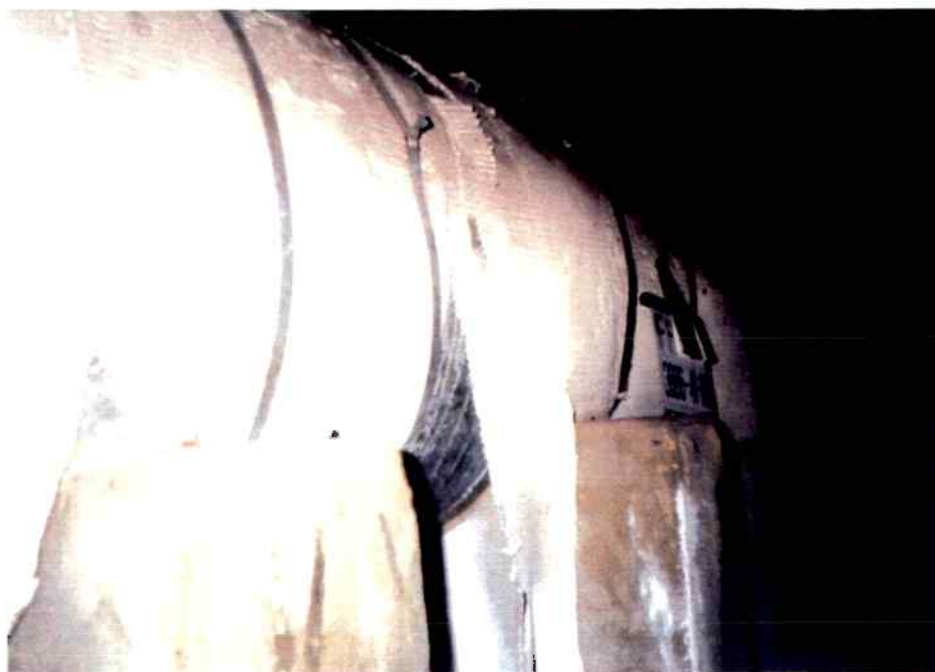
Bldg. 270

Mechanical Room: (Sample FH165) Tank Insulation Tested Positive. Tank Insulation Is Extremely Damaged. Insulation Debris Are Also Found On The Floor.

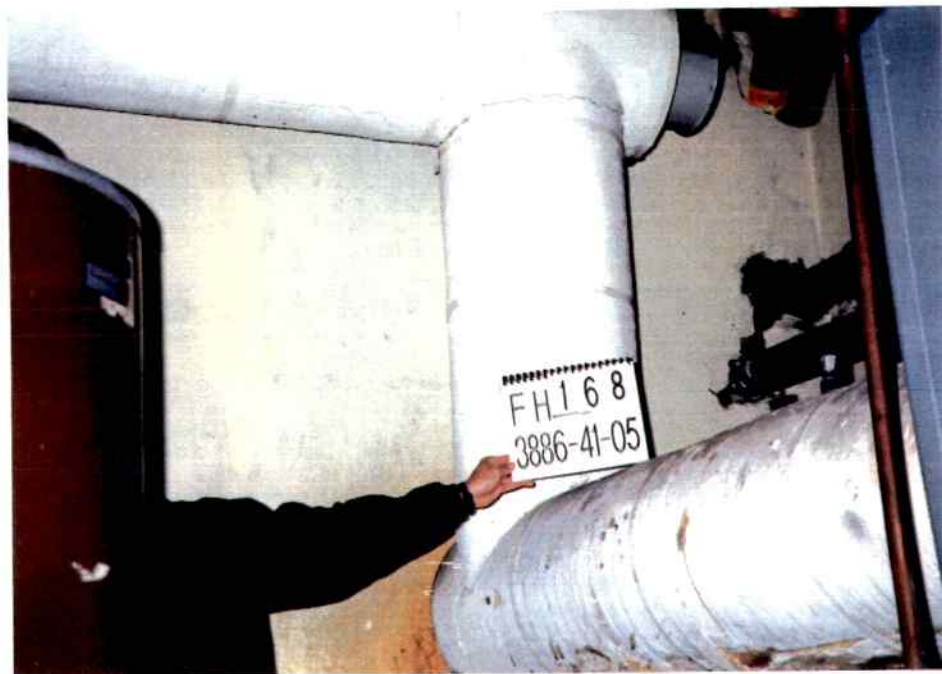
Bldg. 270

Mechanical Room: (Sample FH168) Boiler Breeching Insulation Tested Positive. Breeching Insulation Is Extremely Damaged.

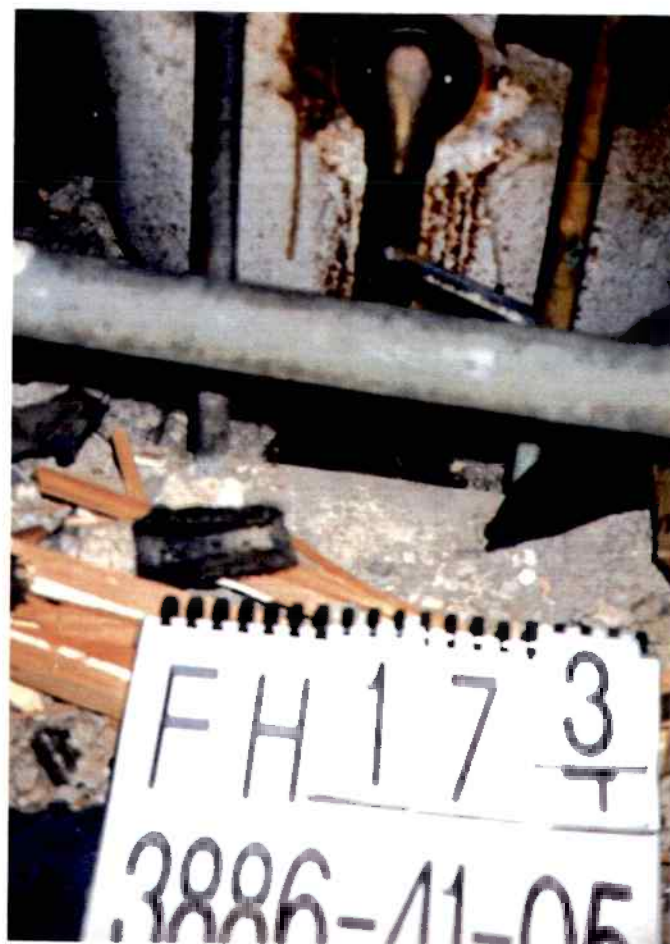
Bldg. 270

Second Floor, Room No. 4 Bathroom: (Sample FH173)  
Pipe Insulation Debris Tested Positive.

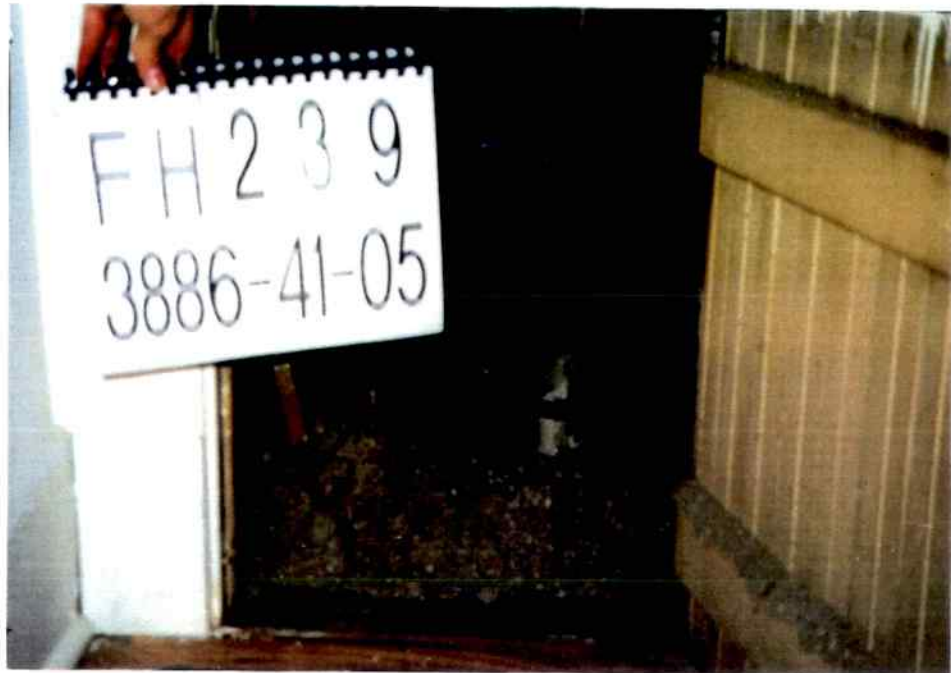
Bldg. 271

Second Floor, Room No. 13 Bathroom: (Sample FH239)  
(Less Than 4 In.) Pipe Insulation Tested Positive.

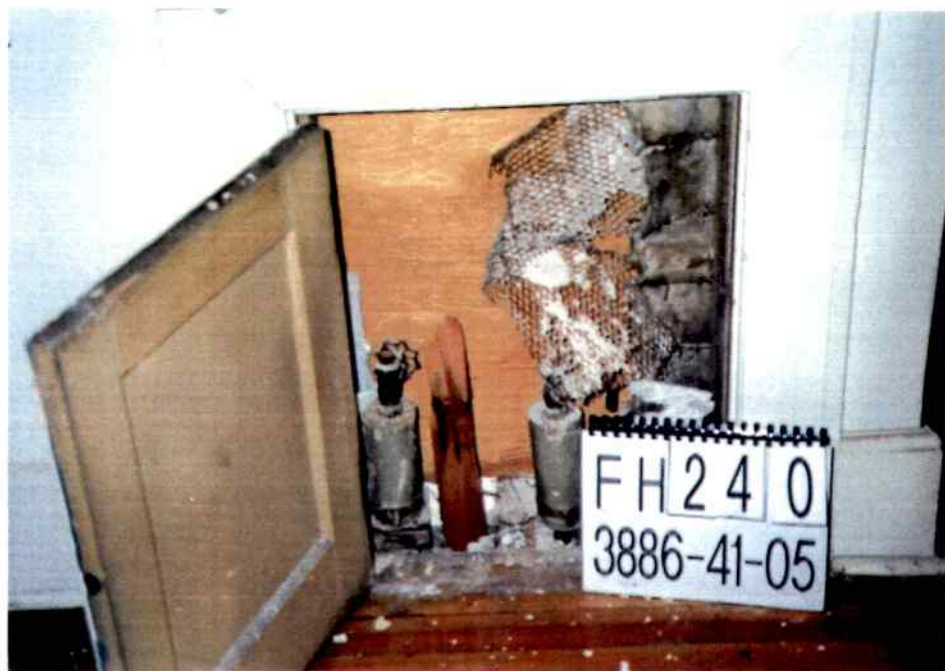
Bldg. 271

Attic, Storage Room: (Sample FH240) (Less Than 4  
In.) Pipe Insulation Tested Positive.

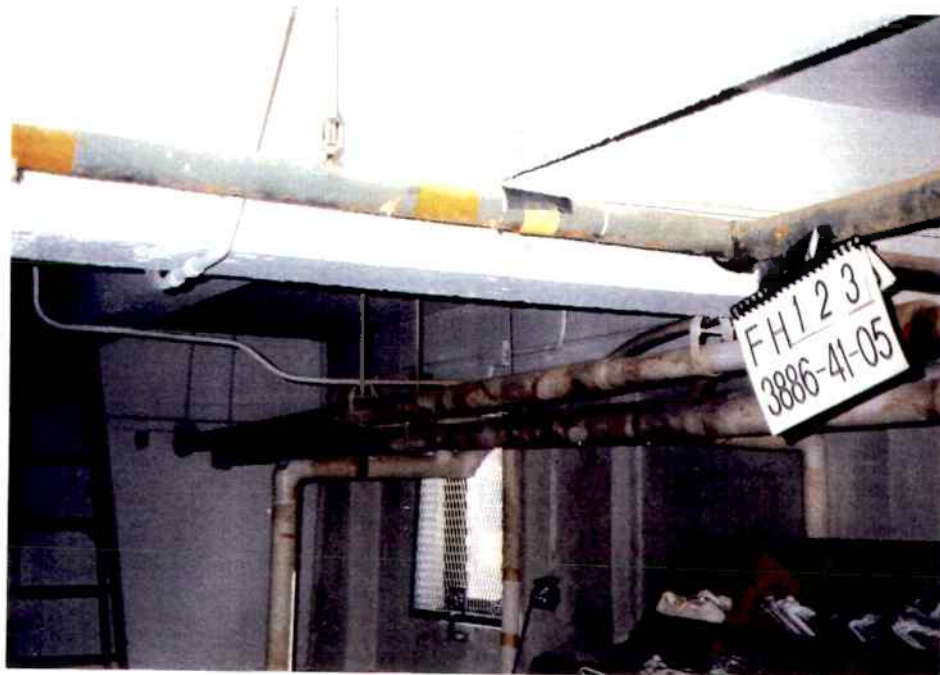
Bldg. 287

Basement Supply/Storage Room: (Sample FH123) Pipe Insulation (Less Than 4 In.) Tested Positive.

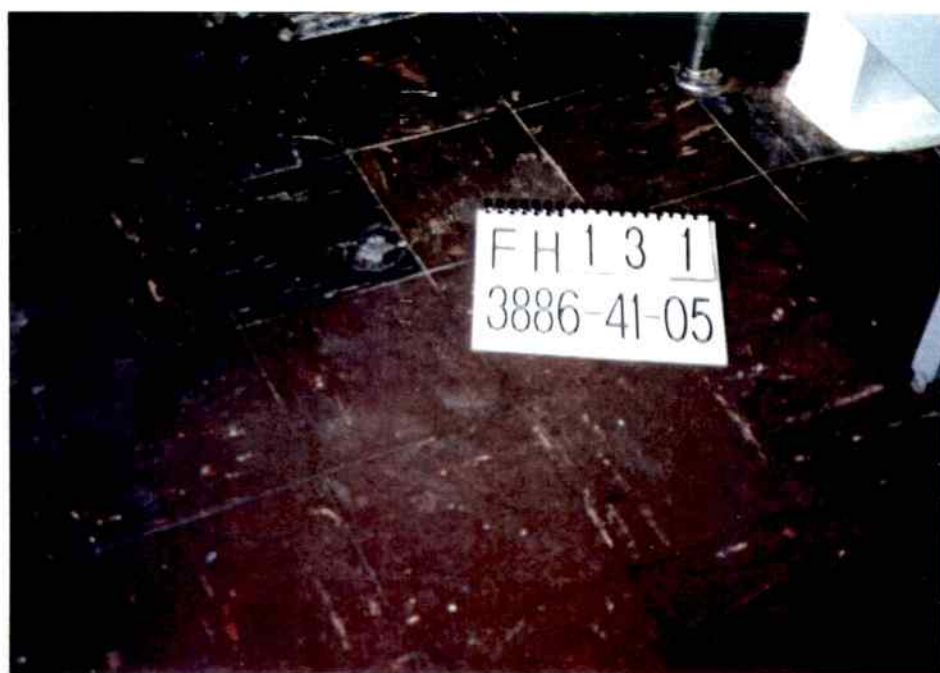
Bldg. 287

First Floor Men's Room: (Sample FH131) Brown (9 In. x 9 In.) Floor Tile Tested Positive.

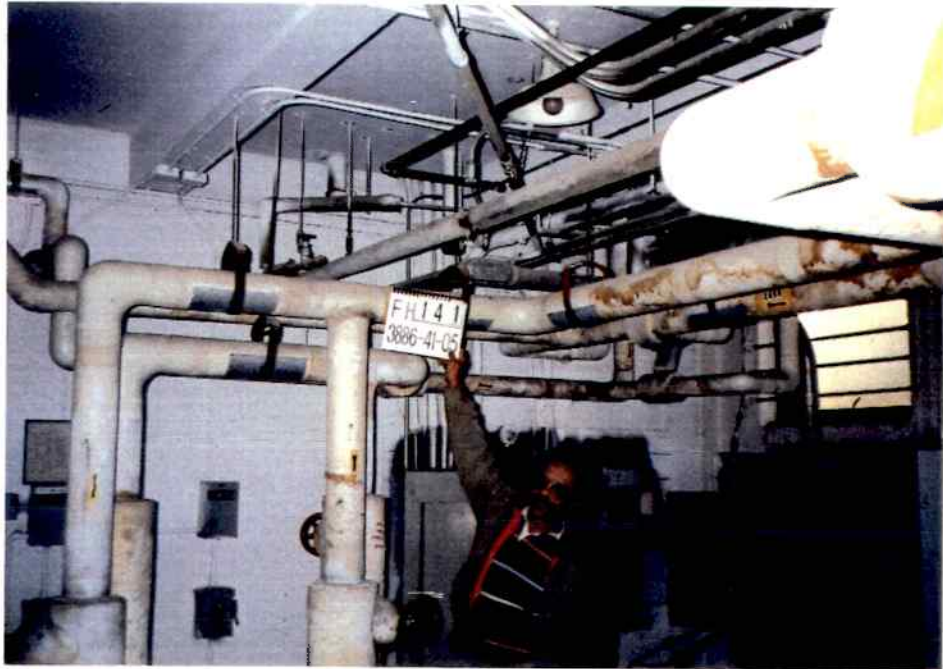
Bldg. 287

Mechanical Room: (Sample FH141) Pipe Insulation  
(Less Than 4 In.) Tested Positive.

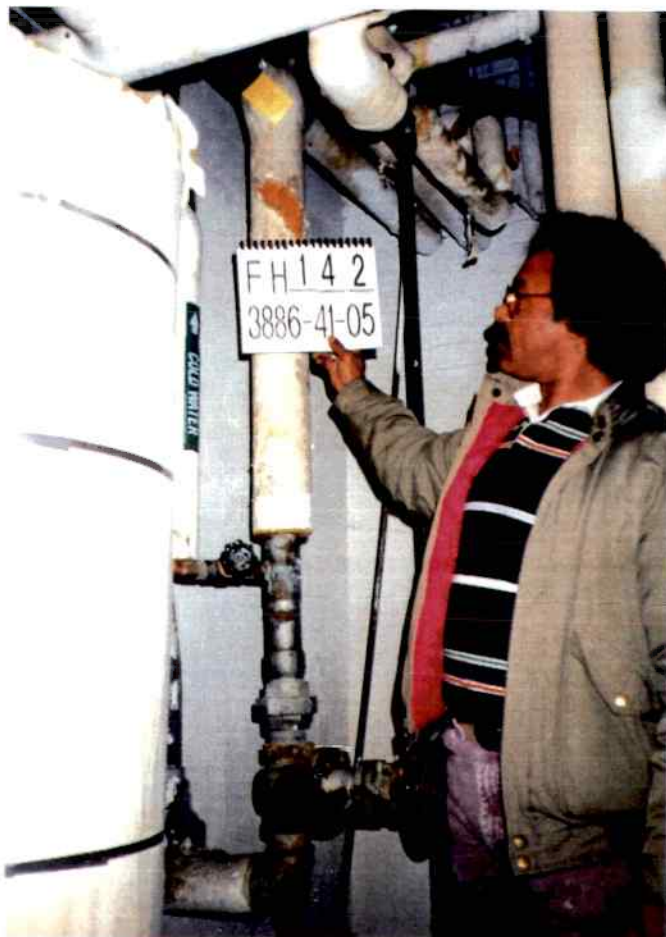
Bldg. 287

Mechanical Room: (Sample FH142) Pipe Fitting  
Insulation (Less Than 4 In.) Tested Positive.

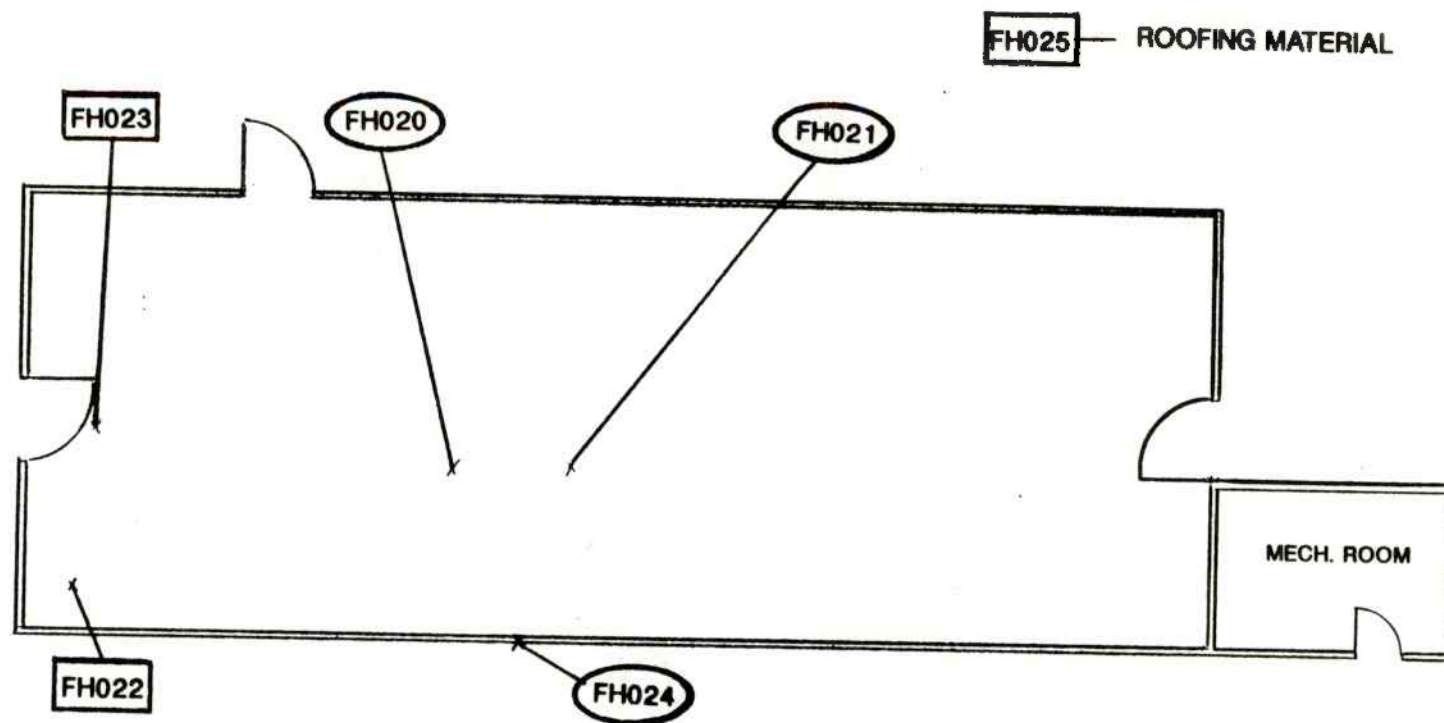
BLDG. 824

\* NOTE:  
TRANSITE SKIRT  
OUTSIDE OF BUILDING
