**U.S. Army Corps of Engineers  
Philadelphia District**

***Volume II - Building Reports for a  
Comprehensive Asbestos  
Survey in Various Buildings at  
Fort Monmouth, New Jersey***

Contract Number DACA61-89-D-0013

**June 1991**

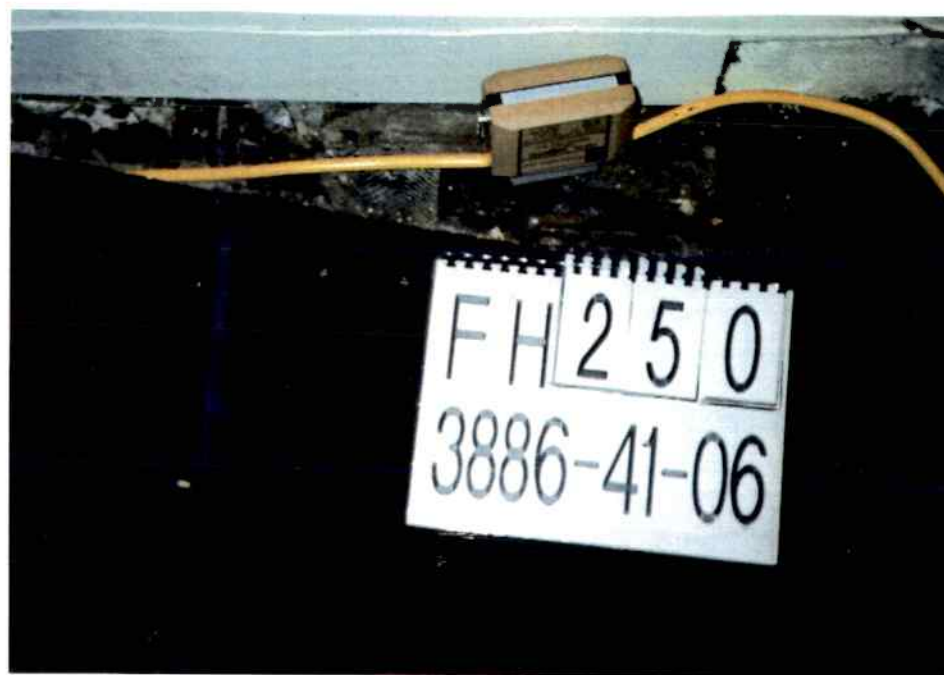
Bldg. 288

Room No. 21 (9 In. x 9 In.) Dark Brown Floor Tiles  
(Under Carpet). Sample No. FH250 Tested Positive.

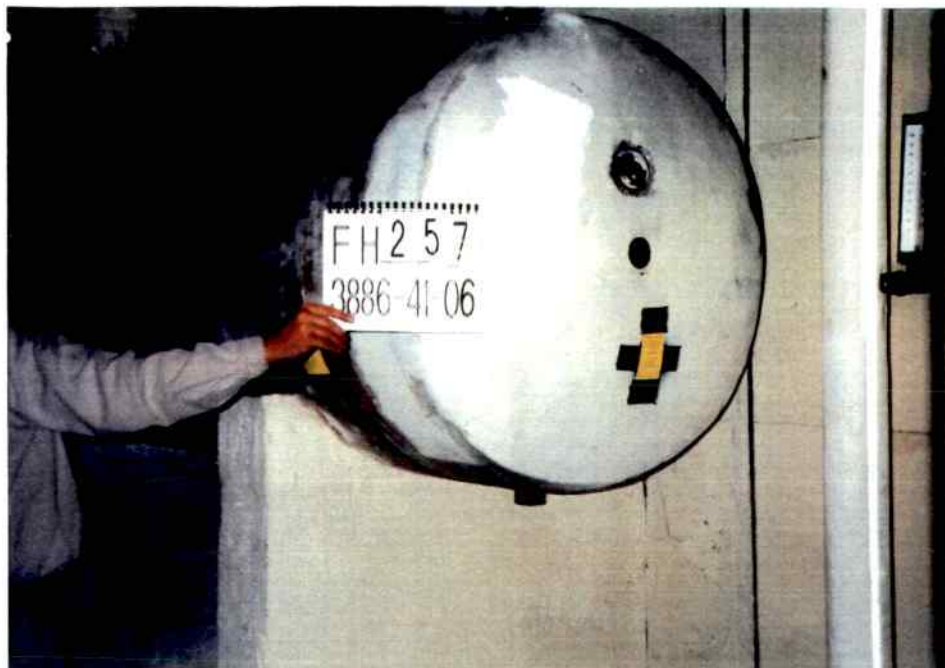
Bldg. 288

Mechanical Room: Tank Insulation (End Cap) Sample FH257 Tested Positive. Tank Insulation Side of Tank (Picture Not Shown); Sample FH258 Also Tested Positive.

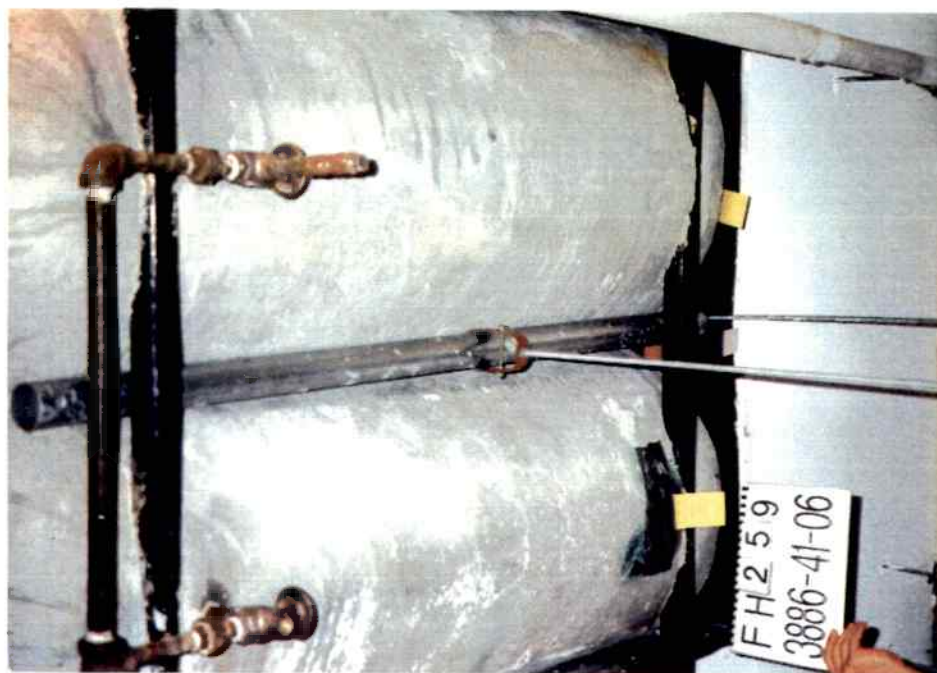
Bldg. 288

Mechanical Room: Tank Insulation (Elevated Tanks) Sample No. FH259 Tested Positive.

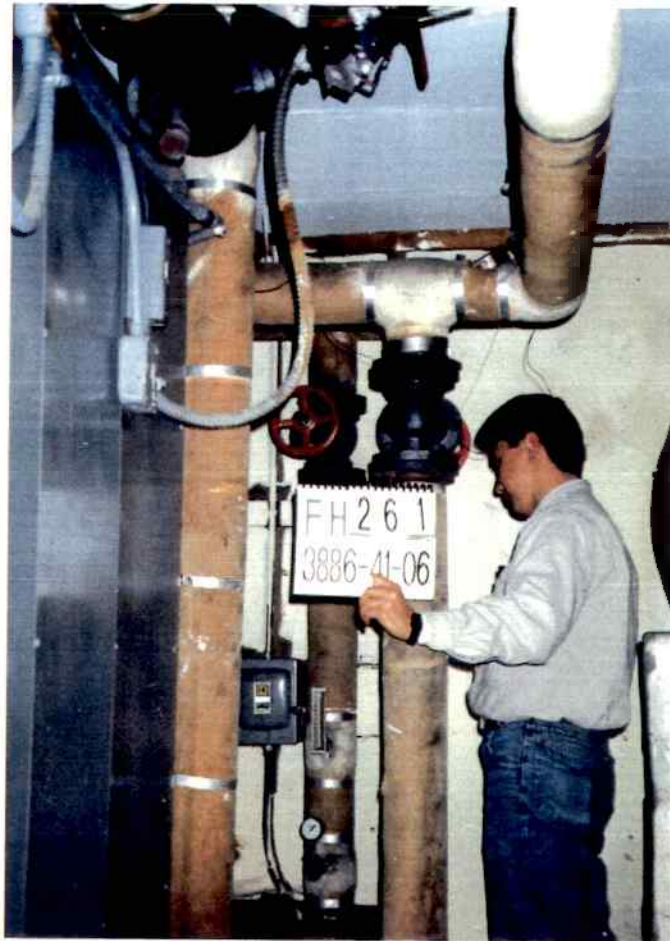
Bldg. 288

Mechanical Room: (Less Than 4 In.) Fitting  
(Associated With An American Standard Boiler Model  
A72B52) Sample FH261 Tested Positive.

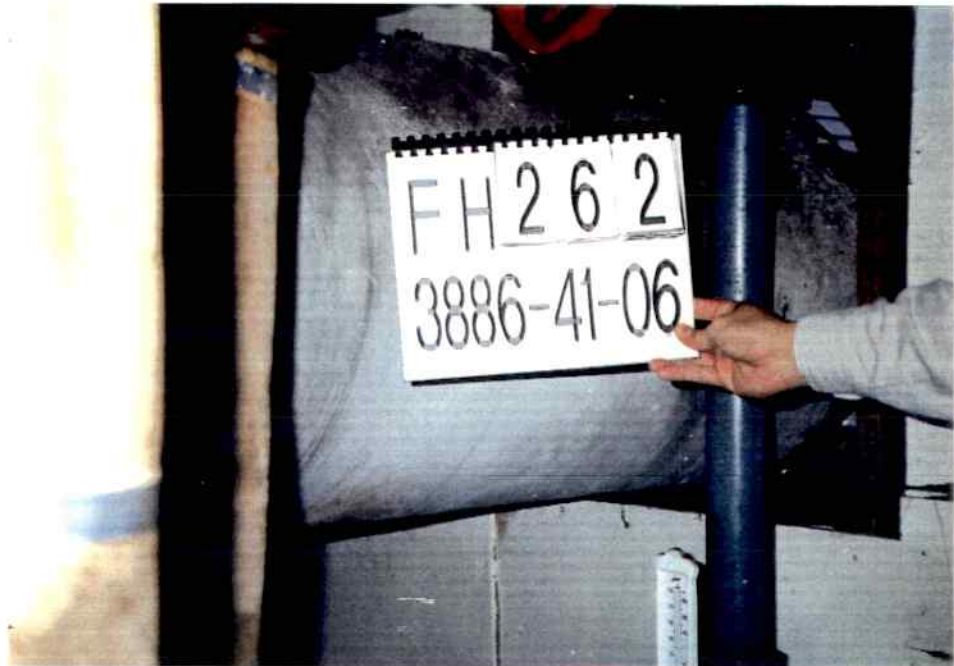
Bldg. 288

Mechanical Room: (Greater Than 14 In.) Breeching  
Insulation (Associated With An American Standard  
Boiler Model A72B-52) Sample FH262 Tested Positive.

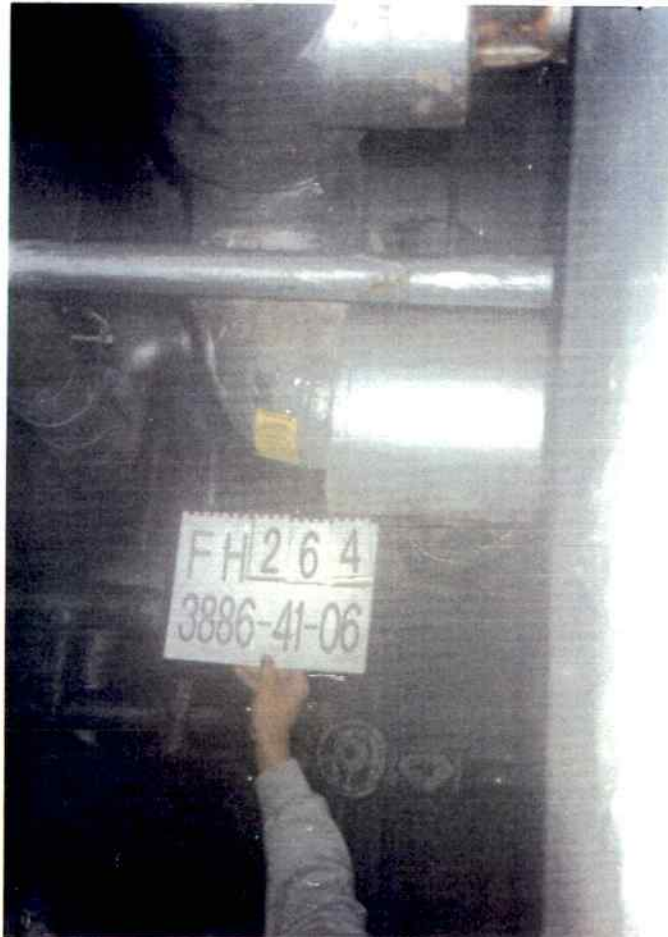
Bldg. 291

Mechanical Room: (4 In. - 8 In.) Fitting  
Insulation Sample FH264 Tested Positive. Pipe Run  
Insulation Is Fiberglass.

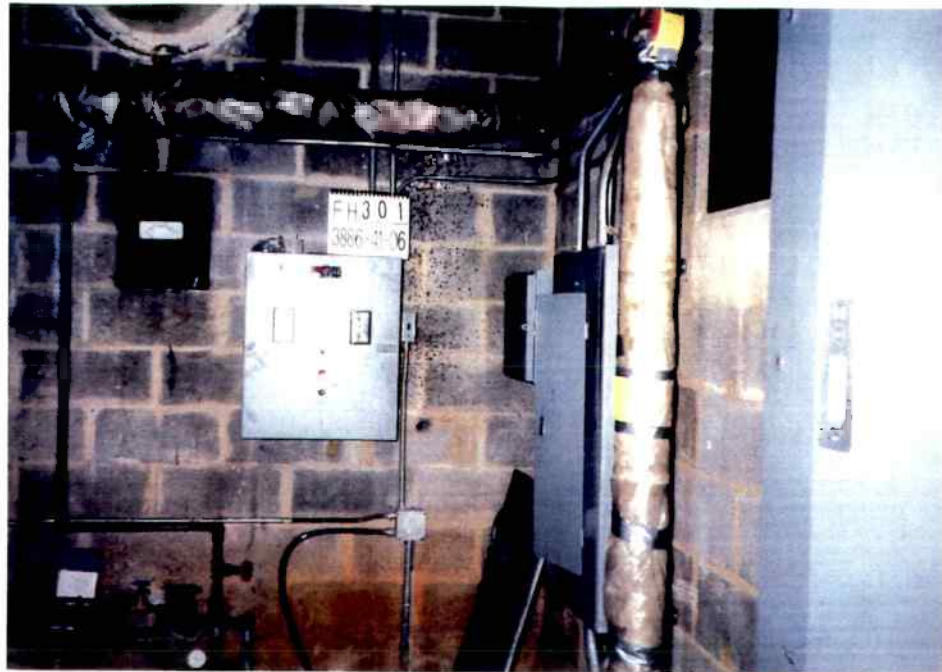
Bldg. 360

Mechanical Room: (Sample FH301)  
(4 In. - 8 In.) Pipe Run Insulation Tested  
Positive. Pipe Fitting Insulation Associated With  
This Run Also Tested Positive (Sample FH302).

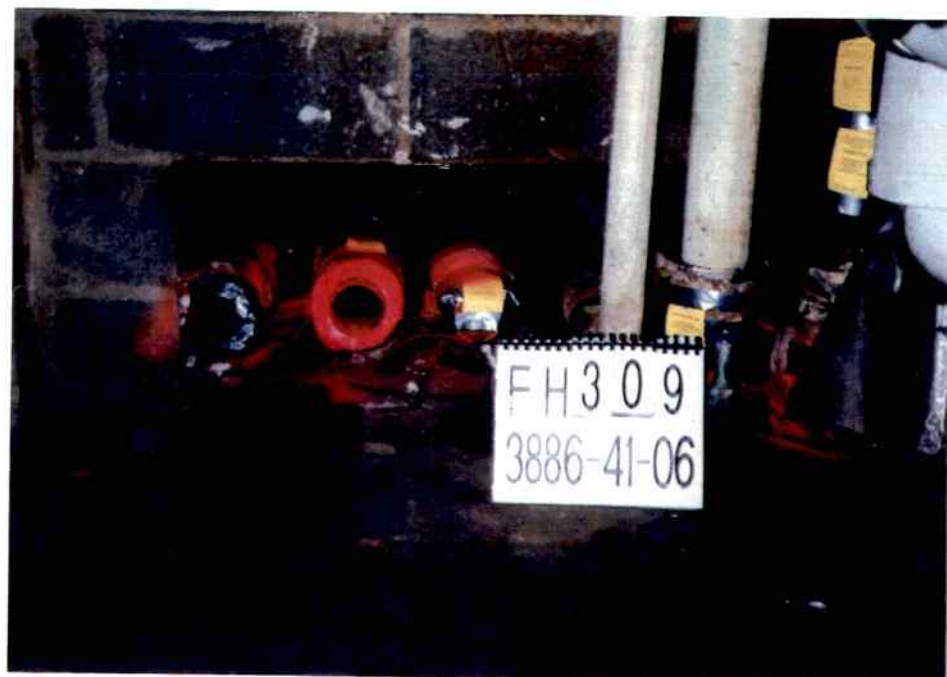
Bldg. 360

Mechanical Room: (Sample FH309)  
(4 In. - 8 In.) Pipe Run Insulation Tested  
Positive. Total Of Six Pipe Runs In Pipe Chase All  
Tested Positive.

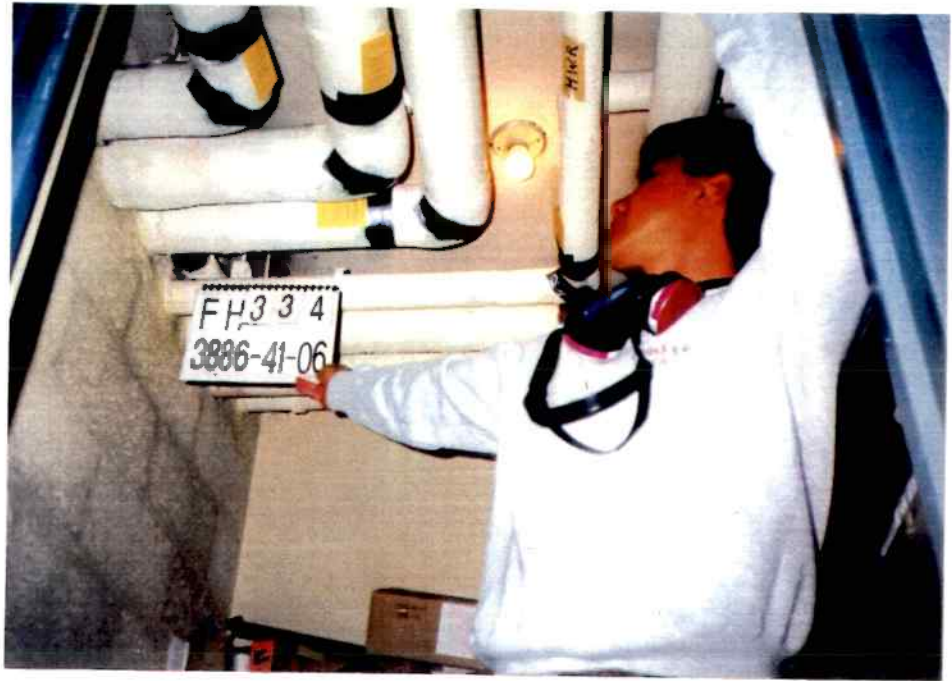
Bldg. 360

First Floor, Janitor's Closet: (Sample FH334) (4 In. - 8 In.) Pipe Run Insulation Tested Positive. All Pipe Runs and Fitting Insulation On First Floor Tested Positive.

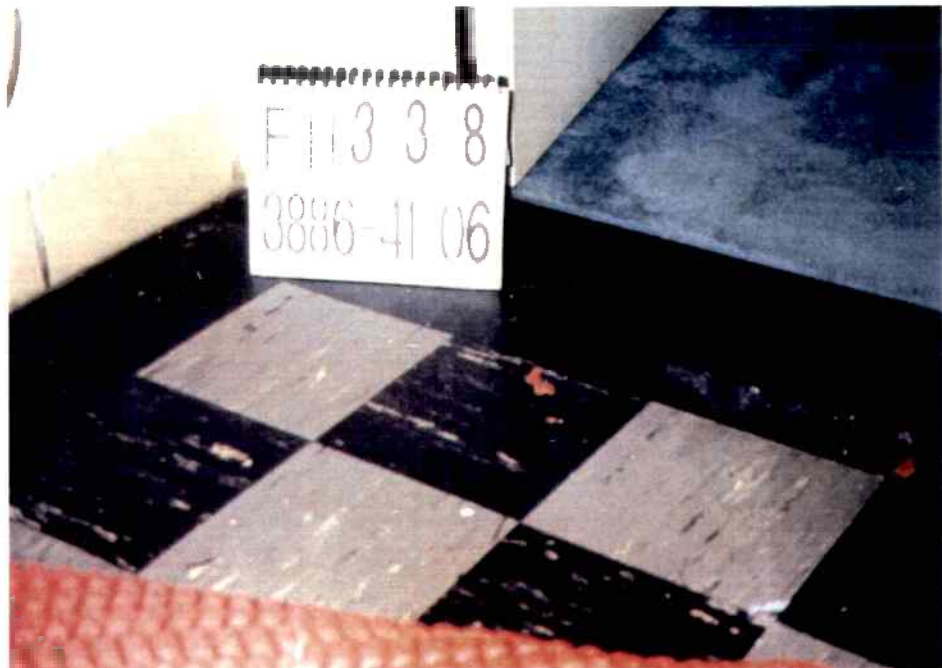
Bldg. 360

Third Floor, Room 358: (Sample FH338) (9 In. x 9 In.) Gray Floor Tile. Black Floor Tile (9 In. x 9 In.) Also Tested Positive. Floor Tiles In Entire Building Tested Positive.

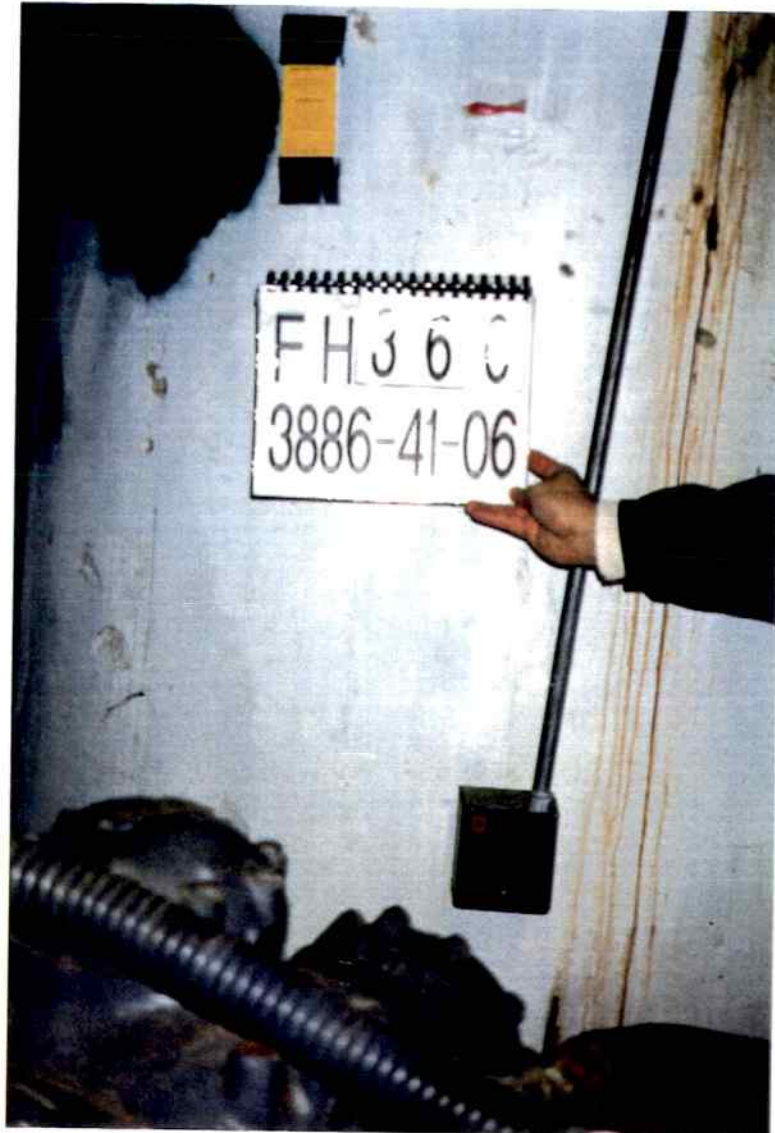
Bldg. 364: Mechanical Room: Tank insulation (side of tank)  
Sample No. FH366 tested positive. Tank insulation  
end cap of tank (Sample No. FH367) also tested  
positive.

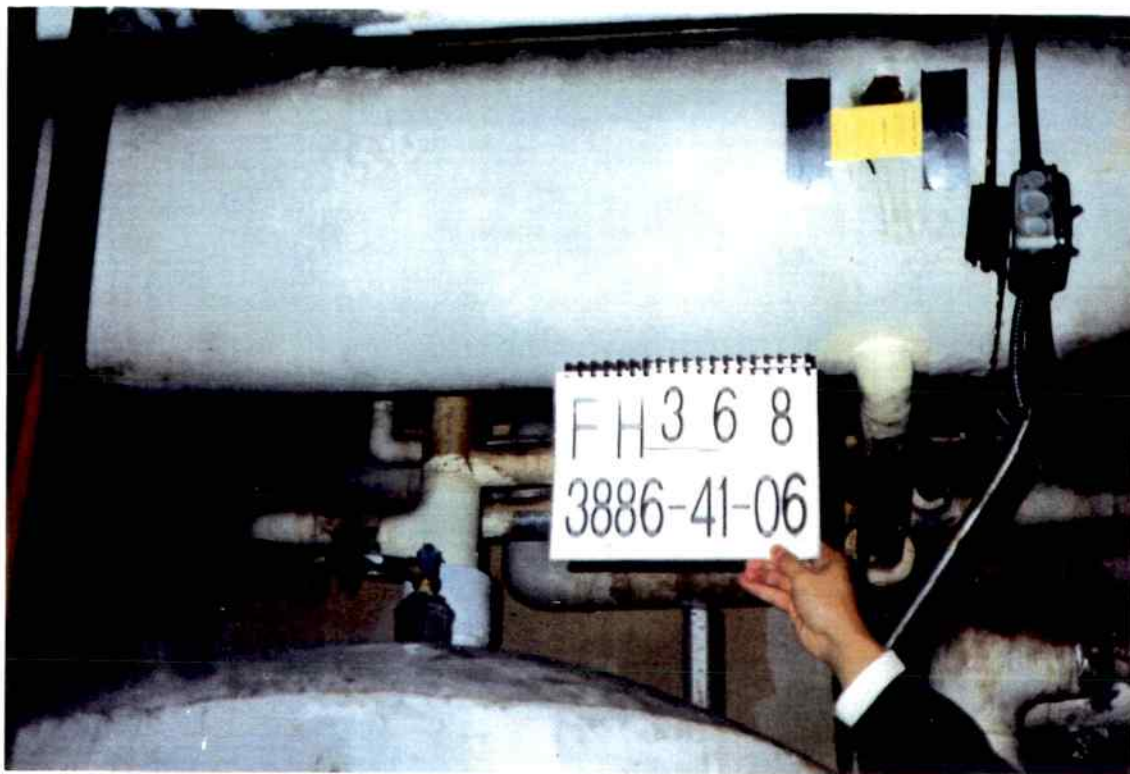
Bldg. 364: Mechanical Room: Tank insulation (side of tank) sample FH368 tested positive.

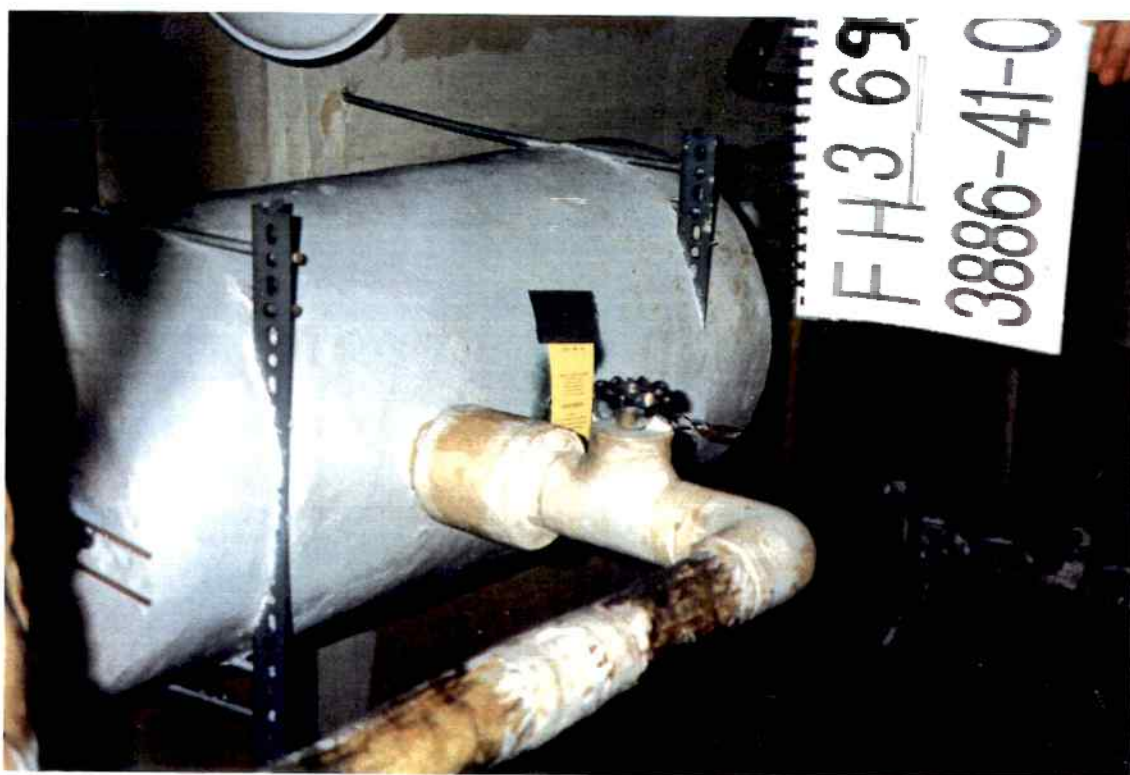
Bldg. 364: Mechanical Room: Tank insulation (end cap) sample FH369 tested positive.

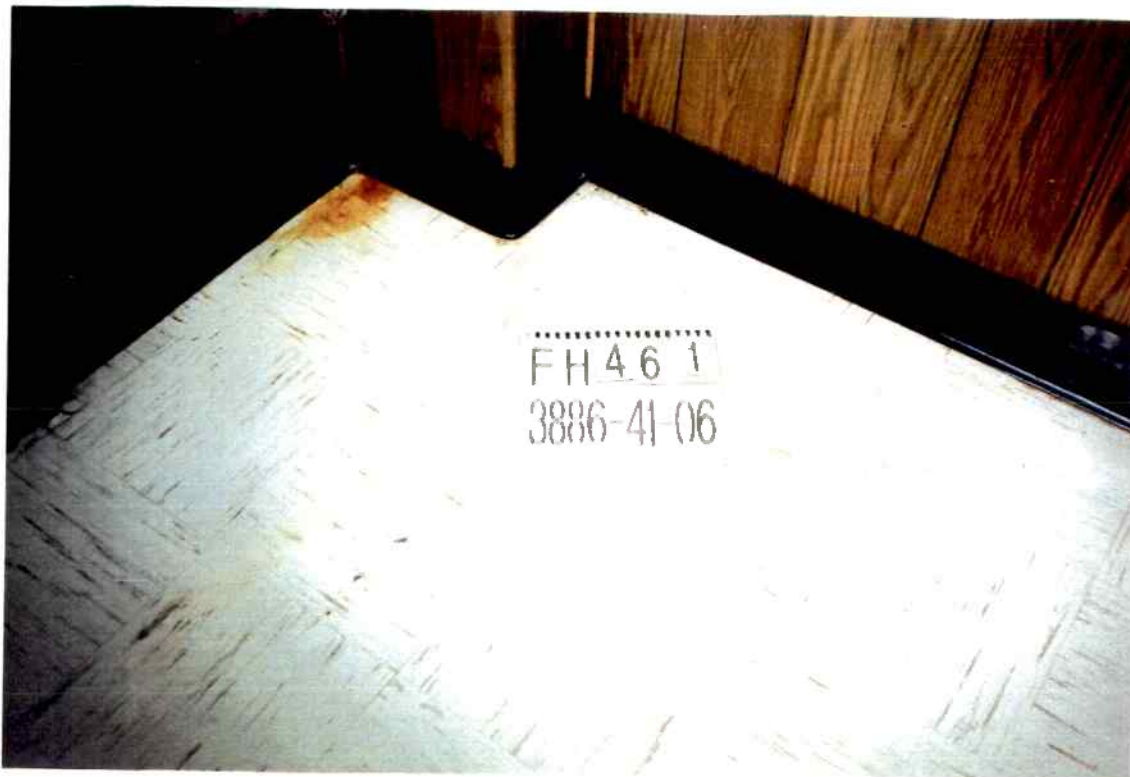
Bldg. 918: 12 x 12" tan floor tile with 9 x 9" brown floor tile below tested positive.

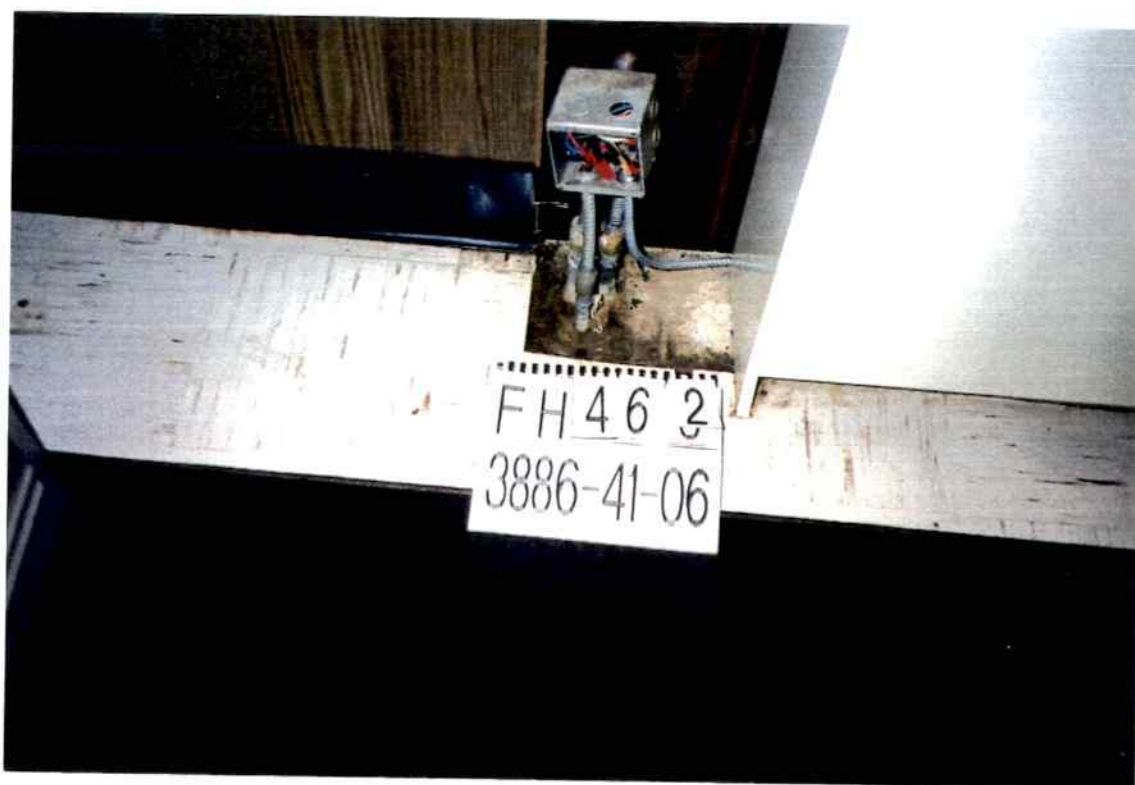
Bldg. 918: 9 x 9" brown floor tile under 12 x 12" tan floor tile tested positive.

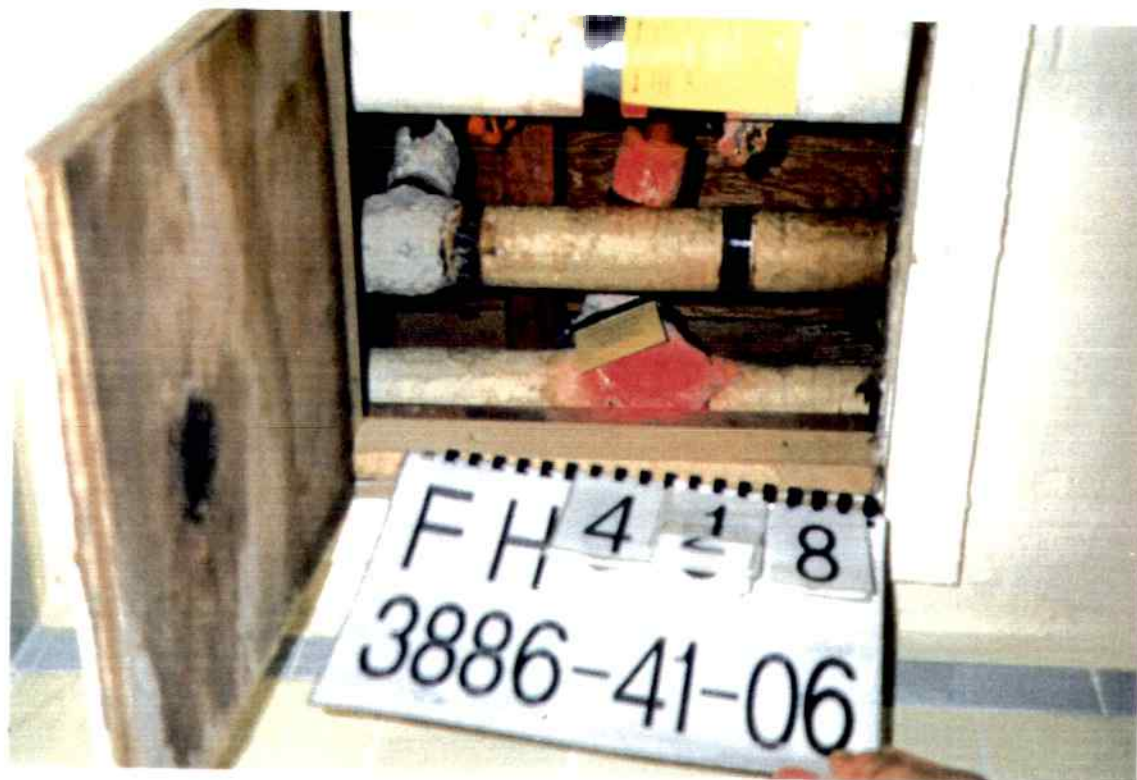
Bldg. 1078: Bachelor Officers Quarters, Bathroom: <4" mud fitting sample FH418 tested positive. Samples FH415 12 x 12" tan floor tiles; FH416, 9 x 9" gray floor tiles; FH517, 9 x 9" gray floor tiles (not shown) also tested positive.

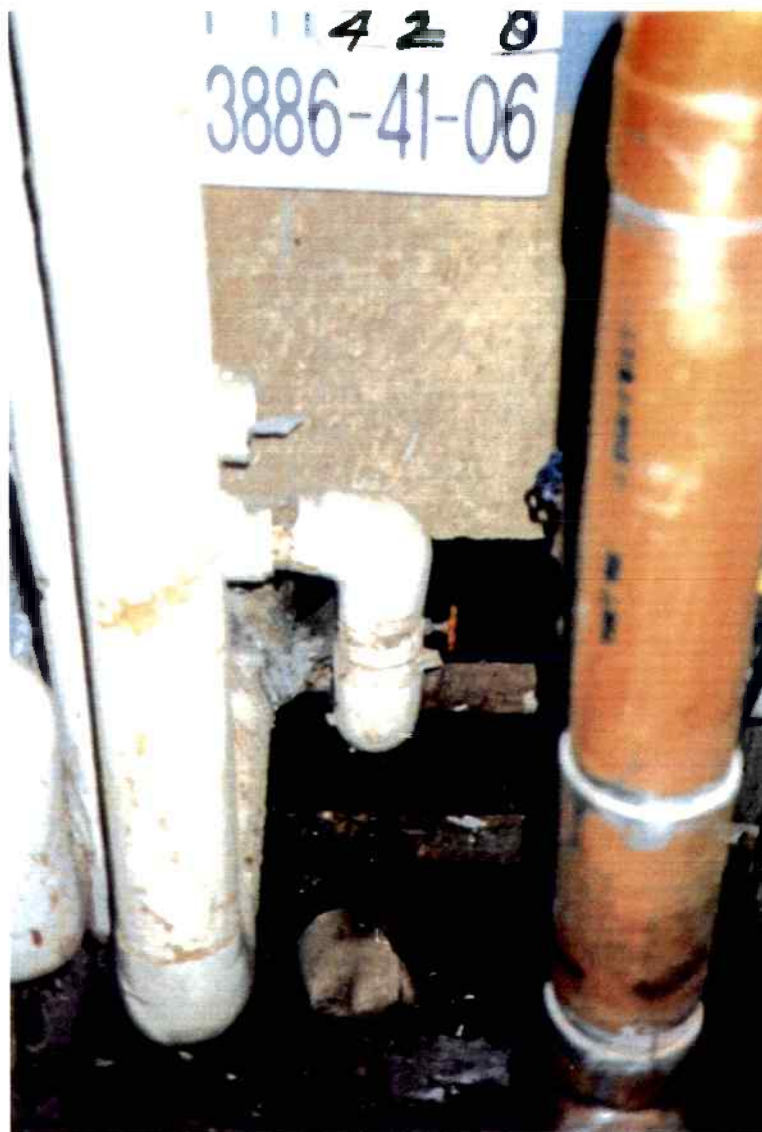
Bldg. 1078: Mechanical Room Pit: <4" pipe runs going underground in pipe trench to Bldg. 1078 tested positive. Samples FH418 < 4" mud fitting; FH419 < 4" pipe run; FH421 < 4" pipe run (not shown) also tested positive.

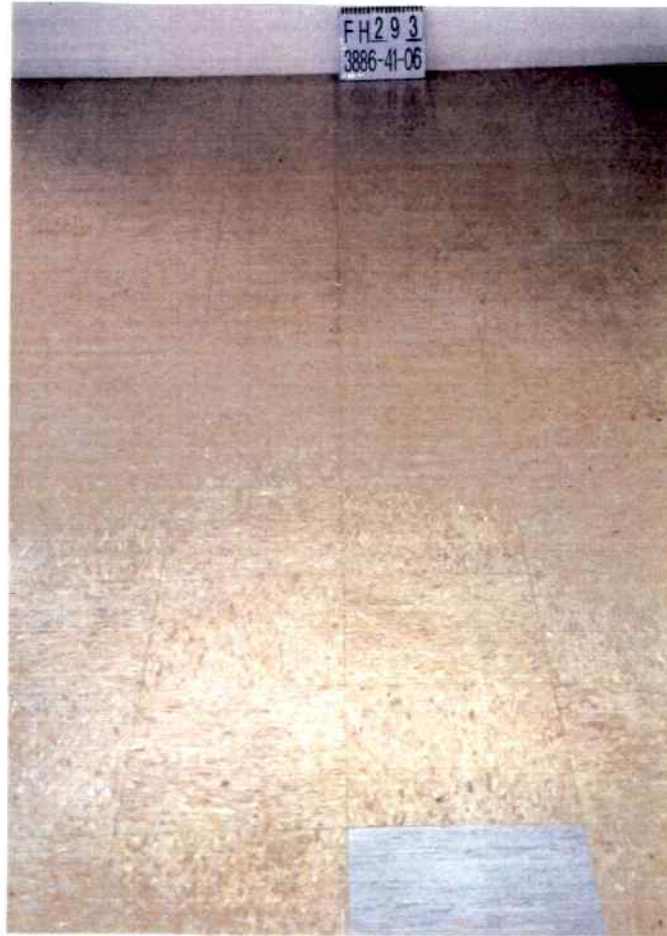
Bldg. 2105

Unit 4, Entire First Floor: (Sample FH293) (12 In. x 12 In.) Tan Floor Tile Tested Positive. Gray Floor Tile (12 In. x 12 In.) On The Second Floor And First Floor Closet Tested Negative.

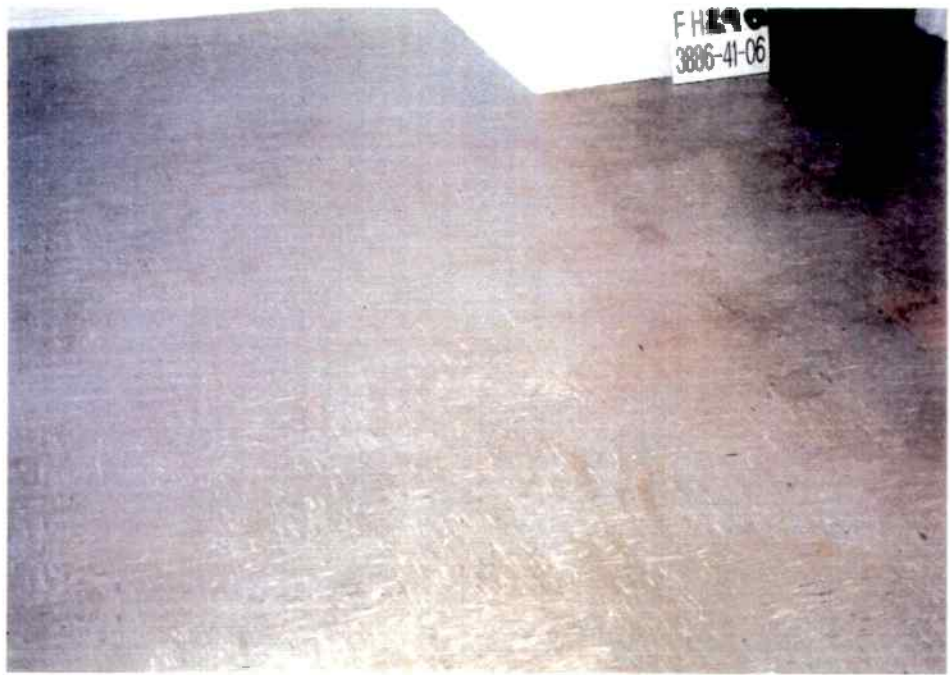
Bldg. 2251

Unit 43, Living Room: (Sample FH290) (9 In. x 9 In.) Gray Floor Tile Tested Positive. Floor Tile In The Kitchen (Brown, 9 In. x 9 In.) Also Tested Positive (Sample FH281).

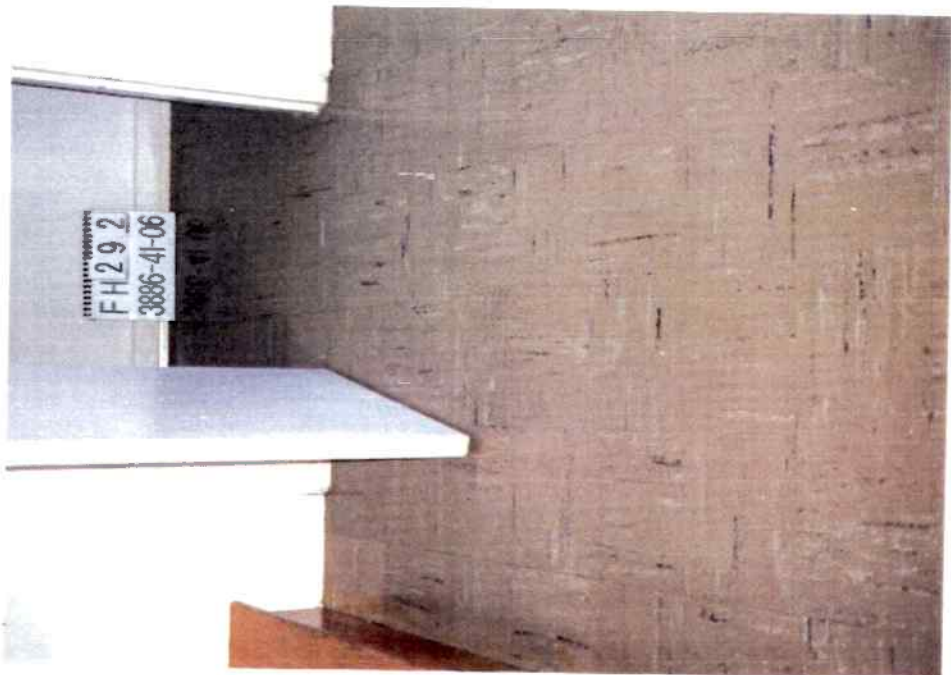
Bldg. 2251

Unit 45, Living Room: (Sample FH292): (9 In. x 9 In.) Brown Floor Tile Tested Positive. Floor Tile In The Kitchen (Green, 9 In. x 9 In.) Also Tested Positive (Sample FH291).

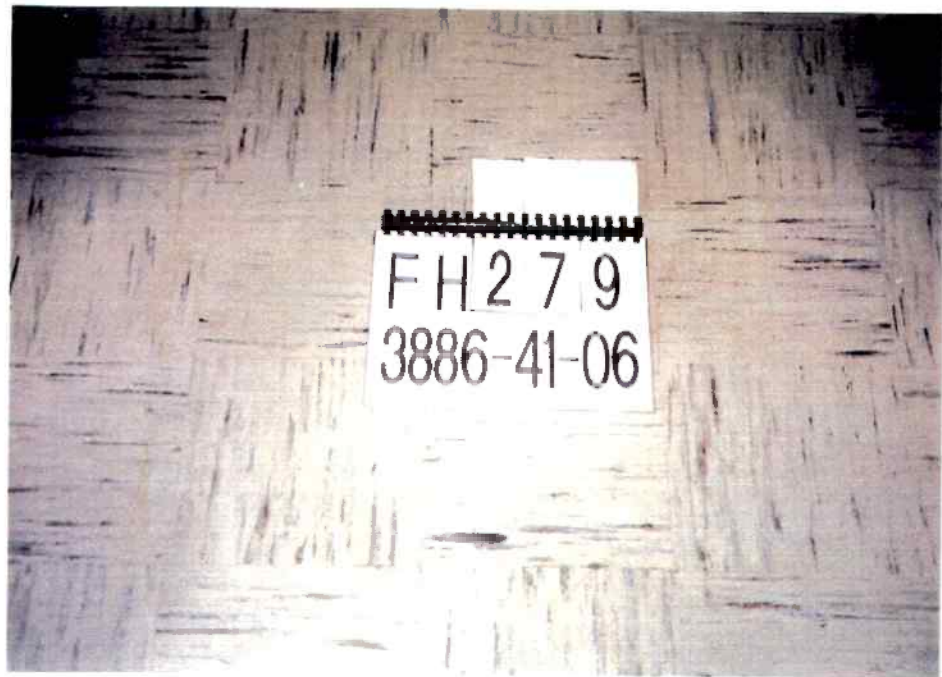
Bldg. 2462

Unit 14, Kitchen: (Sample FH279) (9 In. x 9 In.)  
Gray Floor Tile Tested Positive.

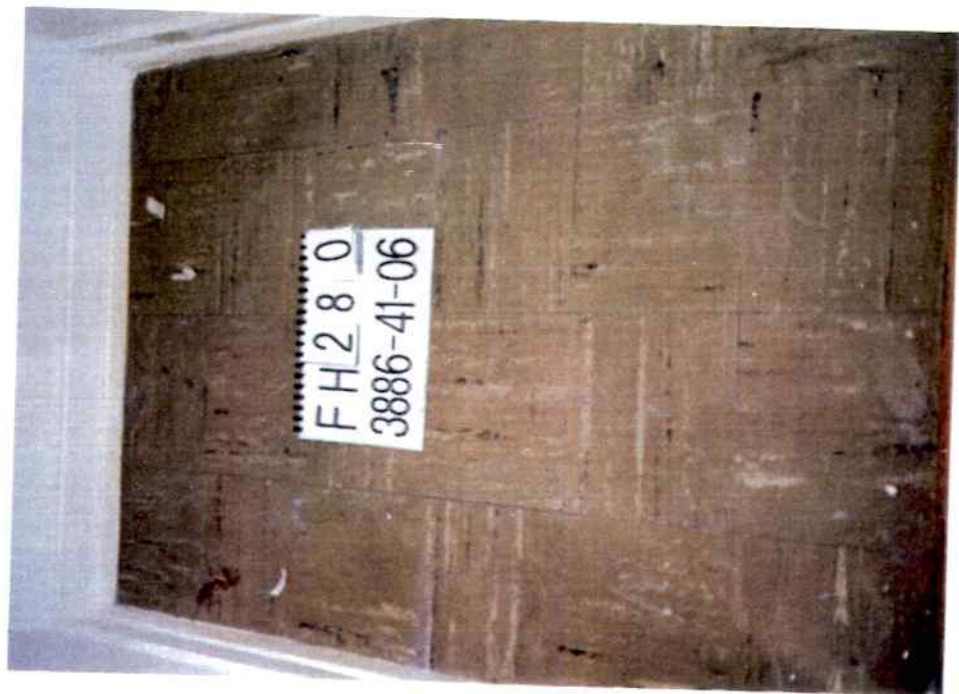
Bldg. 2462

Unit 14, Closet: (Sample FH280) (9 In. x 9 In.)  
Brown Floor Tile Tested Positive.

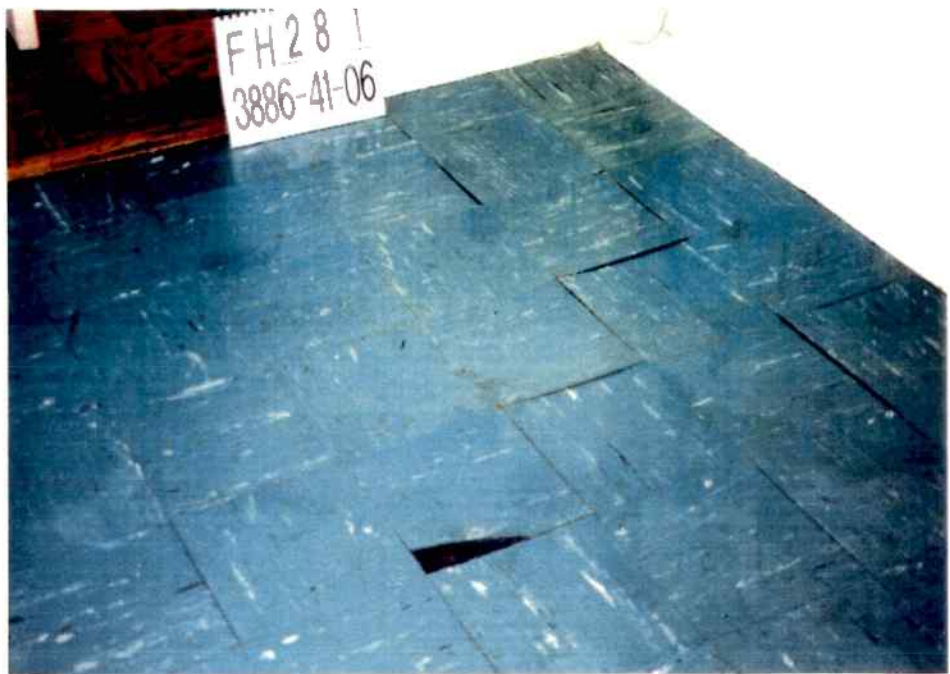
Bldg. 2463

Unit 27, Kitchen: (Sample FH281) (9 In. x 9 In.)  
Green Floor Tile Tested Positive. Floor Tile Is  
Extremely (Water) Damaged.

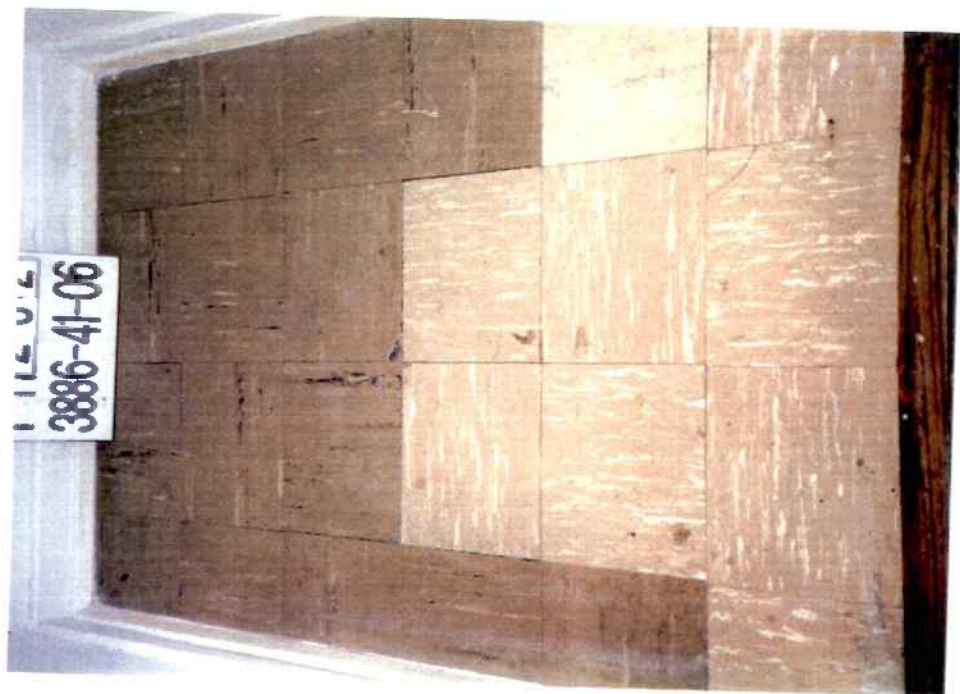
Bldg. 2463

Unit 27, Closet: (Sample FH282) (9 In. x 9 In.)  
Brown Floor Tile Tested Positive.

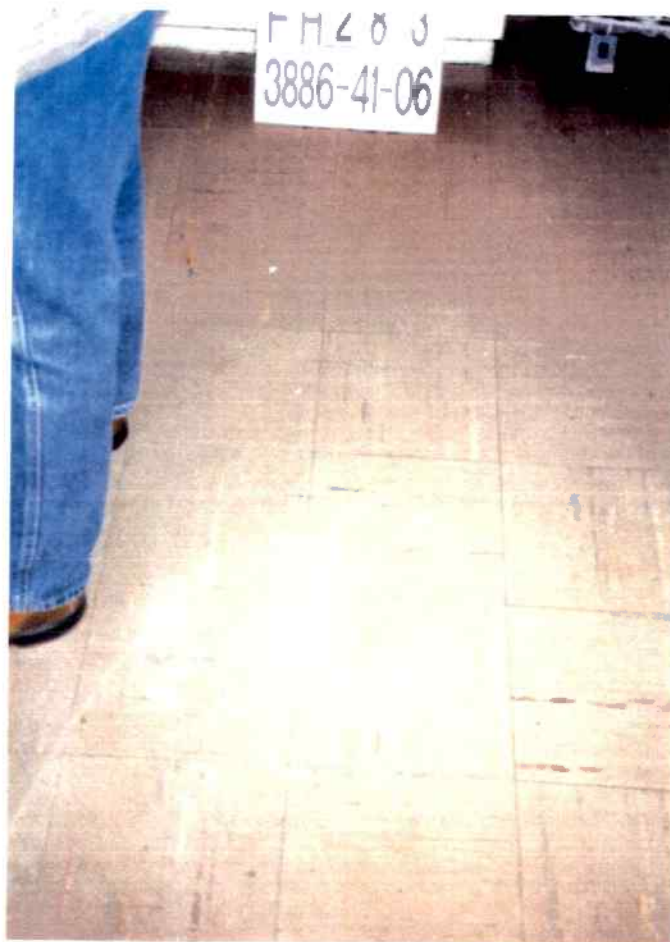
Bldg. 2466

Unit 36, Kitchen: (Sample FH283) (9 In. x 9 In.)  
Brown Floor Tile Tested Positive. Floor Tile In  
The Closet Is Also Tested Positive (Sample FH284).

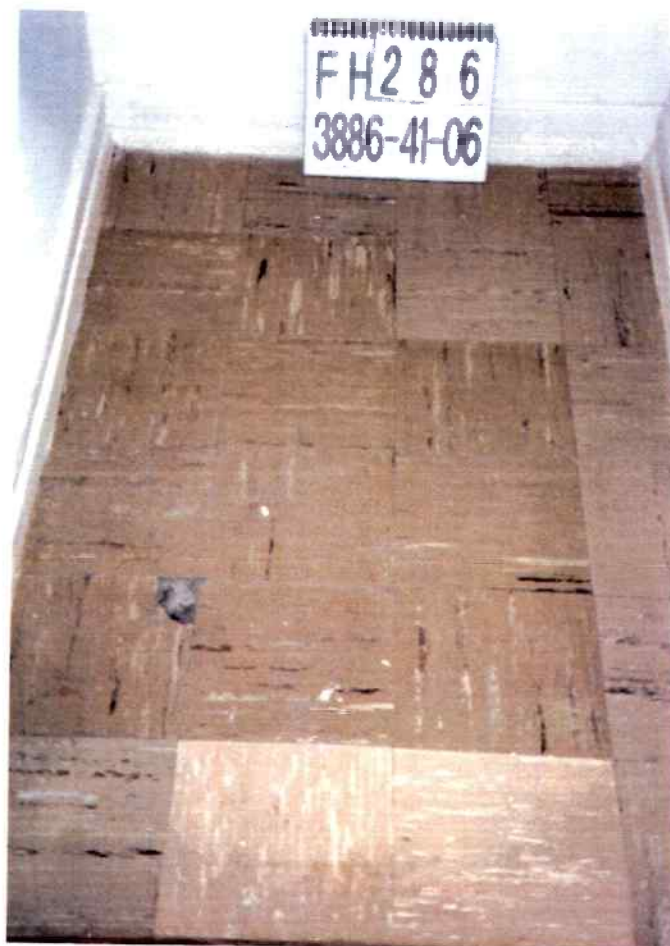
Bldg. 2466

Unit 38, Closet: (Sample FH286) (9 In. x 9 In.)  
Brown Floor Tile Tested Positive. Tan Floor Tile  
(12 In. x 12 In.) In The Kitchen Also Tested  
Positive (Sample FH285).

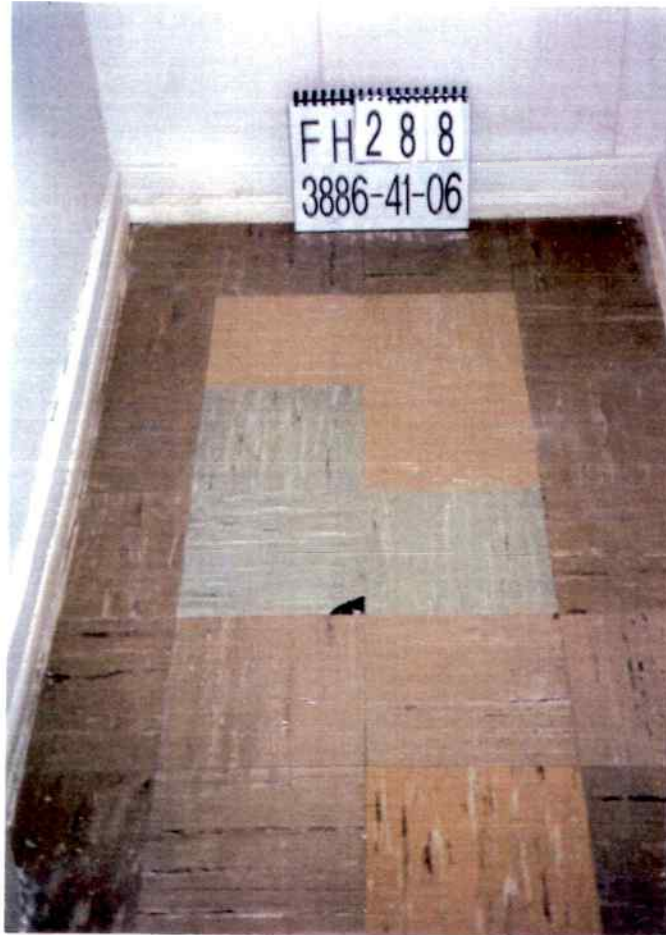
Bldg. 2466

Unit 42, Closet: (Sample FH288) (9 In. x 9 In.)  
Mixed-Color Floor Tile Tested Positive. Green  
Floor Tile (9 In. x 9 In.) In The Kitchen Also  
Tested Positive. (Sample FH287).
