***Volume II - Building Reports for a  
Comprehensive Asbestos  
Survey in Various Buildings at  
Fort Monmouth, New Jersey***

Contract Number DACA61-89-D-0013

**BUILDING REPORTS  
FOR A COMPREHENSIVE ASBESTOS SURVEY  
IN VARIOUS BUILDINGS AT  
FORT MONMOUTH, NEW JERSEY**

**VOLUME II**

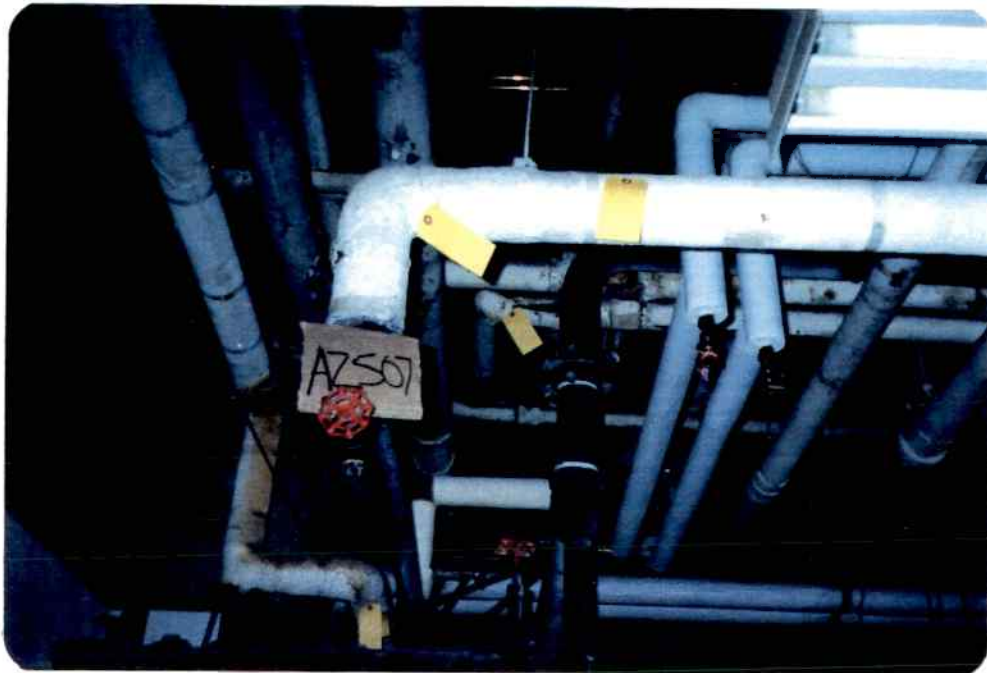
AZ507 - Bldg. 1075 (Hospital) Boiler Room 4-8" pipe fitting tested positive for asbestos.

- o Army Asbestos Deficiency Abatement Project (AADAP) be performed in Boiler Room, Boiler Room Tunnel, and 20 individual rooms in the basement.
- o Basement rooms to be included in AADAP are 1, 2, 3, 4, 6, 7, 8, 9, 10, 12, 13, 14, 16, 17, 18, 19, 20, 21, 22, and 24.

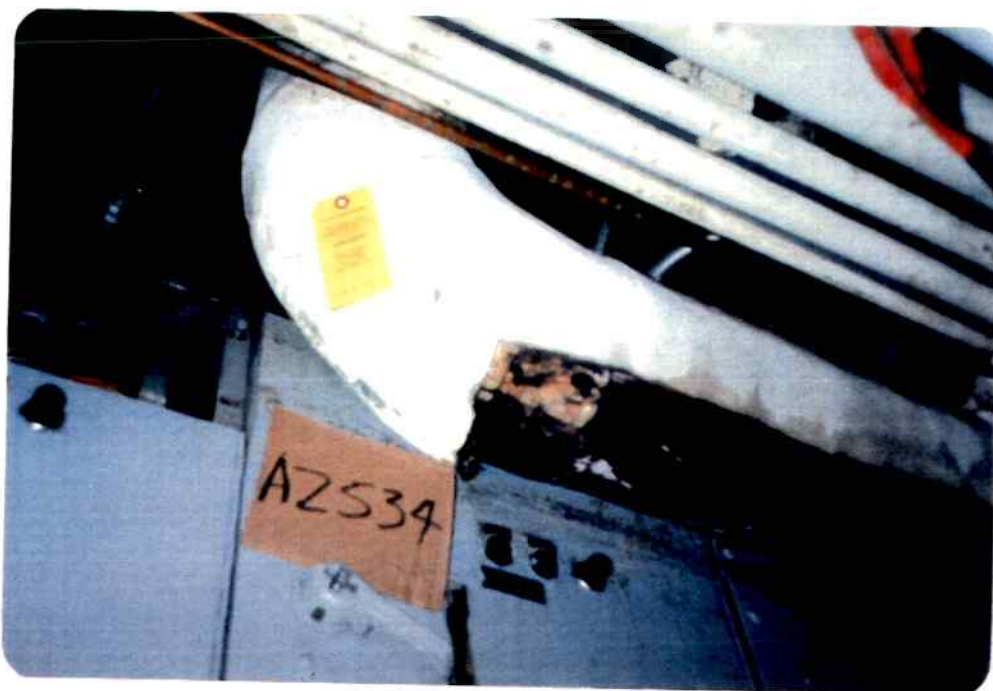
AZ534 - Boiler Room 9-14" pipe fitting tested positive for asbestos.

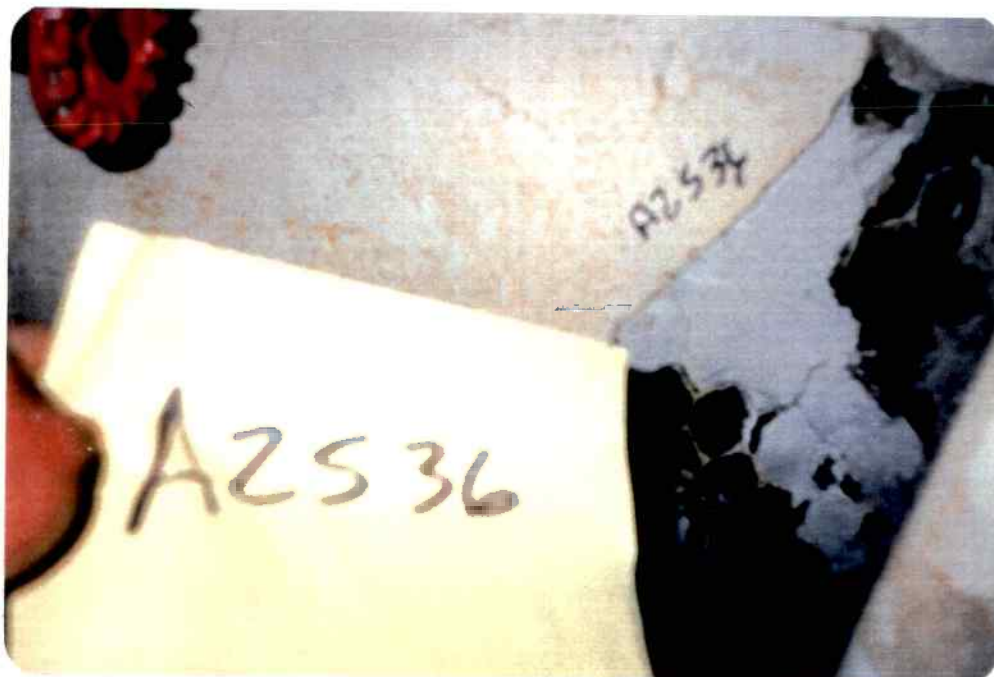
AZ536 - Boiler Room, Air handling equipment insulation tested positive for asbestos.

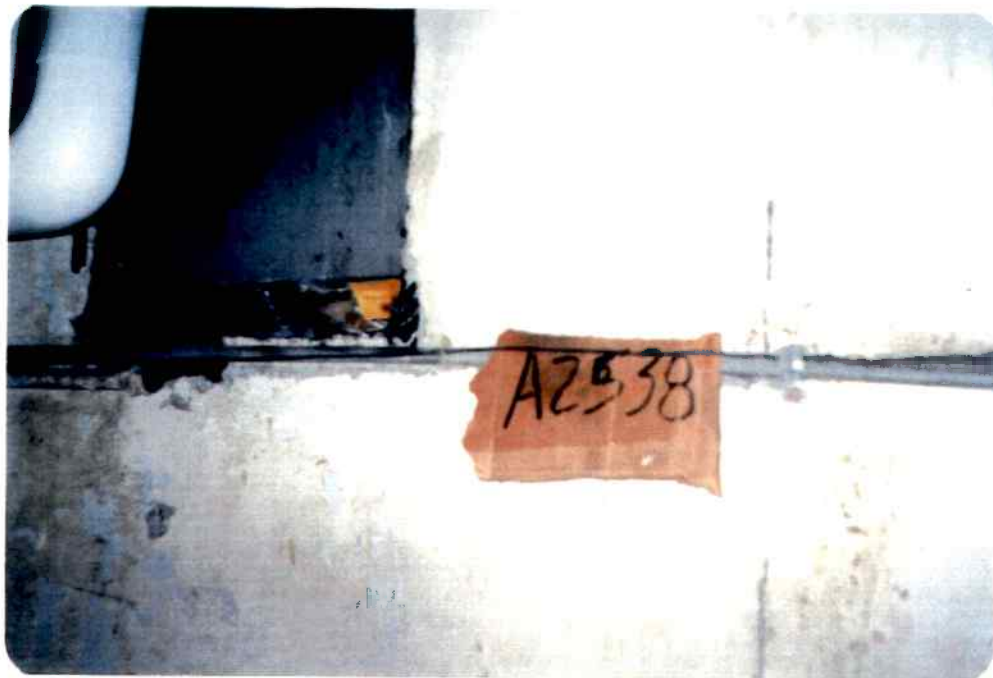
AZ538 - Boiler Room - Air handling equipment insulation tested positive for asbestos.

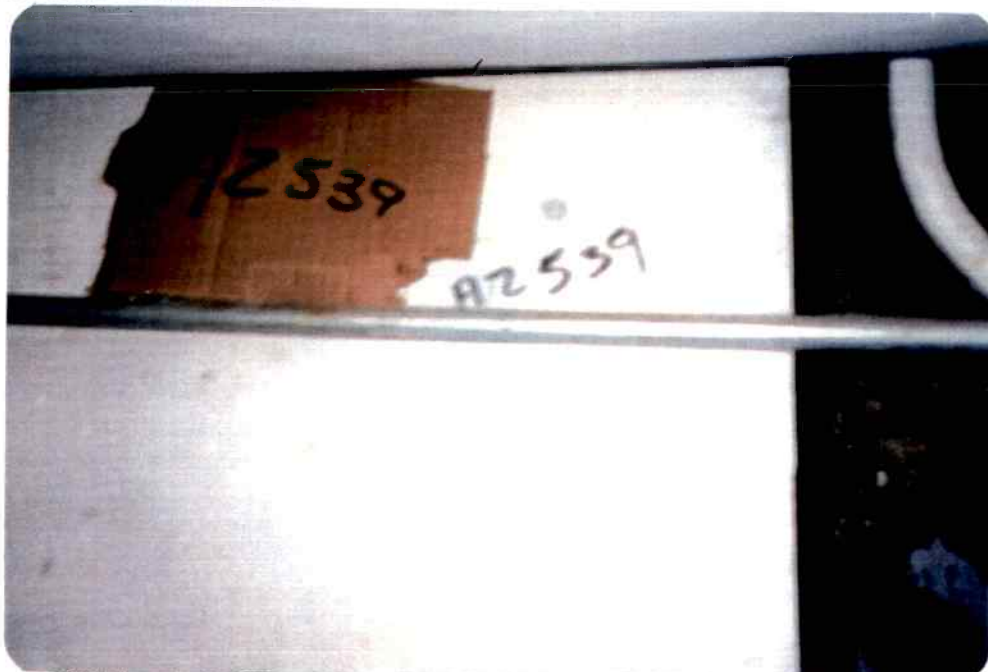
AZ539 - Boiler Room air handling equipment insulation tested positive for asbestos.
