# SITE REMEDIATION UPDATE OCTOBER 21, 2010

## PARCEL 76

SUMMARY OF WORK COMPLETED  
SINCE LAST RAB MEETING

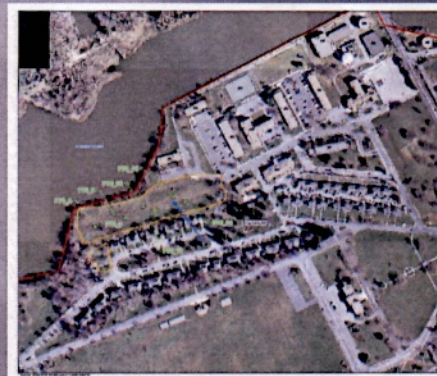
7 UHOTS REMOVED AND 5 OF THEM LEAKED

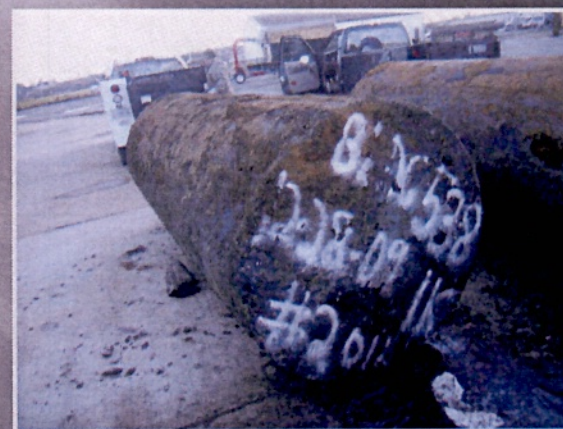
## PARCEL 76-16/BUILDING 538

1000-Gallon UHOT removed on 12/28/09.

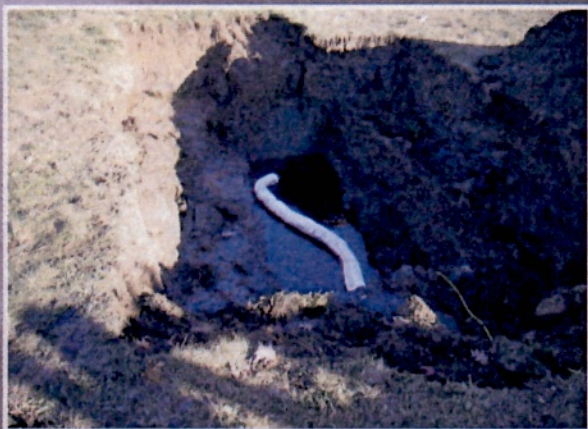
The UHOT leaked and the excavation was remediated on the east, north, and west sides.

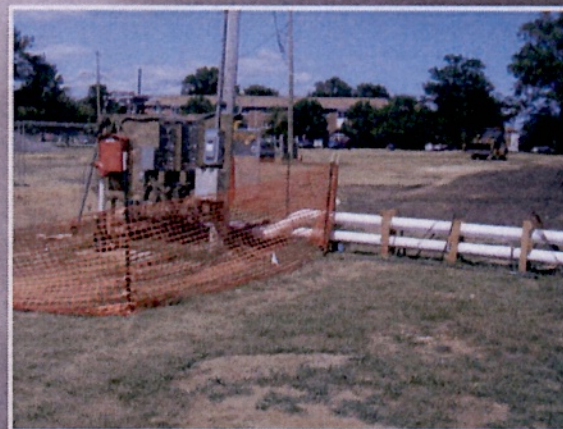
The temporary lift station had to be relocated before the south side of the excavation could be remediated.

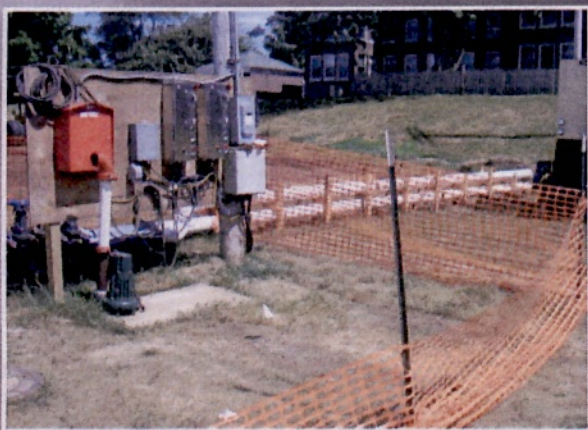
Used a Geoprobe to collect samples on the south and southeast sides of excavation to delineate contamination.

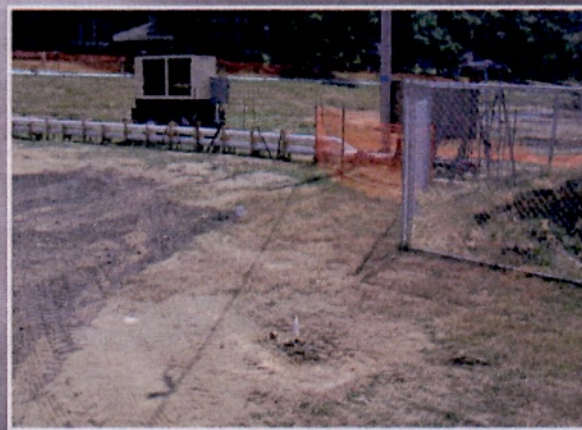
Soil boring locations on southeast side.

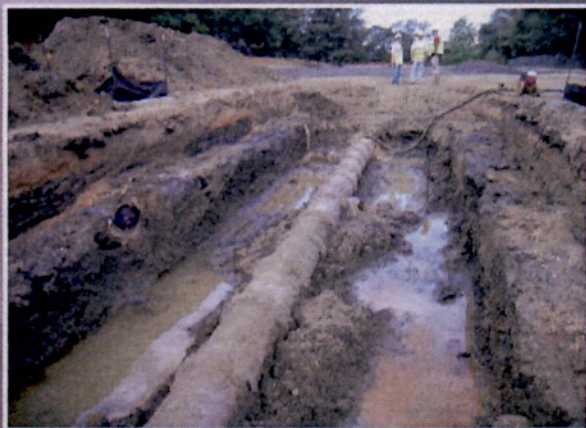
Exposed terra cotta sewer line and removed adjacent petroleum contaminated soil.

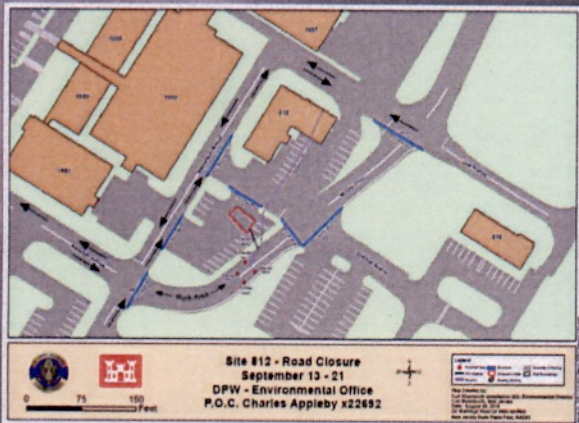
An historic rail line ran along Razor Avenue, between Bldgs. 1007 and 976. Fuel was delivered from the tanker cars on this line using a remote fill pipe. The pipe and the contamination was remediated up to the north side of Building 812 when the Commissary (Bldg. 1007) was built in 1997. This project addressed the pipe and pump island dispenser on the south side of Bldg. 812.

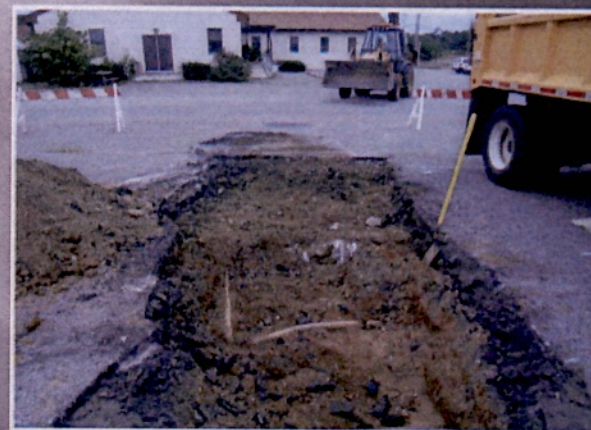
Exposed dispenser island concrete located in Building 812 parking lot.

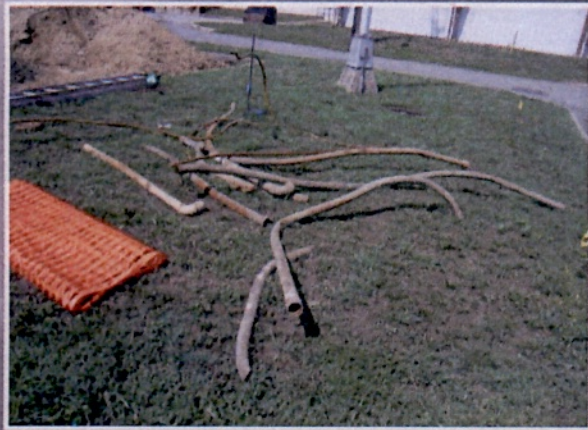
Pipes removed from dispenser island excavation.

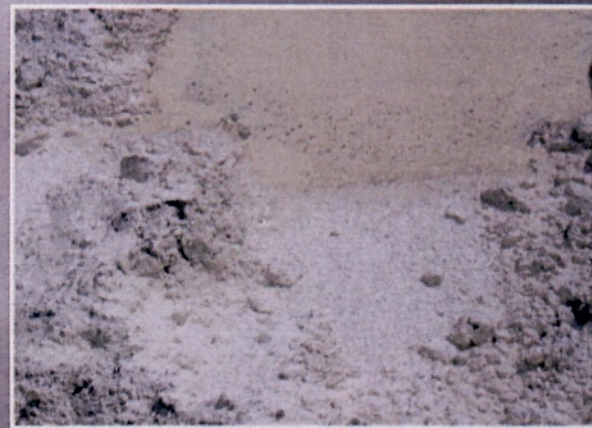
ORC in excavation.

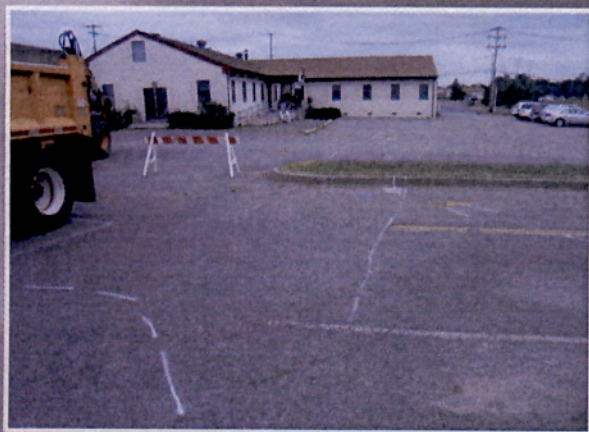
Proposed remote fill pipe excavation. Pipe was located using a metal detector.

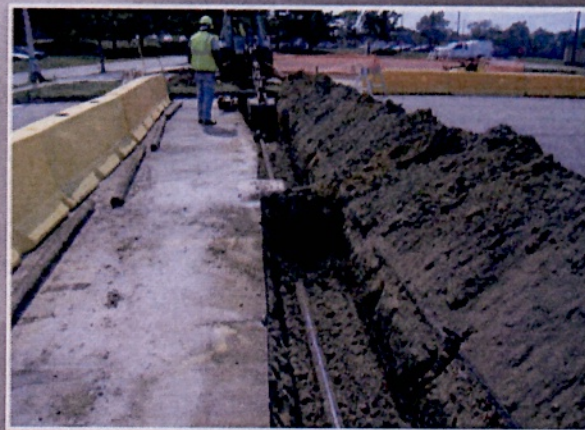
Excavating remote fill pipe. It was a 3" steel pipe with a bituminous coating.

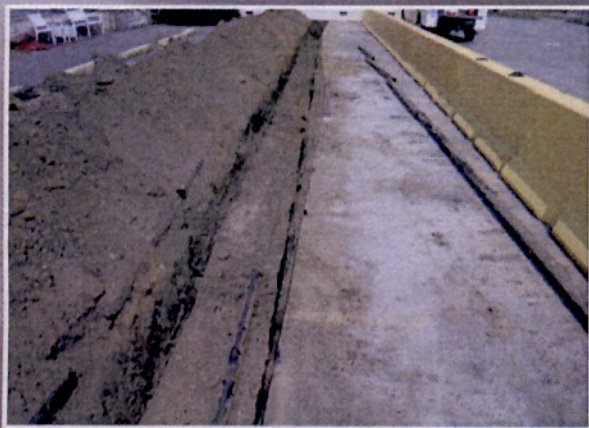
The pipe was removed from the excavation and a sample was collected every 15 linear feet from beneath the pipe.

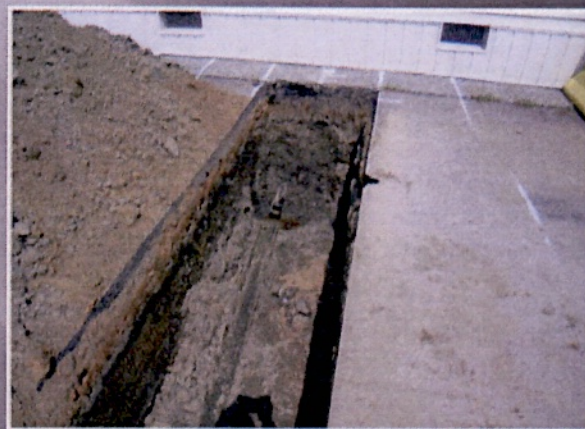
The remote fill pipe went under the eastern portion of Building 812.

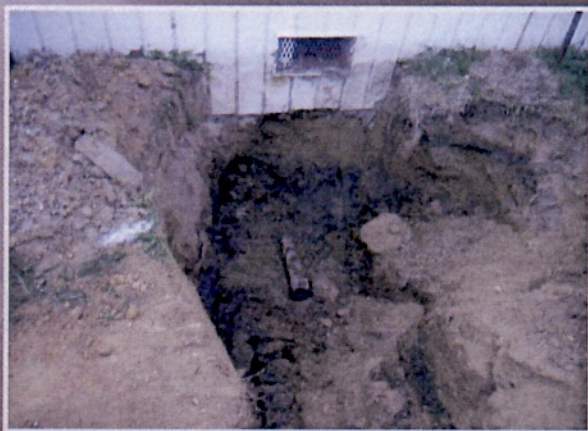
The pipe ended on the north side of Building 812.

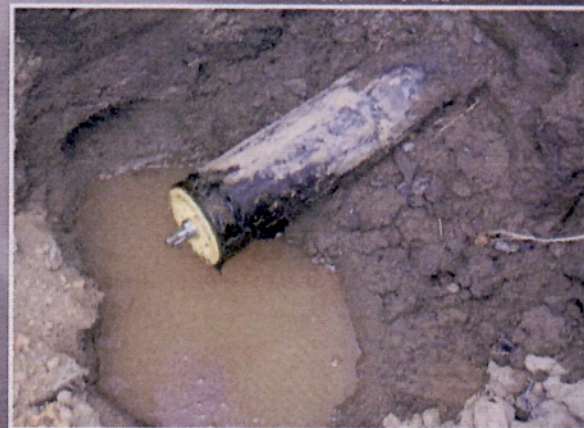
The pipe could not be pulled out from beneath the building without causing structural damage. In order to leave it in place we had to prove it did not leak by performing a pressure test. Here you can see one end of the pipe was plugged.

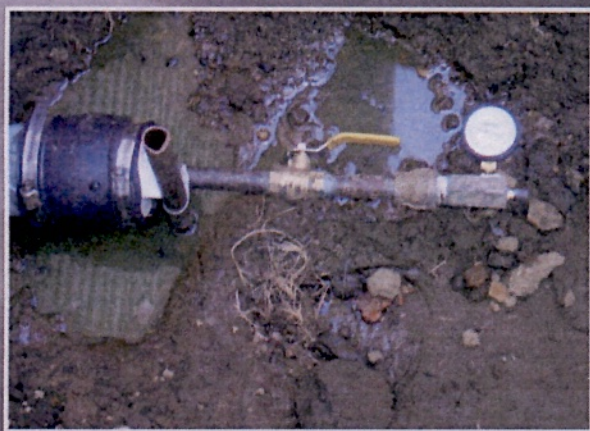
The other end of the pipe was pressurized using an air compressor. A gauge was added to the end of the pipe to read the pressure. The pipe was left pressurized for 72 hours and no leaks were noted.

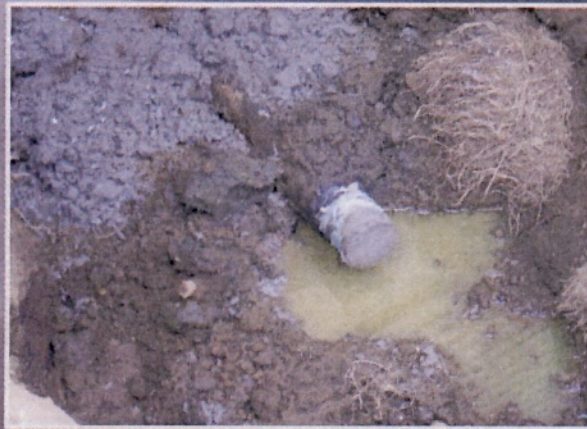
Sealed pipe.

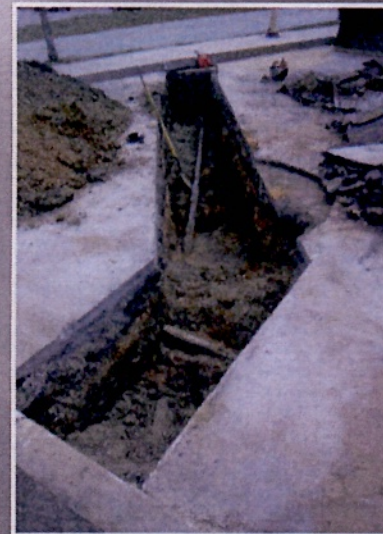
The remote fill lines continued passed the pump island and into  
Murphy Drive.

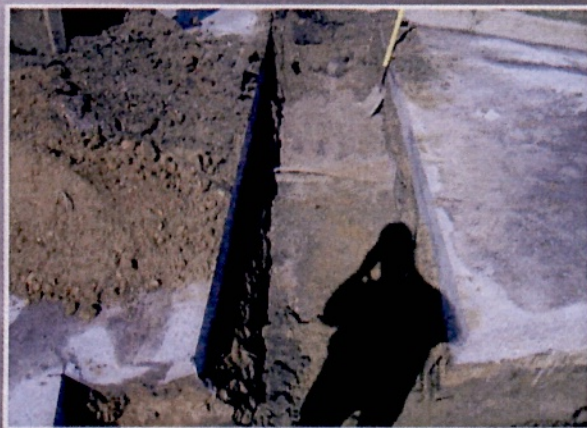
Abandoned fuel lines found in Murphy Drive.

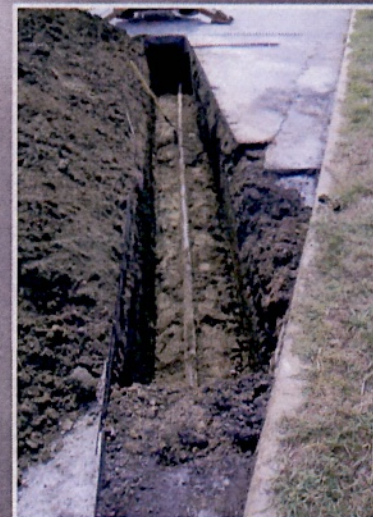
Remote fill line in Murphy Drive

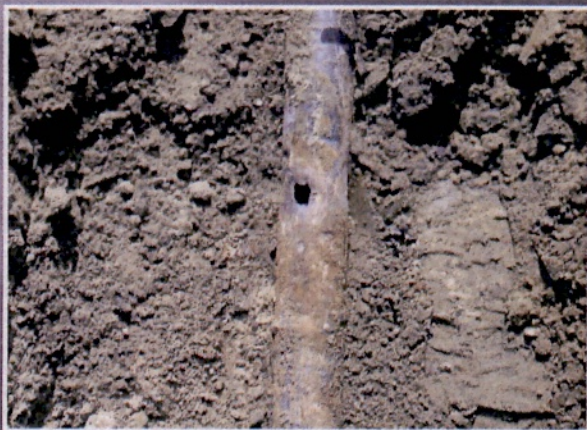
A hole was observed in the remote fill pipe in Murphy Drive. Petroleum contaminated soil was excavated from the area prior to sampling.

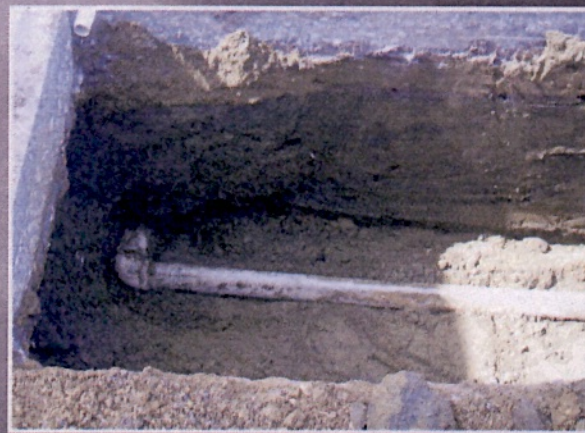
There was a 90 degree turn and pipe lead back to the Building 812 parking lot. The end of the pipe was cut and pinched off under the curb line.

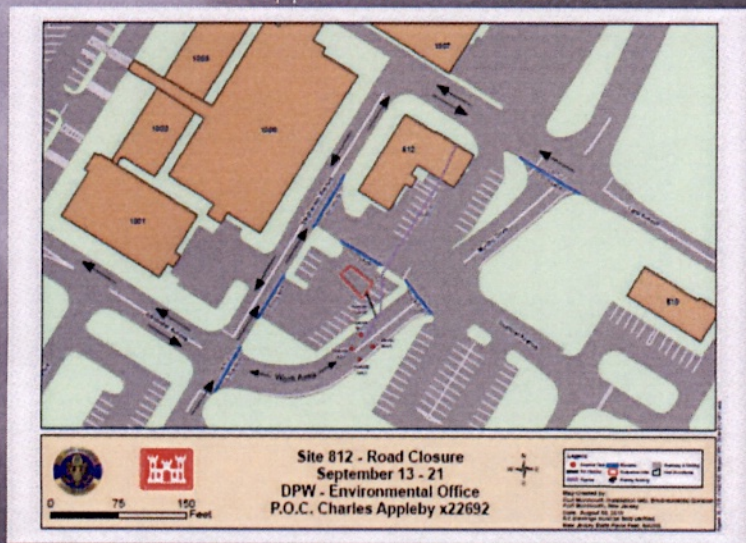
Test pits were dug on the south side of Murphy Drive to confirm that the pipes did not continue to another site.

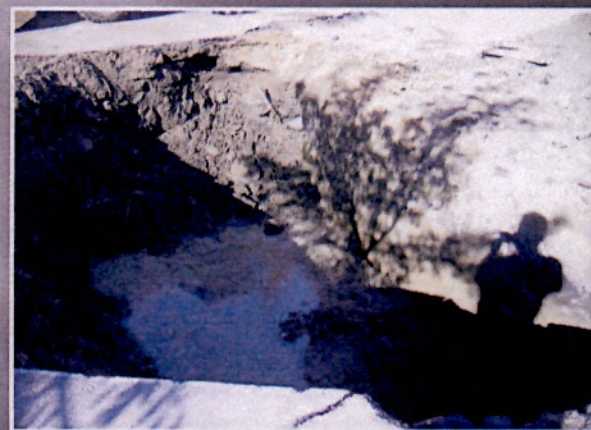
Additional debris and contamination was found on the south side of the pump island. This may be where the USTs were located. We are continuing with remediating this section of the site.

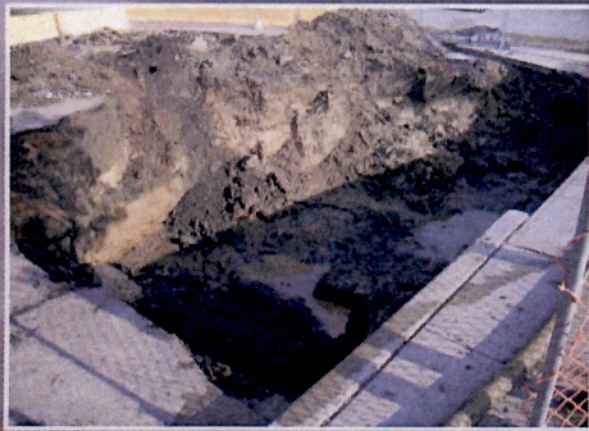
Two sets of tank straps and concrete UST cradles were found in the excavation.

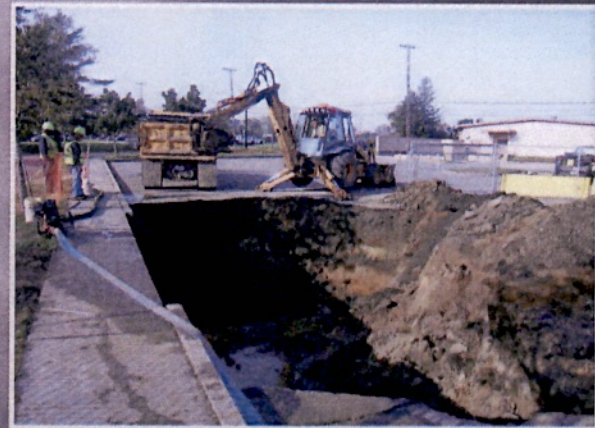
Approximately 100 cubic yards of petroleum contaminated soil has been excavated from the site to date. Once cleaned up additional ORC will be applied to the area prior to backfilling.
