December 1993 ERI-02-001-93

ERI Aerial Photographic Site Analysis

Evans Area
Charles Wood Area
Fort Monmouth, New Jersey

United States Army Environmental Center

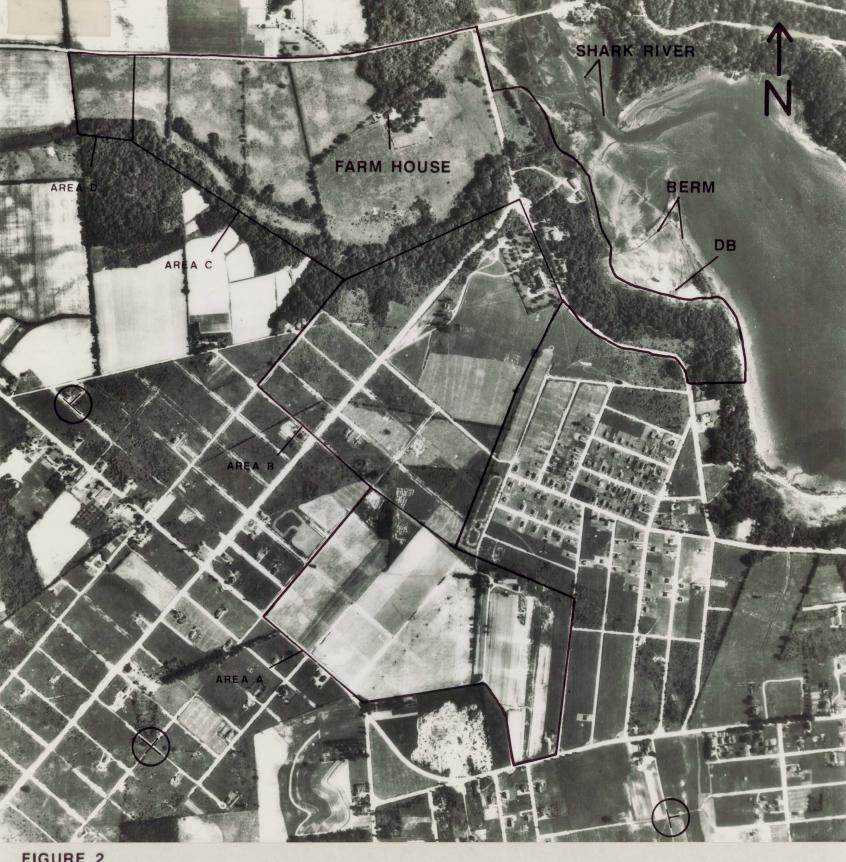
FIGURE 2 **EVANS AREA**

AREA A: Agricultural land use.

AREA B: Agricultural land in transition.

AREA D: Agricultural land use.

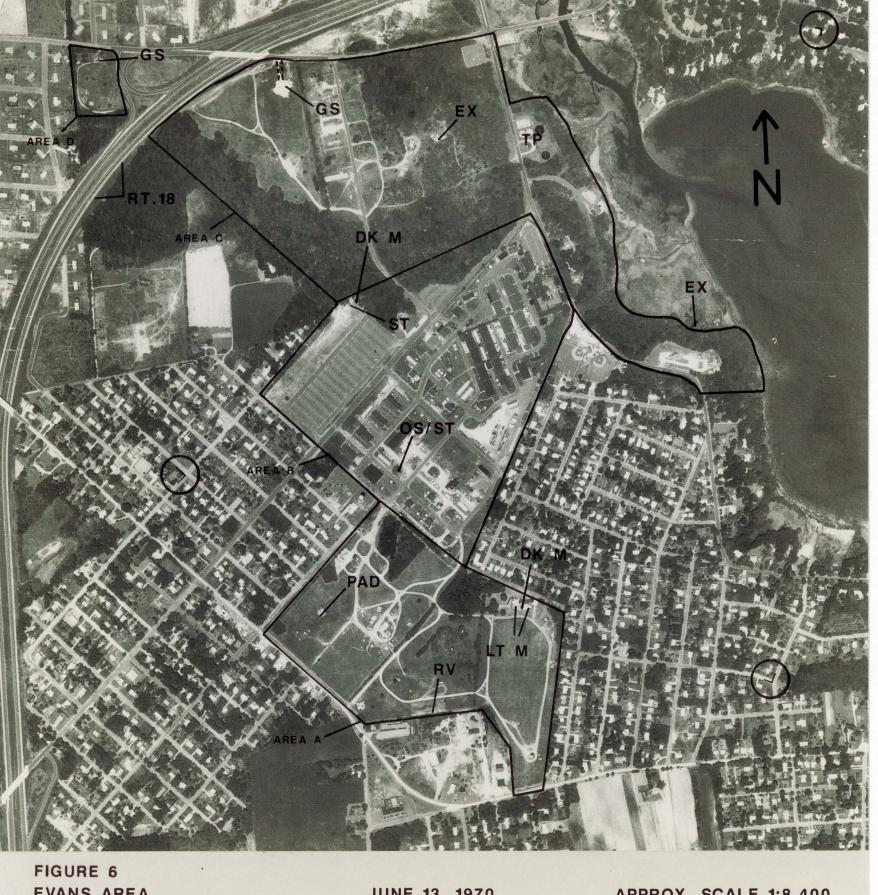
JUNE 13, 1970

AREA B: Staining continues to be noted in the open storage in the south central portion of AREA B. Dark-toned material and a stain are visible at the north end of the large parking lot located along the northwest border of AREA B.

AREA C: The excavated area west of the treatment plant appears inactive. The square ground scar remains visible further west. An access road now leads to this scarred area from the north. The ground scar noted in the wooded area has been covered over by the construction of State Route 18.

AREA D: A building foundation (not annotated) and a ground scar are noted in the north end.

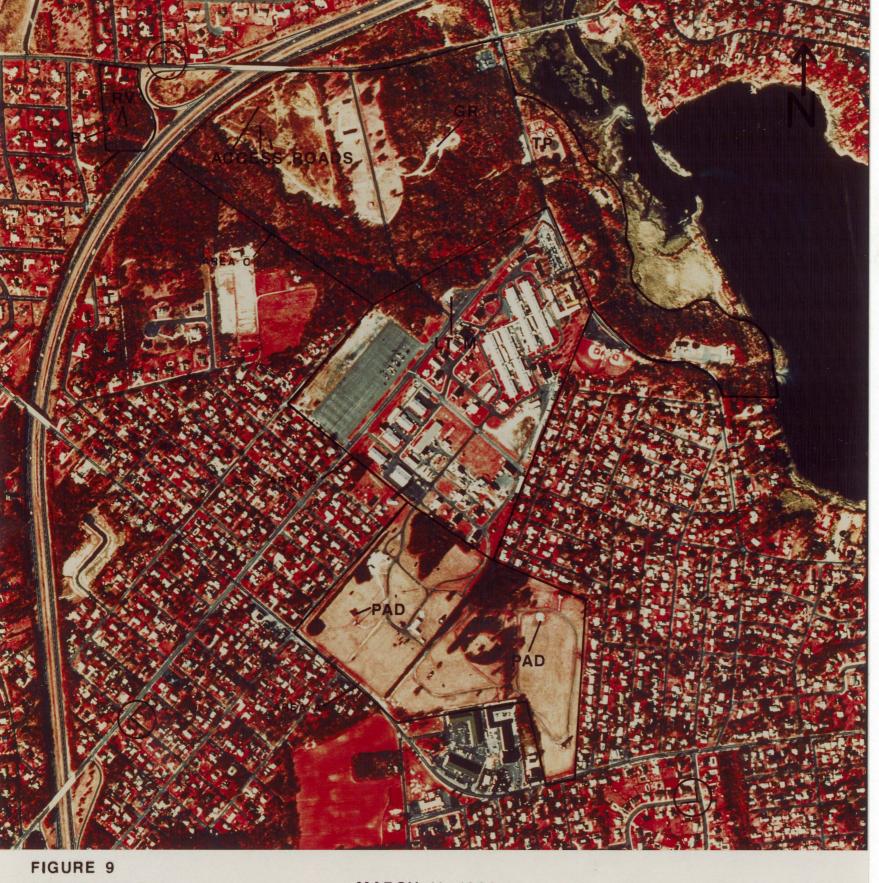
MARCH 11, 1991

AREA A: A circular pad is visible in the vicinity where dark and light-toned material was noted in previous years in the eastern portion of AREA A.

AREA B: Light-toned material is visible at the north end of AREA B. No staining is noted in the open storage area located in the south central portion of AREA B.

AREA C: The former excavated area noted west of the treatment plant appears graded. Remnants of access roads (not annotated) remain in the western portion of AREA C.

AREA D: New homes were constructed in the northern end of AREA D. The fenced building remains in the southern end. The scarred areas noted in the southern end in 1981 have revegetated.

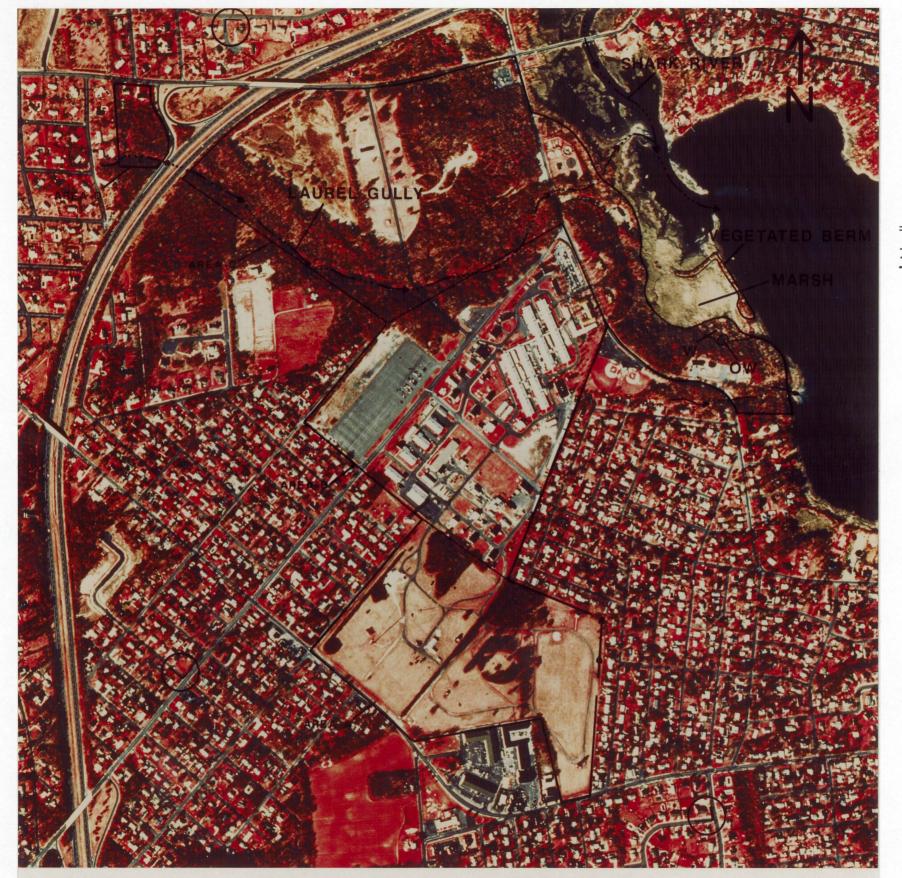
FIGURE 10 EVANS AREA

WETLANDS AND DRAINAGE ANALYSIS MARCH 11, 1991

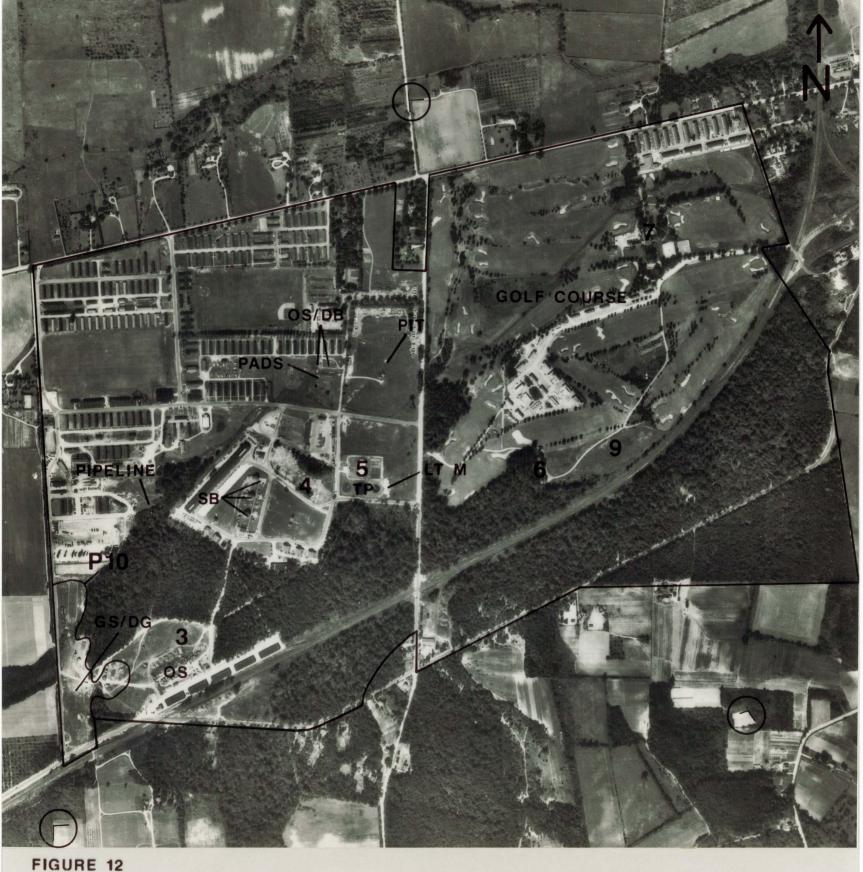
FIGURE 12 CHARLES WOOD AREA

- 1, 2, 3,: This year of aerial photography pre-dates Site 1 and 2, and post-dates Site 3.
- 4: A linear building and a parking area are located in this area. No environmentally significant activity is noted in this location throughout the study period; therefore, this site will not be discussed further.
- 5: Sanitary Waste Treatment Plant (TP). Light-toned material is visible on the east side of the plant.
- 6: A road leads through the golf course to the pesticide storage building at the edge of a wooded area.
- 7: An L-shaped building is present.
- 8: Aerial photography pre-dates the existence of this site.
- 9: A grass covered, open area is visible in this location.
- P10: Two ground scarred/disturbed ground (DG) areas are located in the central portion of this area.

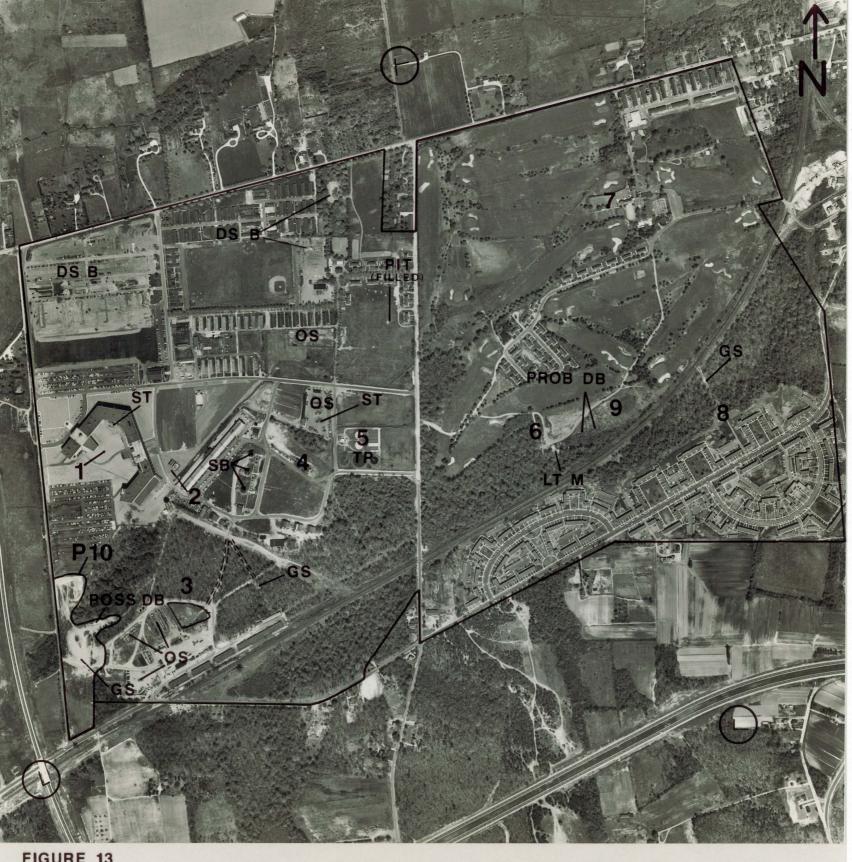
FIGURE 13 CHARLES WOOD AREA

- 1, 2: Rectangular light-toned areas appear at the approximate location of sites 1 and 2. No other environmentally significant features are noted at these locations throughout the study period; therefore, these sites will not be discussed further.

- 3: An access road leads into a graded, triangular-shaped area. This is likely the remnants of the Army Air Force landfill referred to in Report 171. No other environmentally significant features are noted in this location; therefore, this site will not be discussed further.

- 5: The light-toned material noted on the east side of treatment plant in 1947 is no longer visible.
- 6: Two buildings are present. Light-toned material is present south of the building. This light-toned material is likely lime and/or fertilizer for the golf course as reported in collateral information.

- 7: Building remains. No significant features noted.
- 8: A small building is present. No other environmentally significant features are noted at this site throughout the analysis; therefore, this site will not be discussed further.

- 9: Possible debris is noted in the western edge of site 9.
- P10: The ground scarred area has increased in size since 1947. Probable debris is visible along an access road at the eastern portion of site P10.

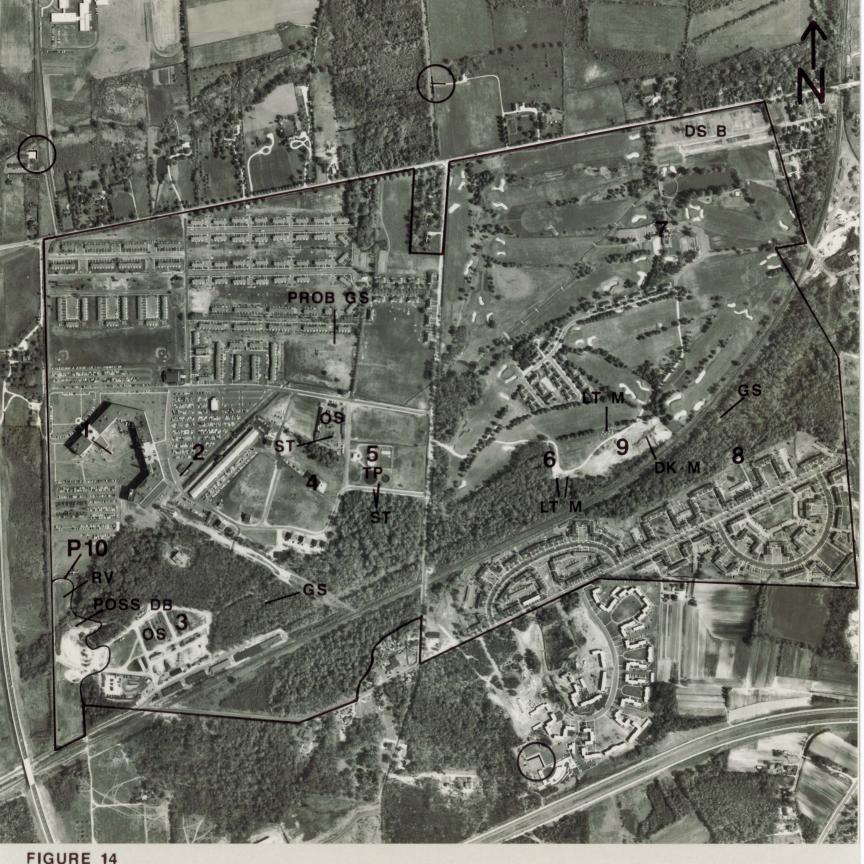
FIGURE 14 CHARLES WOOD AREA

- 5: Staining present in the southern end of site 5 may represent seepage from the treatment plant.
- 6: Two piles of light-toned material remain south of the building. Additional piles of light-toned material appear to the east.
- 9: A large cleared area containing several piles of darktoned mounded material is visible.
- P10: The northern portion of the ground scarred area appears revegetated. The southern end remains scarred and possible debris is visible.

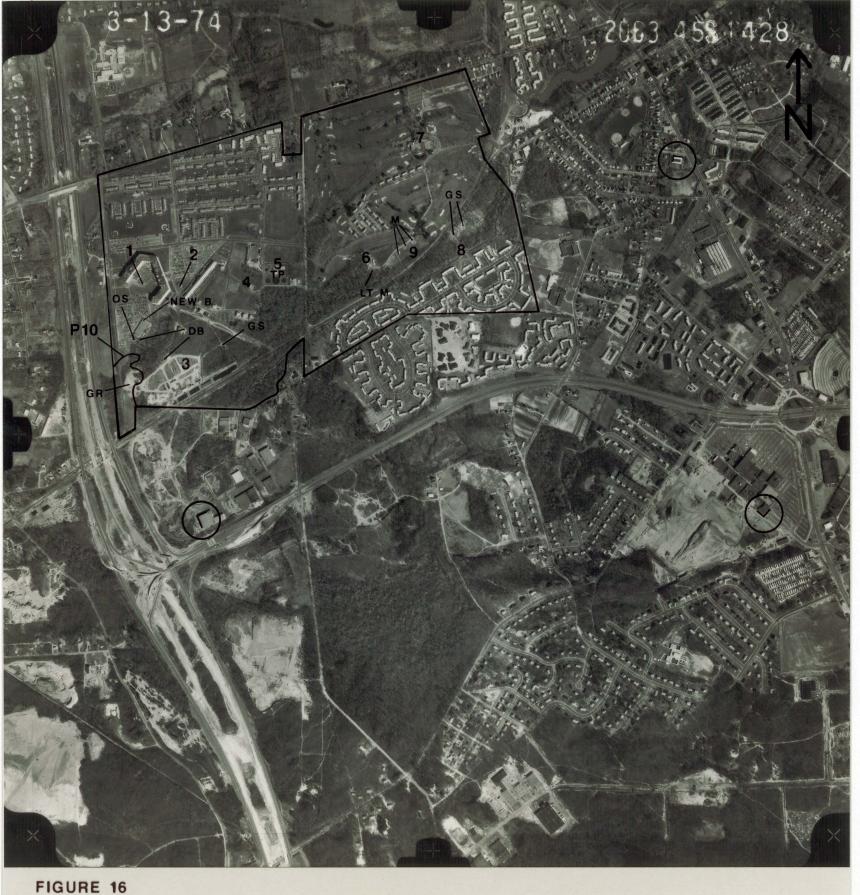
FIGURE 16 CHARLES WOOD AREA

- 5: No significant activity noted.
- 6: Light-toned material remains visible in this area.
- 7: Open storage material and staining are no longer visible.
- 9: Three areas of medium-toned material and an earthmover (not annotated) are visible near the road in this area.
- P10: The ground scarred/disturbed ground area has been graded. Two dump trucks (not annotated) are in motion in this area.

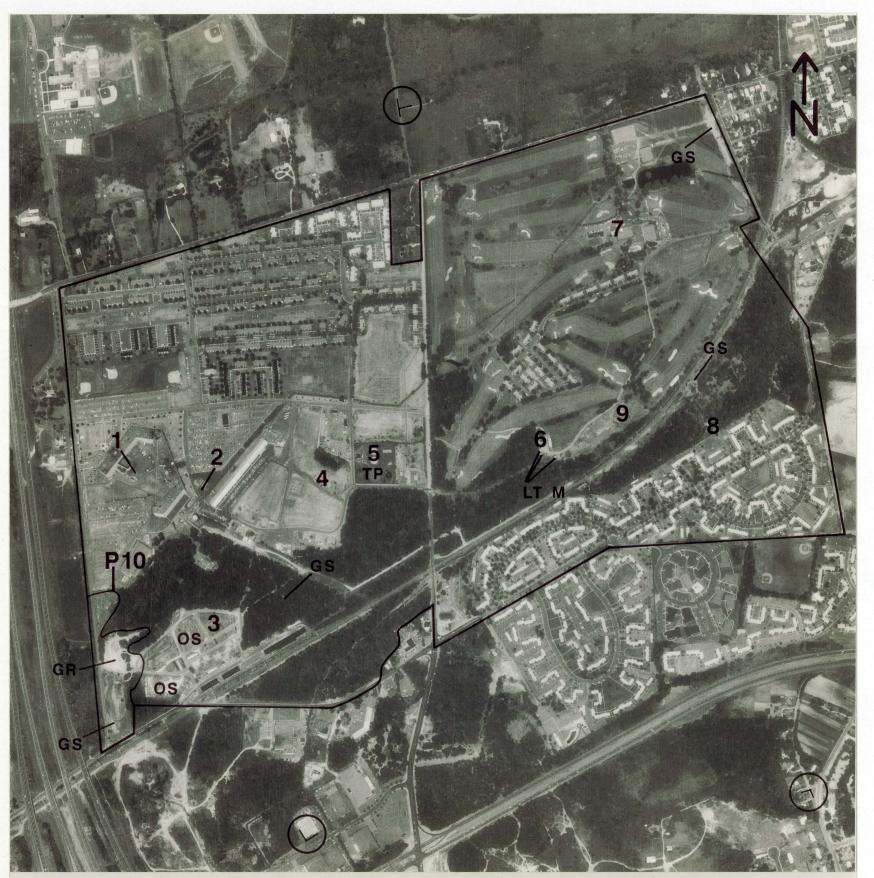
FIGURE 17 CHARLES WOOD AREA

Debris noted near a new building at the southwest corner in 1974 is no longer visible. A linear ground scarred area is visible along the northeastern boundary of CWA.

- 5: No significant activity noted.
- 6: Light-toned material remains visible.
- 7: No significant activity noted.
- 9: This area appears to be revegetating. No evidence of the medium-toned material seen in 1974 is visible.

P10: The central portion of P10 remains cleared of vegetation and graded. An oval-shaped ground scarred area is visible at the southern end of P10.

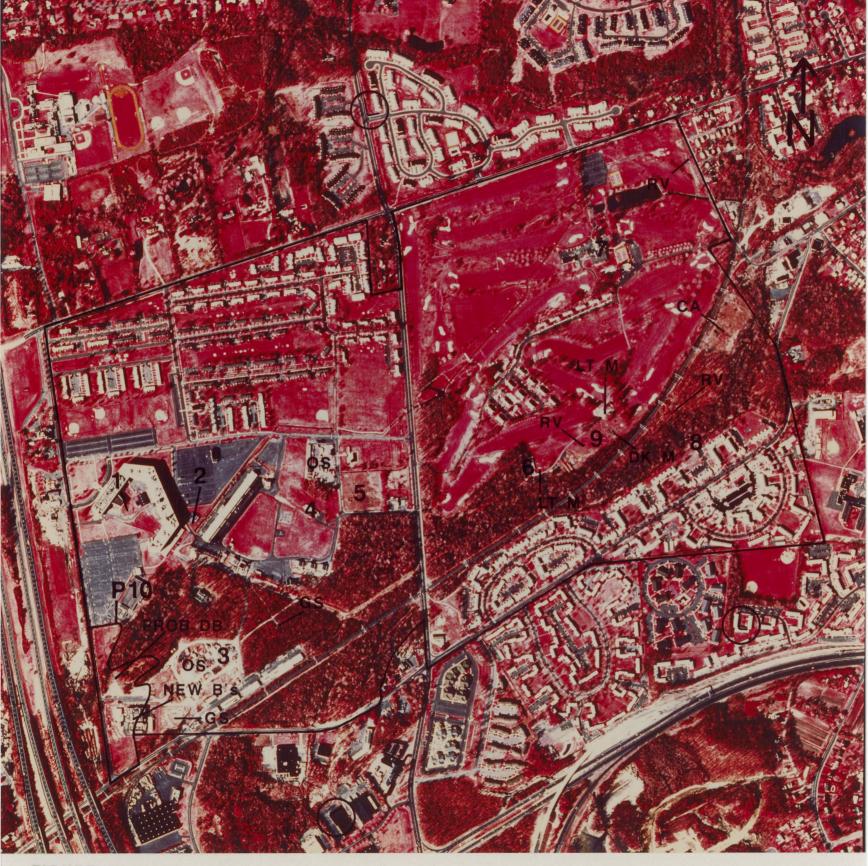
FIGURE 18 CHARLES WOOD AREA

The linear ground scar area noted along the northeastern boundary in 1978 is revegetating. A cleared area (CA) is noted near the eastern site boundary north of Wampum Brook. Ground reconnaissance indicates this area is now used as a railroad storage area. The scarred area noted north of Site 8 since 1957 has revegetated.

- 1, 2: No significant features were noted on the 1991 photography or during the field reconnaissance.
- 3: No significant features were noted on the 1991 photography. Debris was noted in an open storage area within site 3 during the field reconnaissance.

- 4: No significant features were noted in this location on the 1991 photography or during the field reconnaissance.
- 5: The 1991 photography illustrates that the treatment plant is no longer present. The area has been covered and graded. A building was noted in this location during the 1993 field reconnaissance.

- 7: No significant features noted on the 1991 photography or during the field reconnaissance.
- 8: No significant features noted on the 1991 photography or during the field reconnaissance.

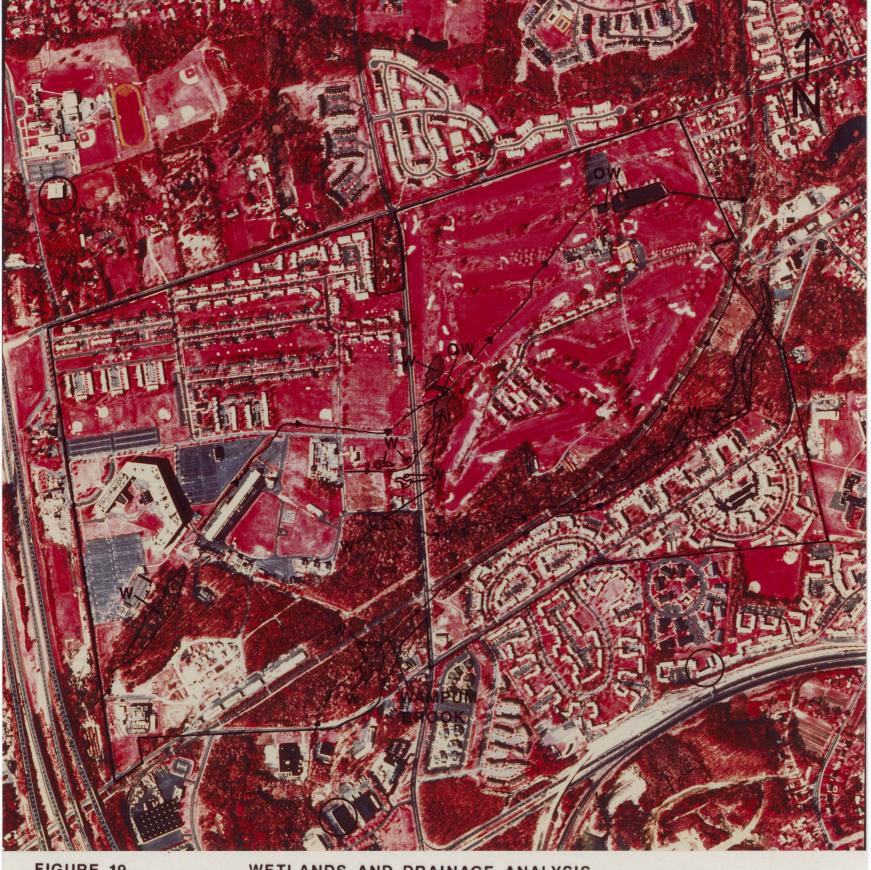
FIGURE 19 CHARLES WOOD AREA

A wetlands and drainage analysis was conducted to identify boundaries for wetlands and open water areas, and to indicate surface drainage types and direction. Forested wetlands are located throughout the southern portion of the CWA being somewhat concentrated along Wampum Creek. Emergent wetlands are located near the center of the CWA. The drainage through the site is generally from the southwest to the northeast.
