Subject: No Further Action Request

Site Investigation Report Addendum for Howard Commons Underground

Storage Tanks, Fort Monmouth, New Jersey

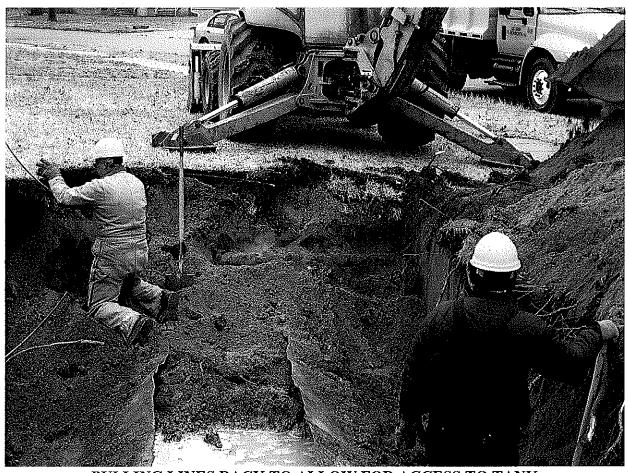
PULLING LINES BACK TO ALLOW FOR ACCESS TO TANK

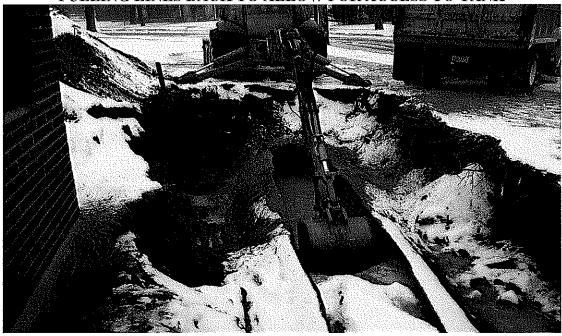
REMOVING SAND FROM TANK

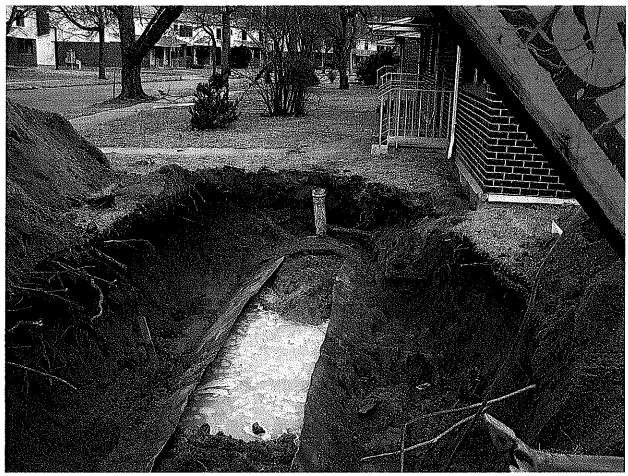
Top of sand filled tank exposed

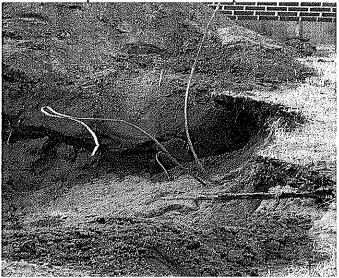
Fill and return lines to tank

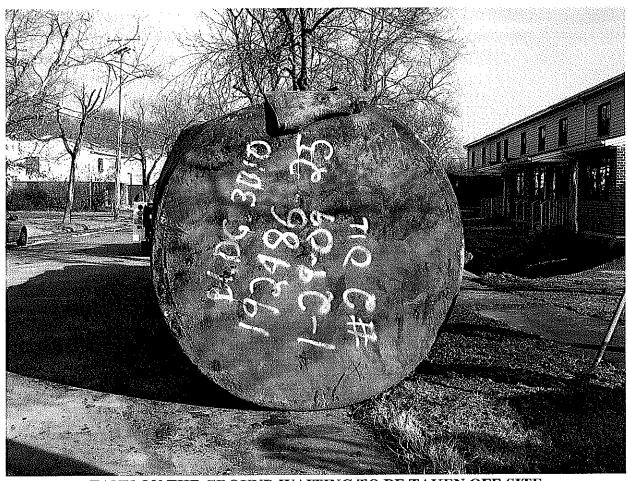
TANK ON THE GROUND WAITING TO BE TAKEN OFF-SITE

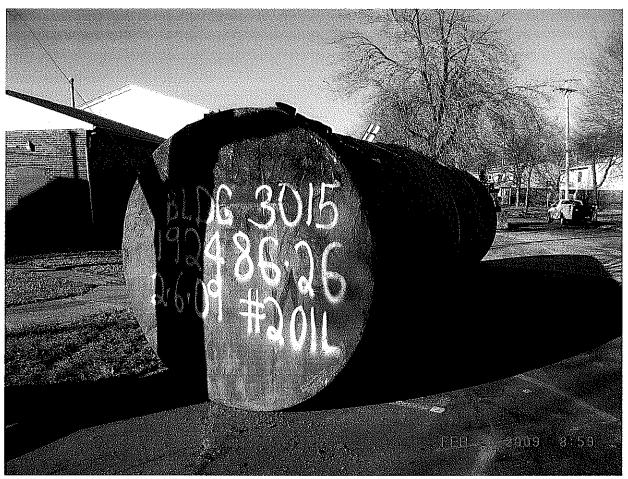
Removed and labeled steel USTs

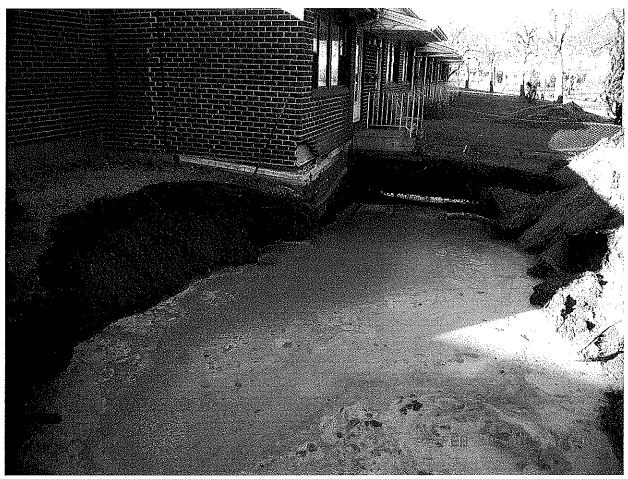
Groundwater in the excavation after the UST has been removed, note remote fill line in rear right of photograph

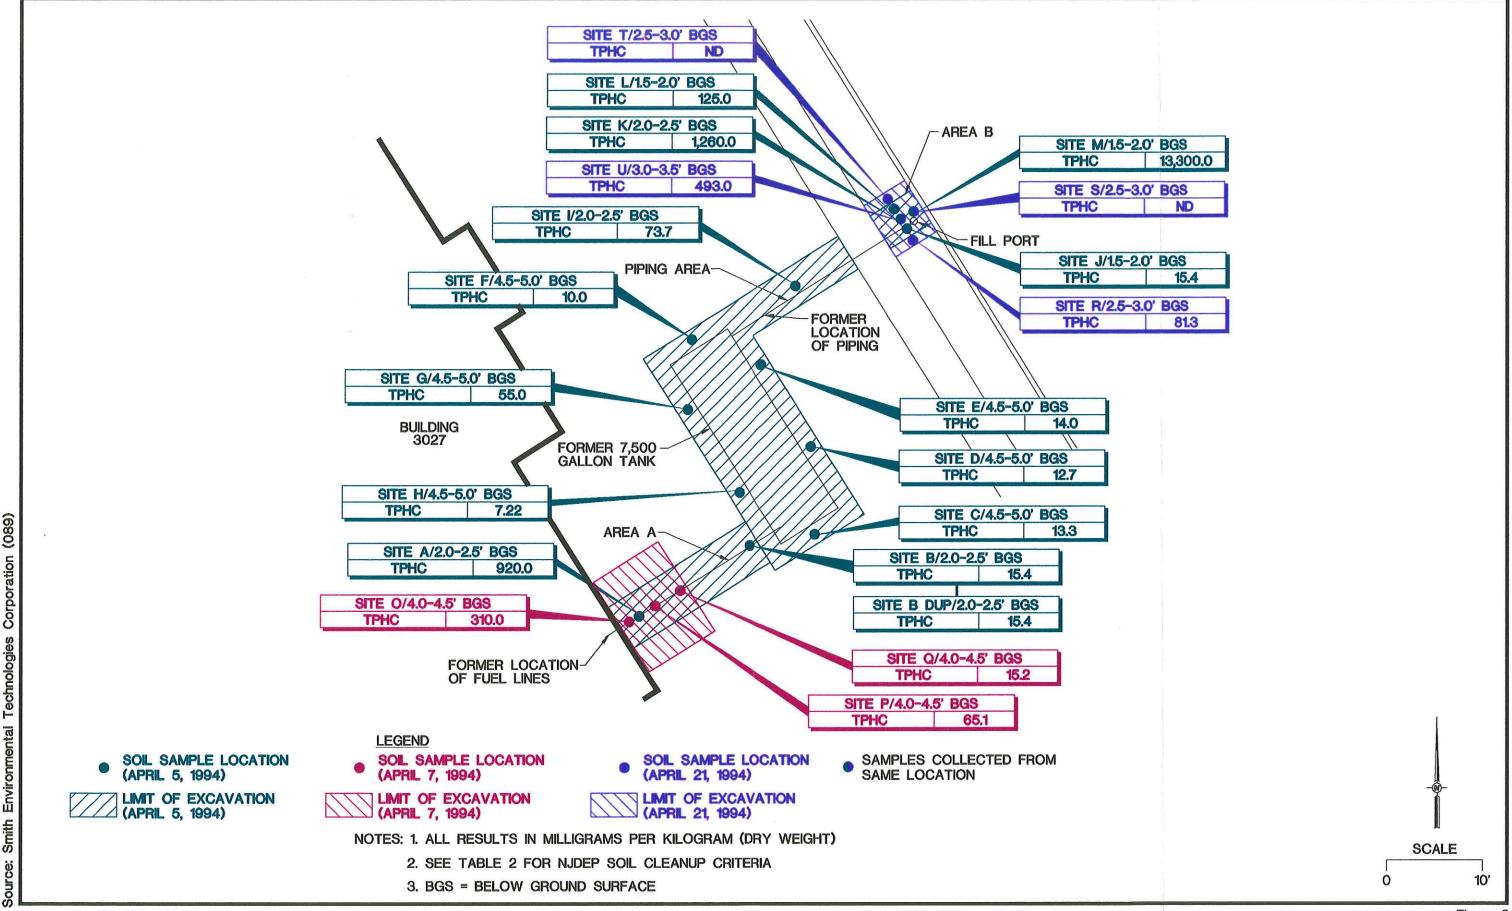
Figure 3 **Building 3027 Soil Sampling Results**

The site assessment was performed by U.S. Army personnel in accordance with the NJDEP *Technical Requirements* and the NJDEP *Field Sampling Procedures Manual*. A summary of sampling activities including parameters analyzed is provided in Table 1. The post-excavation soil samples were collected using polystyrene scoops. Actual soil TPHC values may be higher than reported, due to sample utensil absorbency. If absorbency resulted in reducing the actual soil TPHC concentration by 50 %, the highest soil contaminant would have been 986.0 mg/kg, still below the applicable NJDEP soil cleanup standard for total organic contaminants of 10,000 mg/kg. Following soil sampling activities, the samples were chilled and delivered to U.S. Army Fort Monmouth Environmental Laboratory located in Fort Monmouth, New Jersey, for analysis.

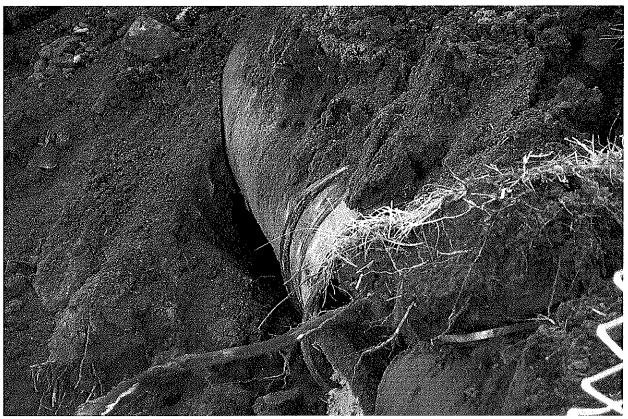
Transite water pipe exposed in the west end of excavation

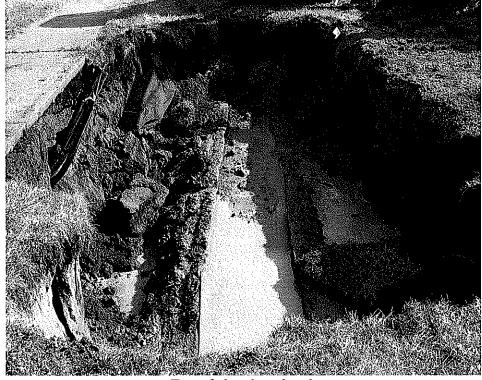
Top of abandoned tank

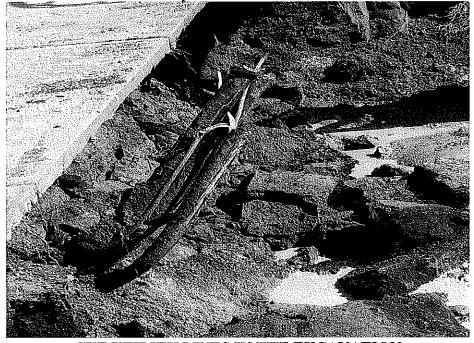
CUT UTILITY LINES IN THE EXCAVATION

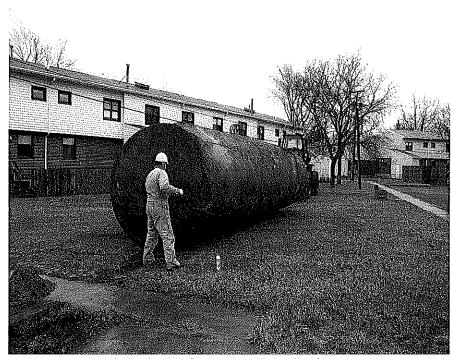
TANK REMOVED FROM GROUND

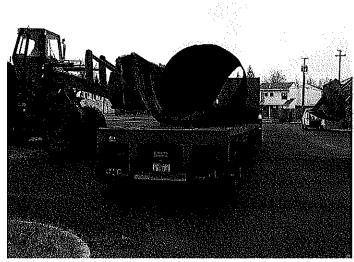
TANK BEING LOADED FOR OFF SITE TRANSPORT
