U.S. Army - Fort Monmouth

Volume 2B - Building Reports for a Comprehensive Asbestos Survey in Various Buildings at Fort Monmouth, New Jersey

May 1993

Roy F. Weston, Inc. West Chester, Pennsylvania 19380

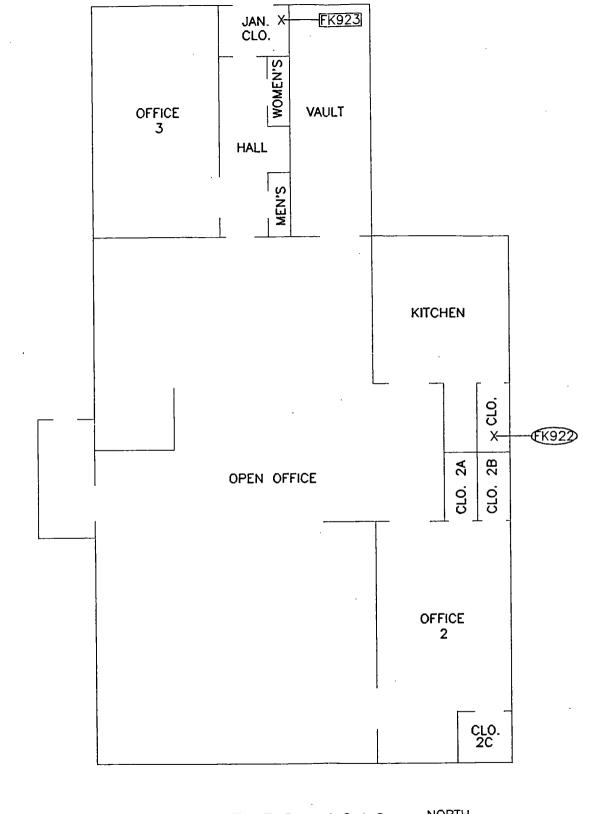
BLDG. 1010 NOT TO SCALE

• Floor tile was the material in Building 1010 found to be ACM.

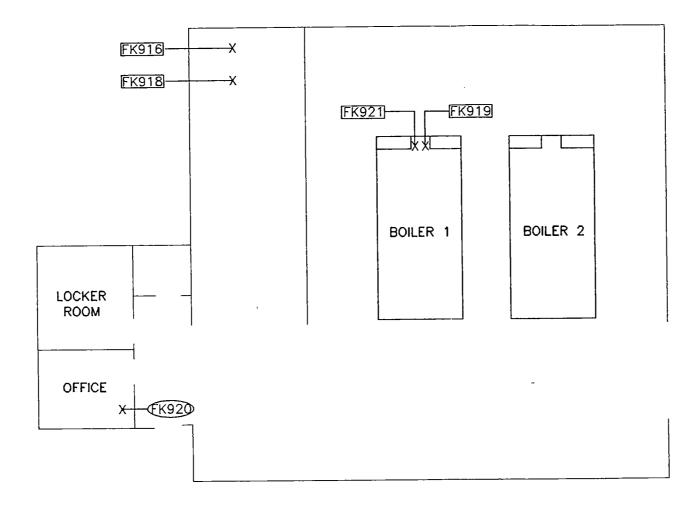
BLDG. 1076
NOT TO SCALE

Floor tile was the material in Building 1076 found to be ACM.

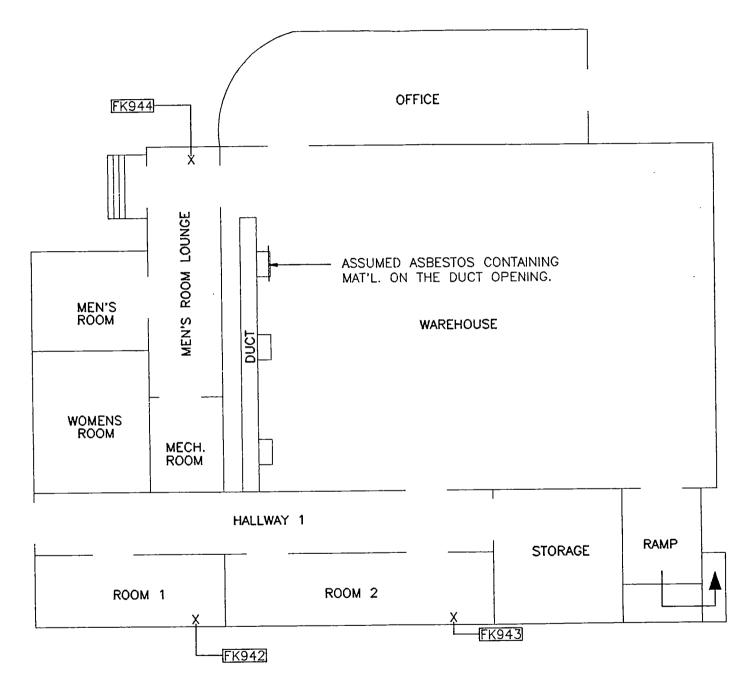
BLDG. 2018

Assumed asbestos-containing duct (opening) insulation was found in the warehouse area of Building 2018. This material was not sampled; instead it was referenced to a similar insulation material found in Building 2542, which was tested to be ACM.

- Duct-opening cover/insulation material was the material in Building 2018 found to be ACM.
- The ACM listed above should be labeled under the O&M Program.

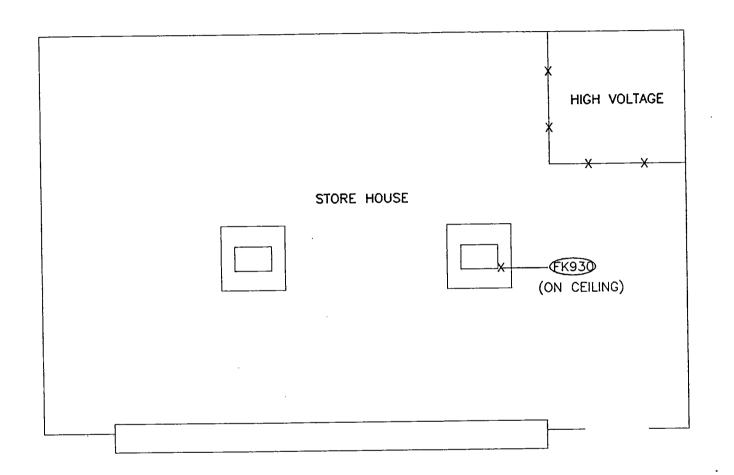
BLDG 2542 NOT TO SCALE

Ceiling insulation (exhaust flue) was the material in Building 2542 found to be ACM.

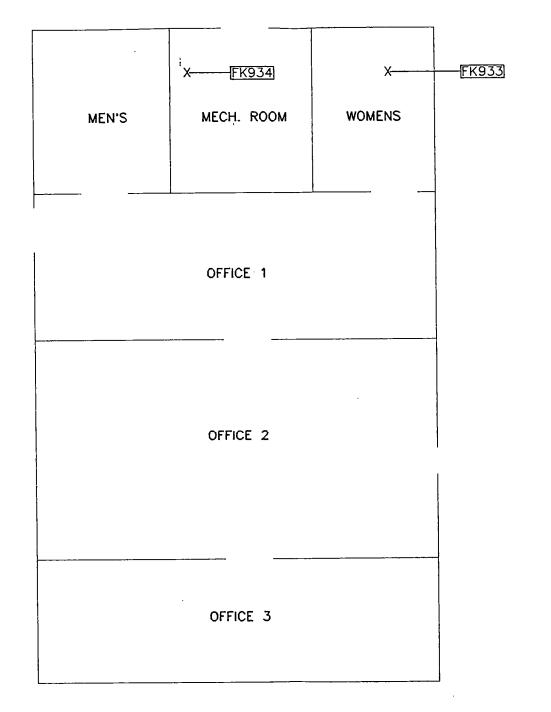
BLDG. 2561 NOT TO SCALE

Assumed asbestos-containing transite panel was found in the Mechanical Room (ceiling) of Building 2561. This material was not sampled; instead it was referenced to a similar transite panel found in Building 2564, which was tested to be ACM.

- Transite panel was the material in Building 2561 found to be ACM.
- Asbestos-containing transite panel should be labeled under the O&M Program.

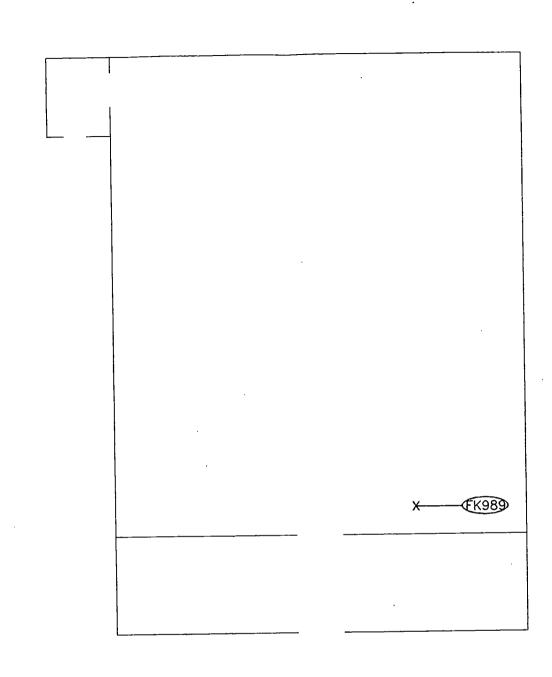
BLDG. 9345 NOT TO SCALE

Polarized Light Microscopy (PLM) with dispersion staining was used to analyze one sample of suspect material collected from the building. This sample was found to be asbestoscontaining material (ACM). Table 9345.1 lists the analytical result for the bulk samples.

- Floor tile was the material in Building 9345 found to be ACM.
- Asbestos-containing floor tile present in Building 9345 should be labeled under the O&M Program.

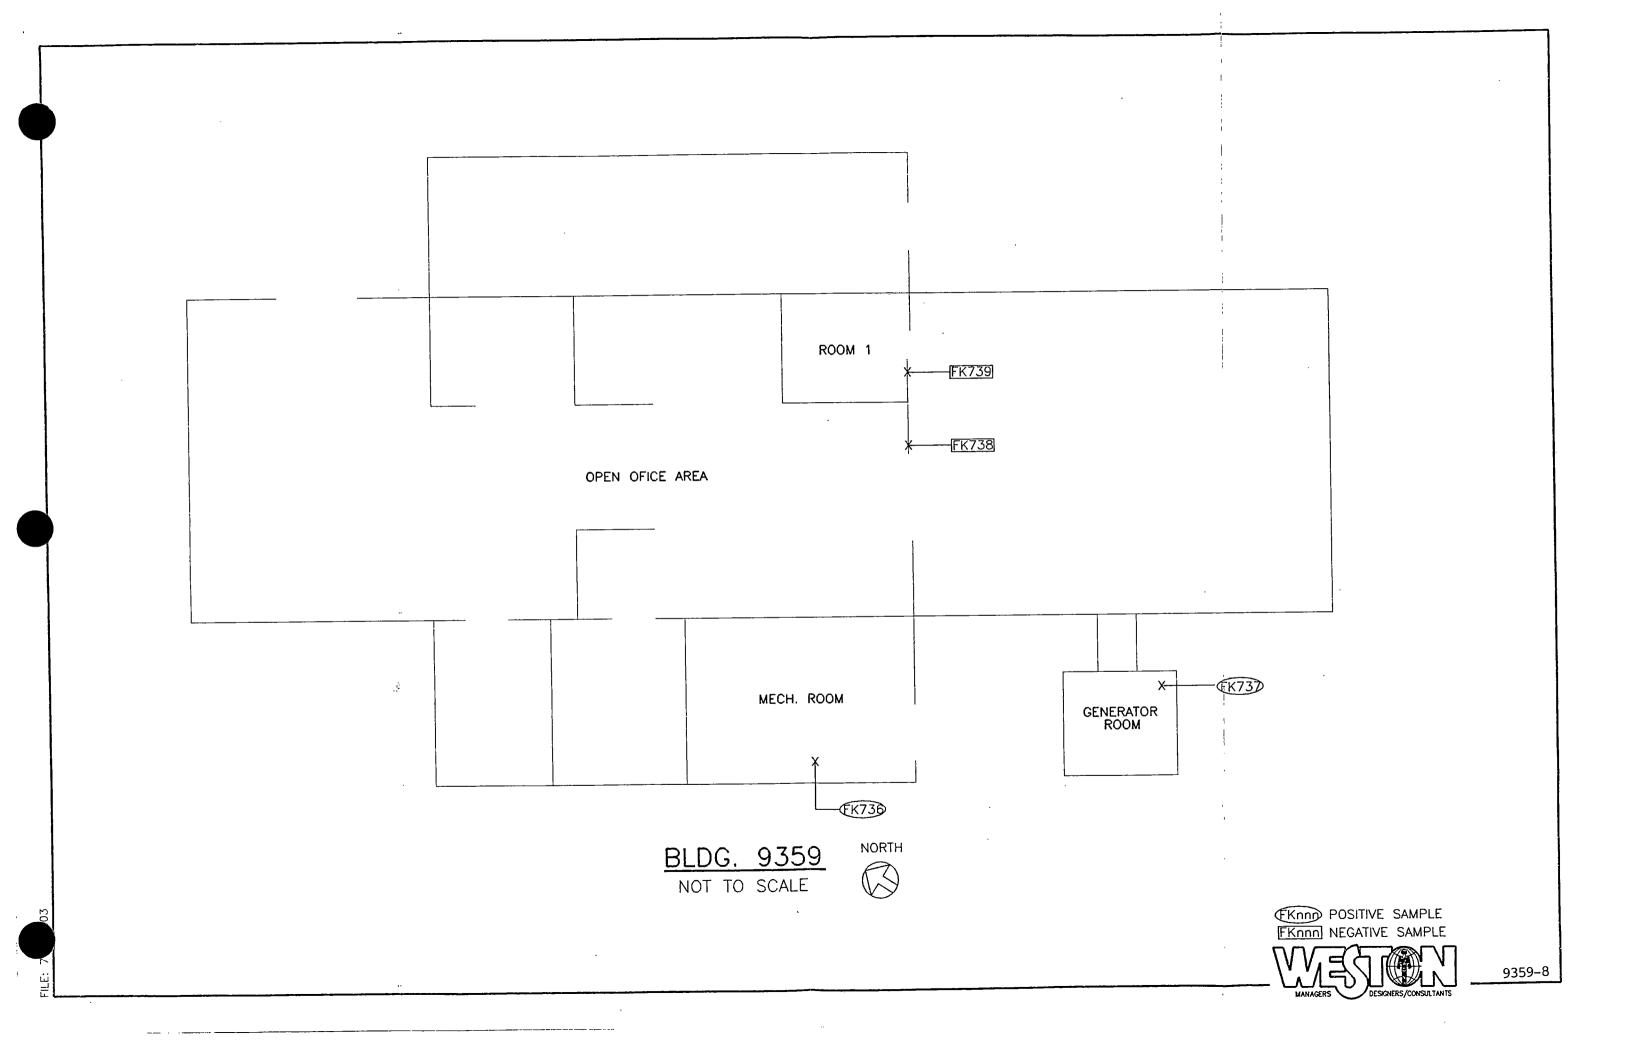
Polarized Light Microscopy (PLM) with dispersion staining was used to analyze four samples of suspect material collected from the building. Of these samples, two were found to be asbestos-containing materials (ACM). Table 9359.1 lists the analytical results for the bulk samples.

Assumed asbestos-containing transite panel was found in the generator room (electrical panel) of Building 9359. This material was not sampled; instead it was referenced to a similar transite panel found in Building 9312, which was tested to be ACM.
