**U.S. Army Corps of Engineers  
Philadelphia District**

***Volume III - Building Reports for a  
Comprehensive Asbestos  
Survey in Various Buildings at  
Fort Monmouth, New Jersey***

Contract Number DACA61-89-D-0013

**June 1991**

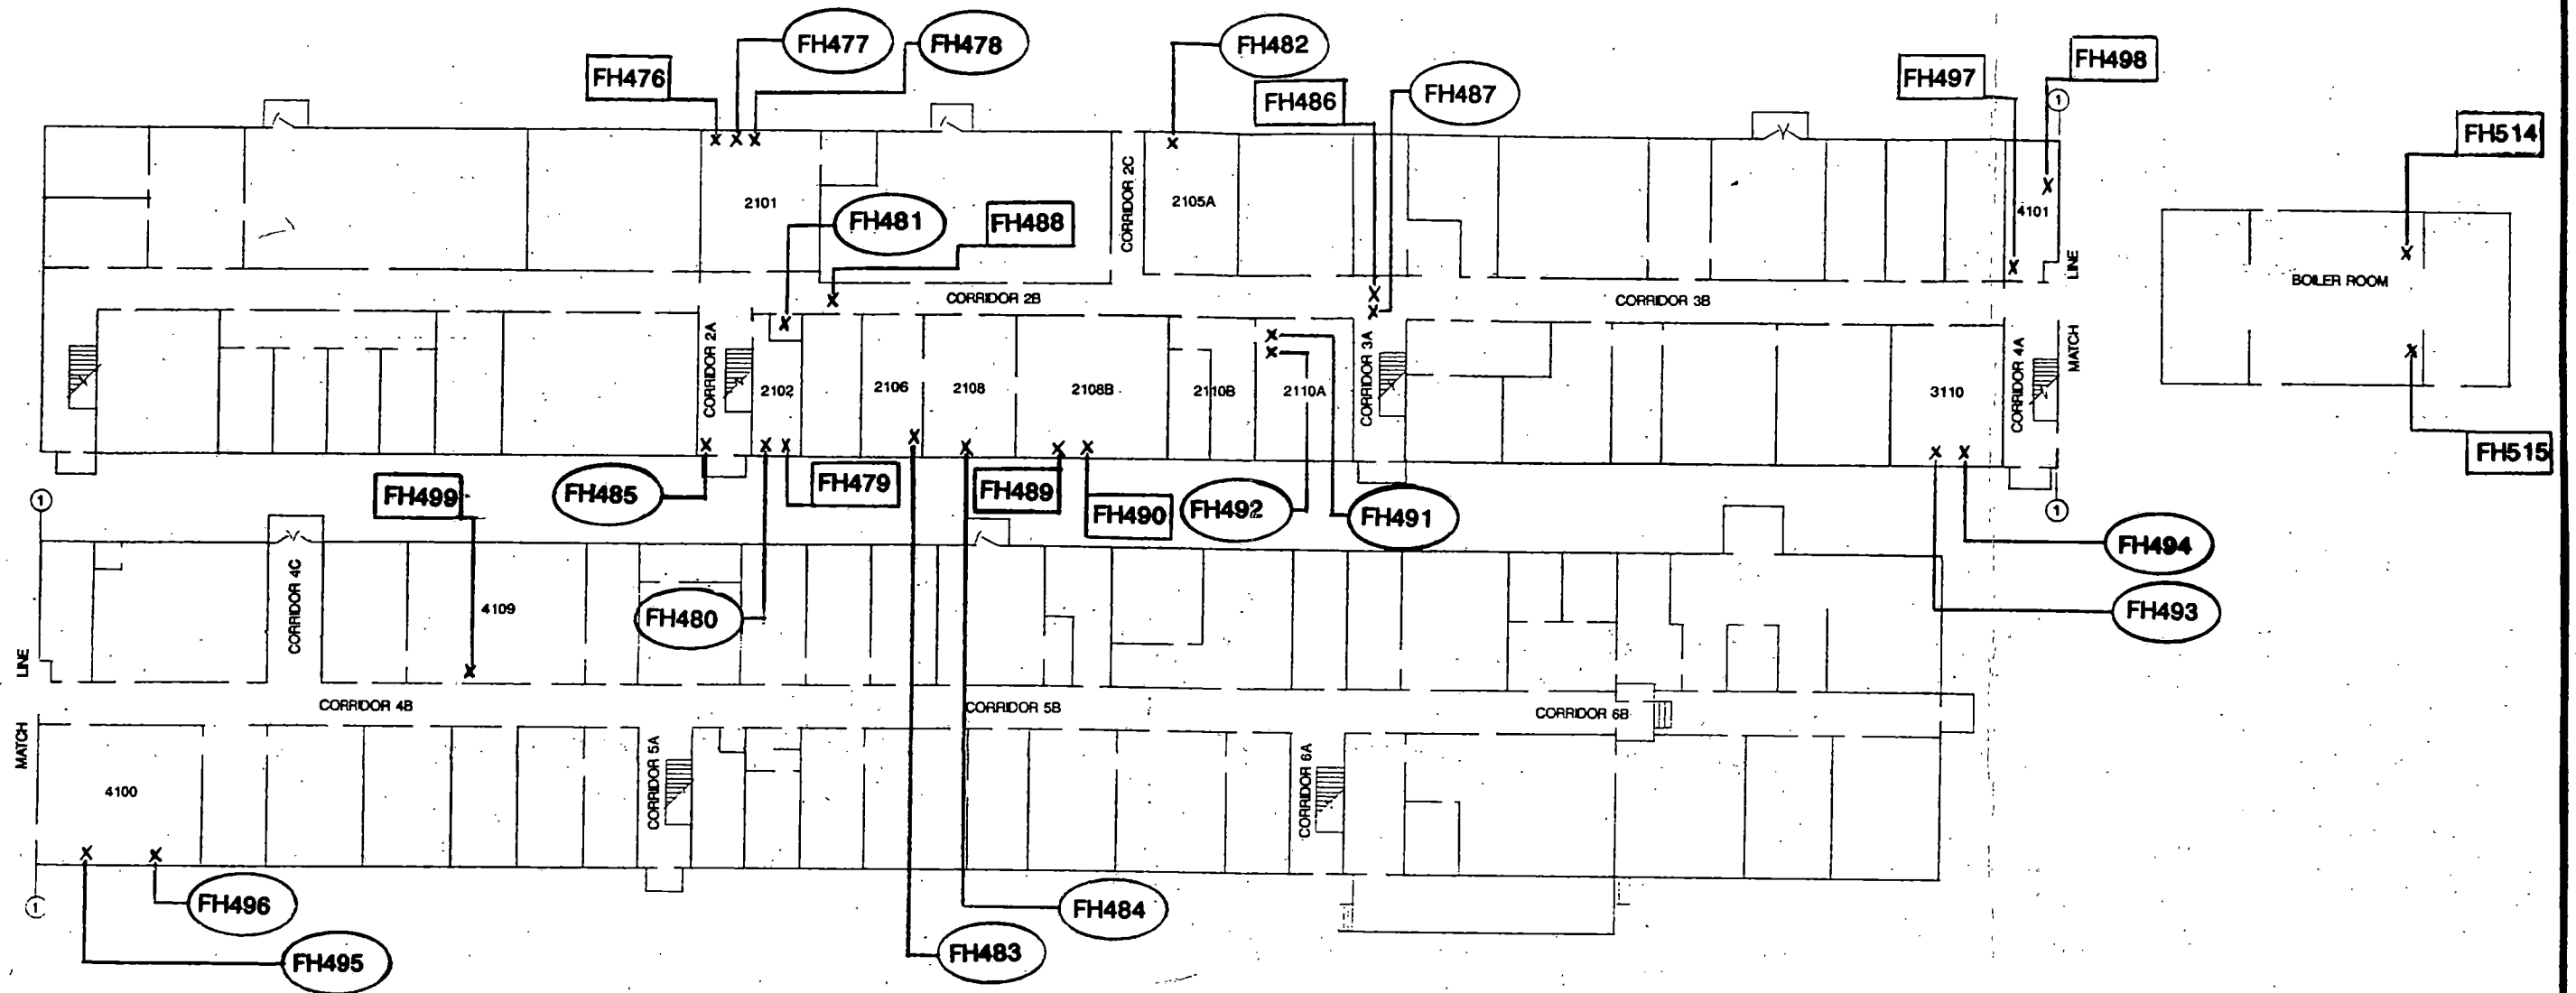
BLDG. 2525  
FIRST FLOOR PLAN

Bldg. 2525 Room 2105A: Sample FH482, 4 - 8" mud fitting tested positive. Samples FH484 (not shown) 4 - 8" mud fitting tested positive.

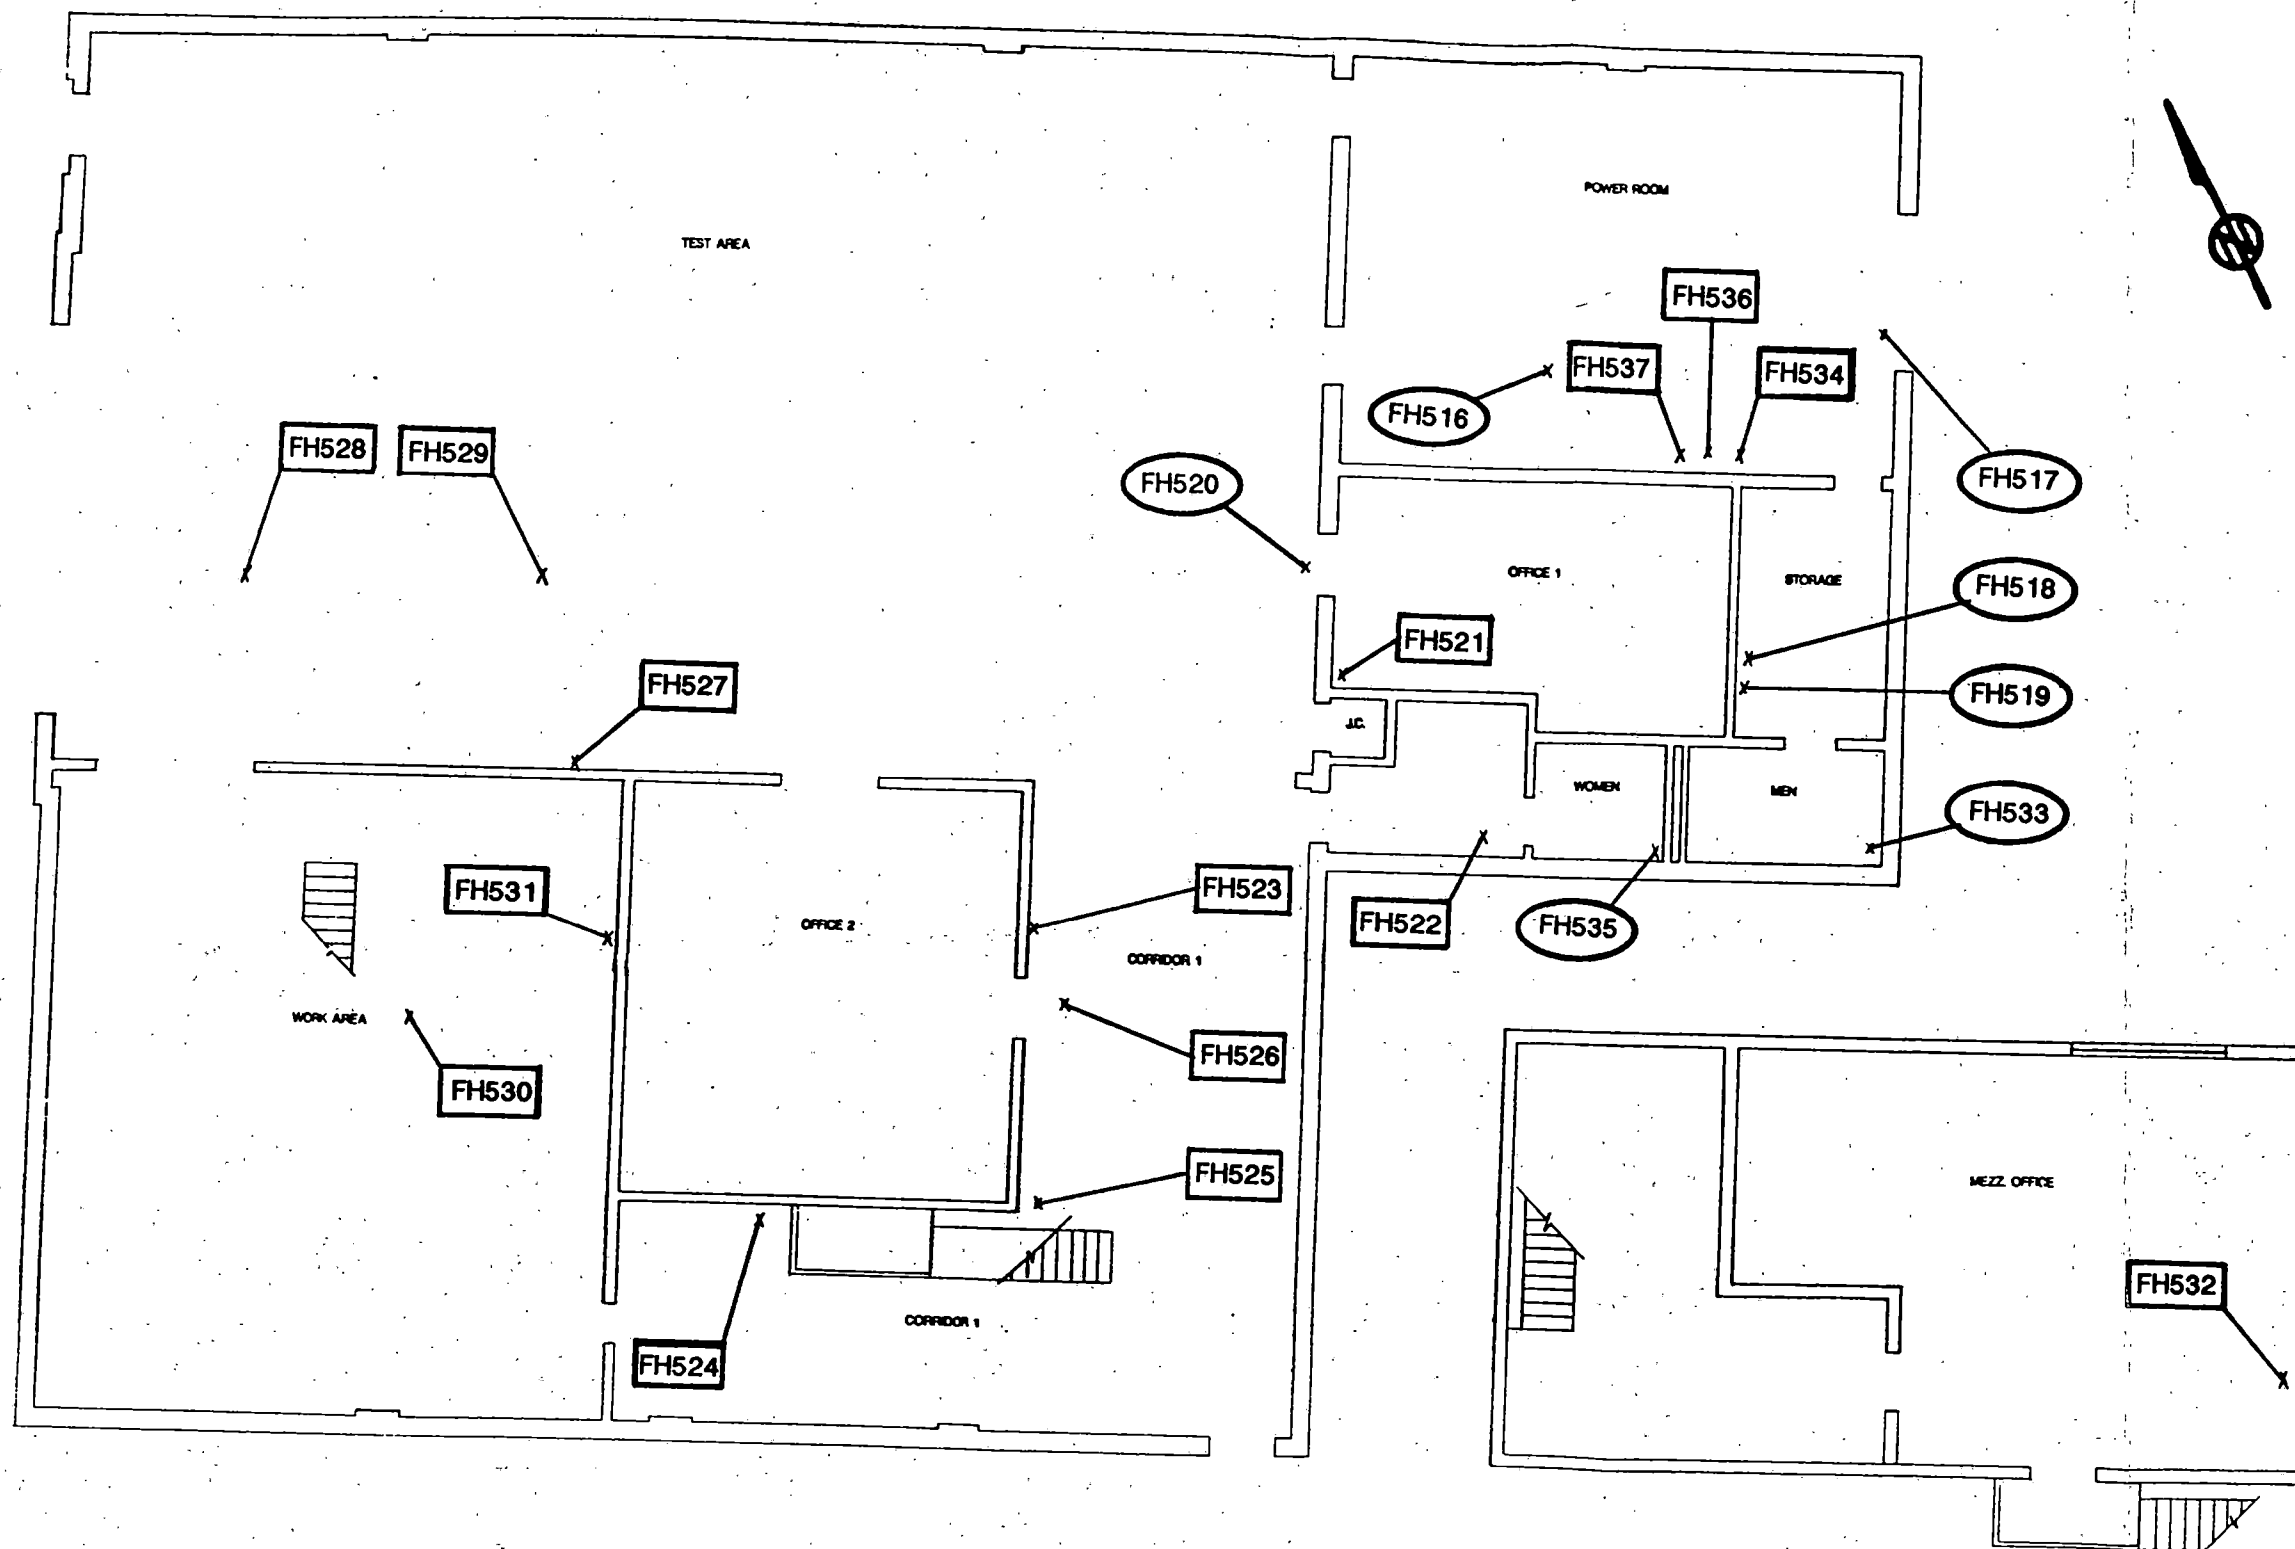
FIRST FLOOR PLAN

Bldg. 2704 - Test Chamber: < 4" mud fitting (Ladies Room) sample FH535 tested positive. Sample FH533 (not shown) also tested positive.

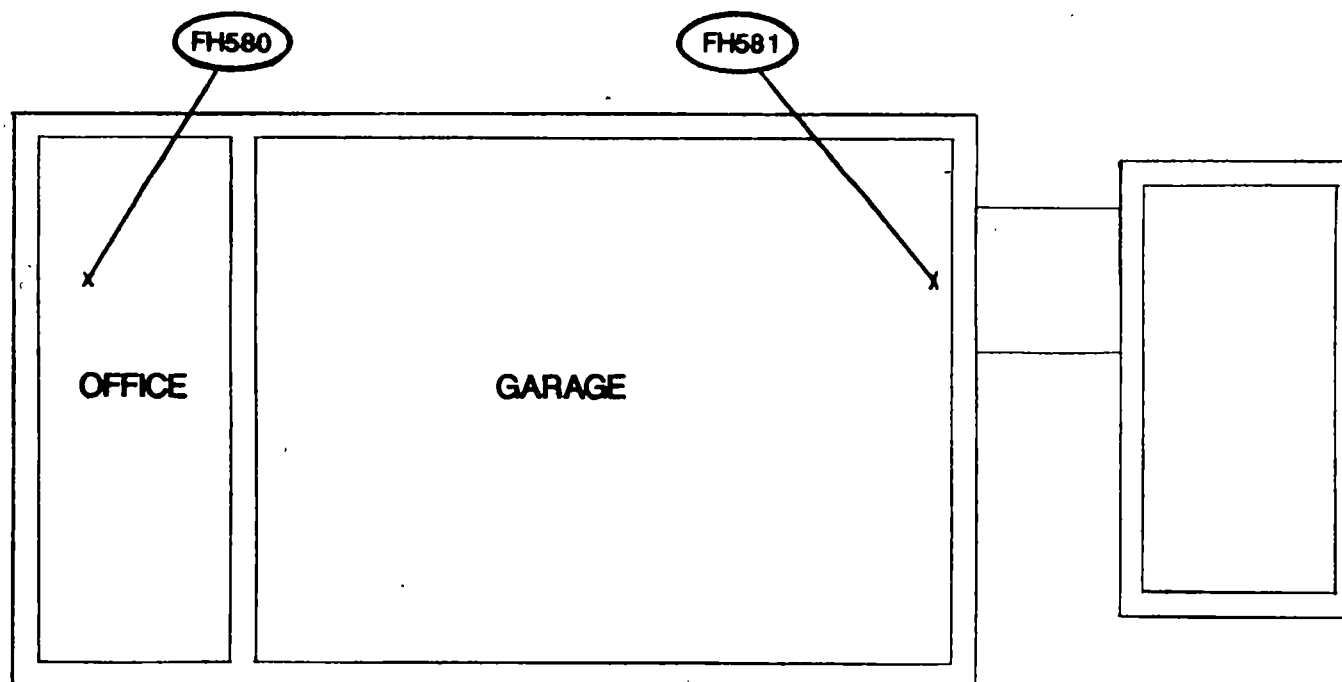
BUILDING 9009

Bldg. 9009 - Serv-Air Garage/Shop: 9 x 9" floor tiles sample FH580 tested positive.

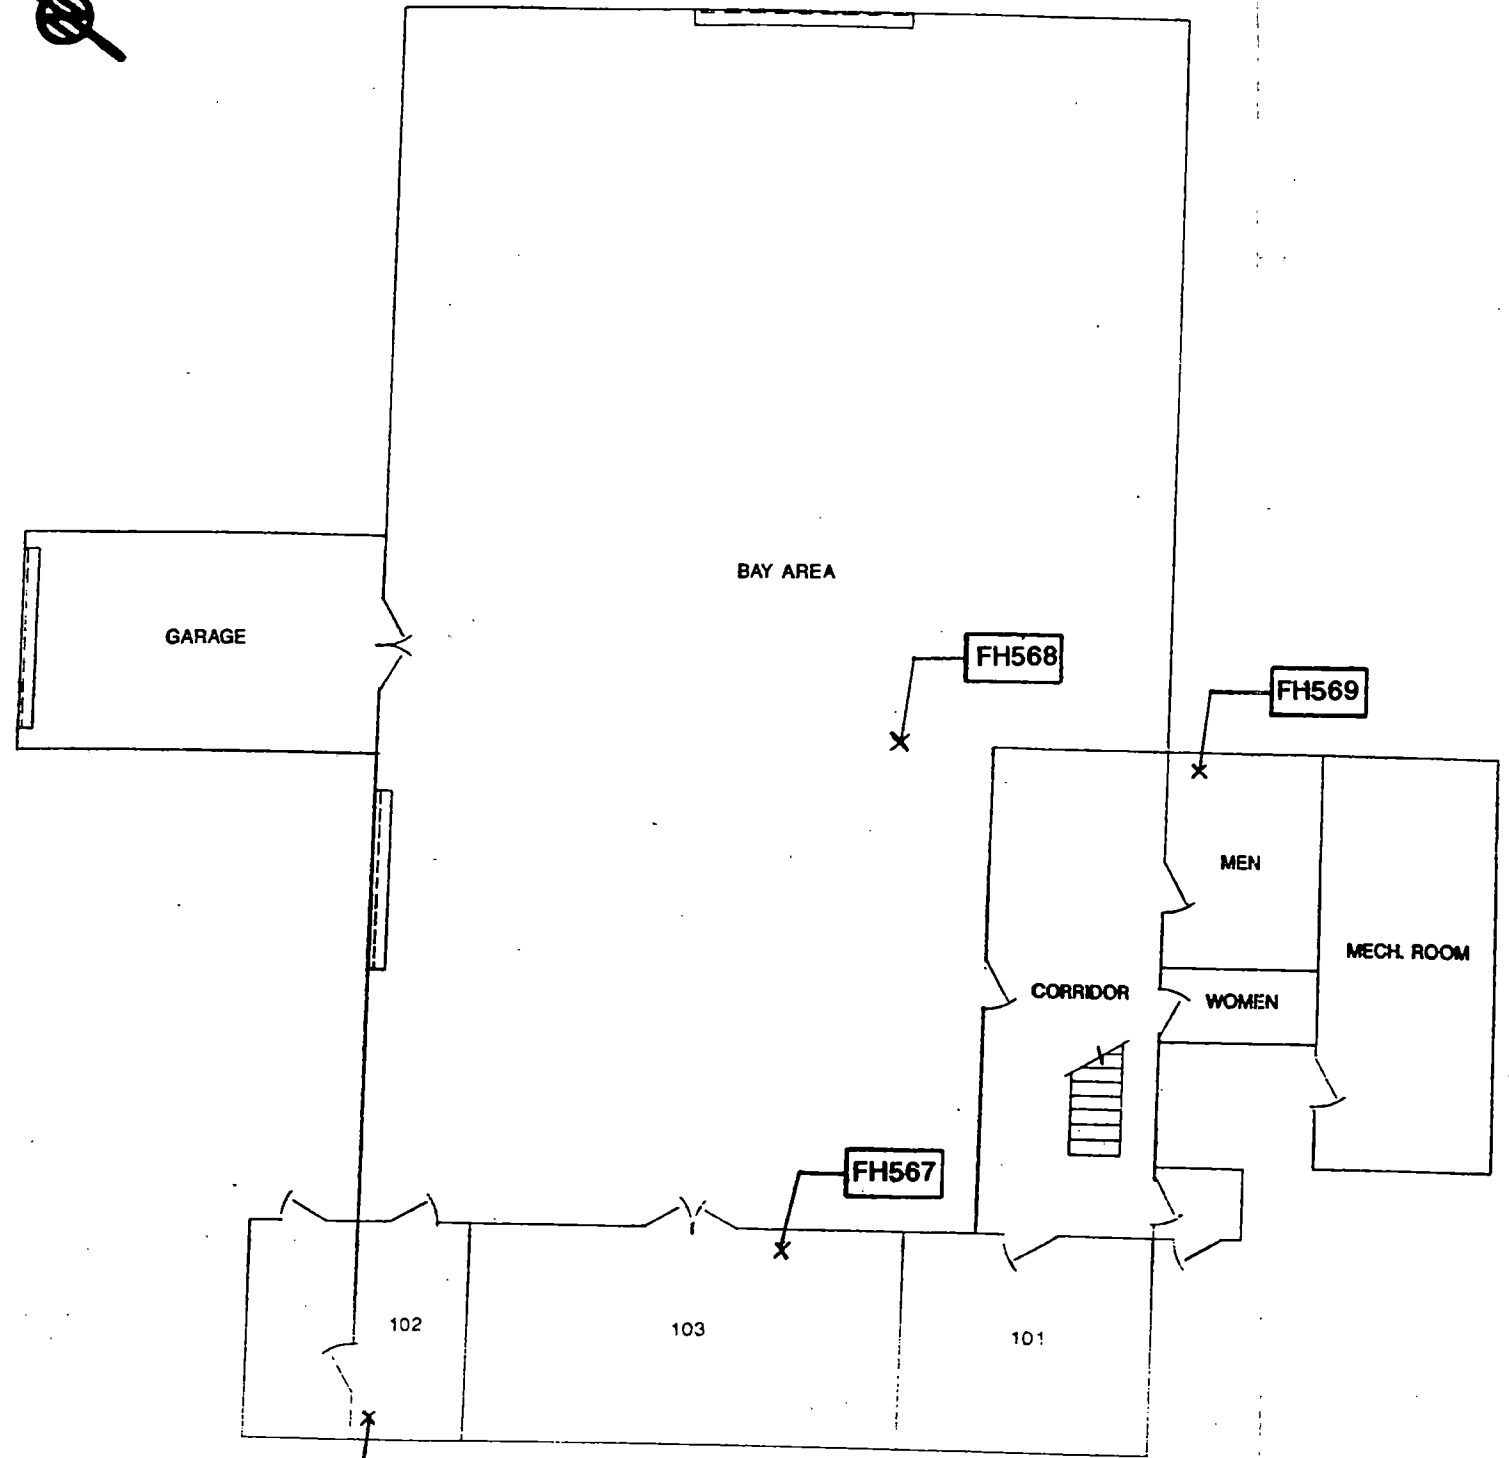
FIRST FLOOR PLAN

Bldg. 9015 - EW RSTA: 9 x 9" brown floor tiles FH570 tested positive.

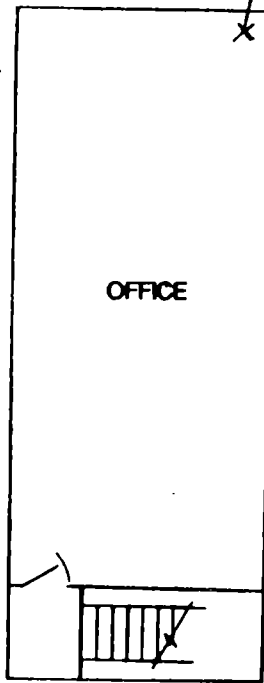
SECOND FLOOR PLAN  
BUILDING 9023

Bldg. 9023 - Metal Shop: Duct insulation sample FH574 tested positive; also sample FH572, 12 x 12" tan floor tiles in shop area tested positive. Sample FH573, 12 x 12" tan floor tiles upstairs offices (FH572 and FH573 not shown).

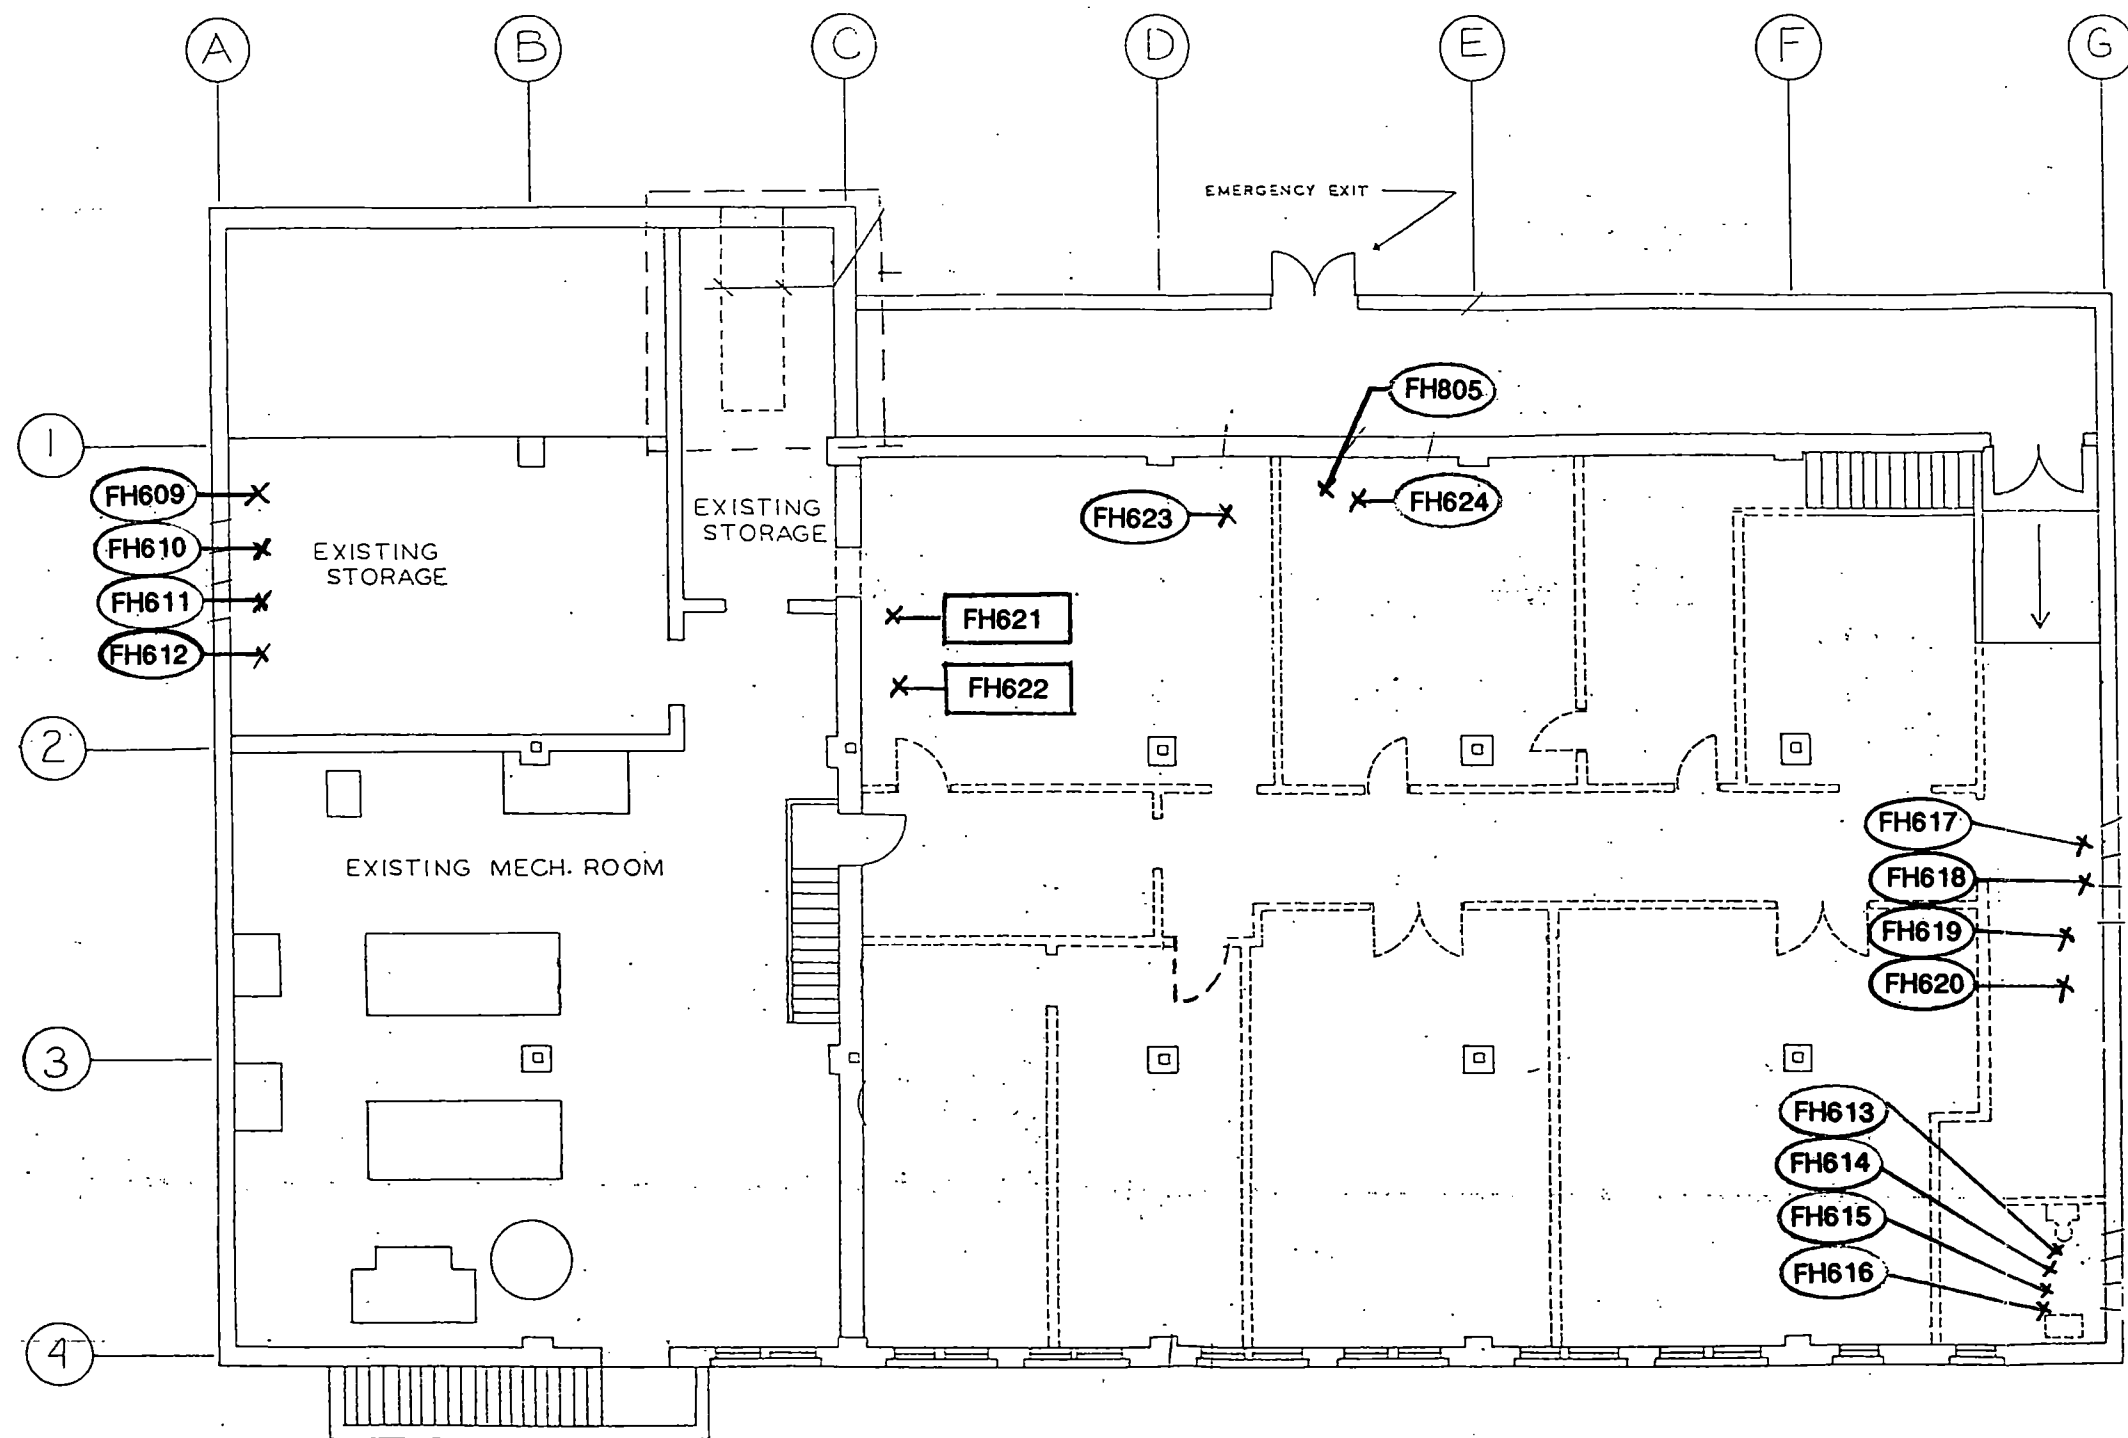
BLDG. 9041 - BASEMENT PLAN

Bldg. 9041 - Basement:   Aircell-type pipe insulation tested positive.

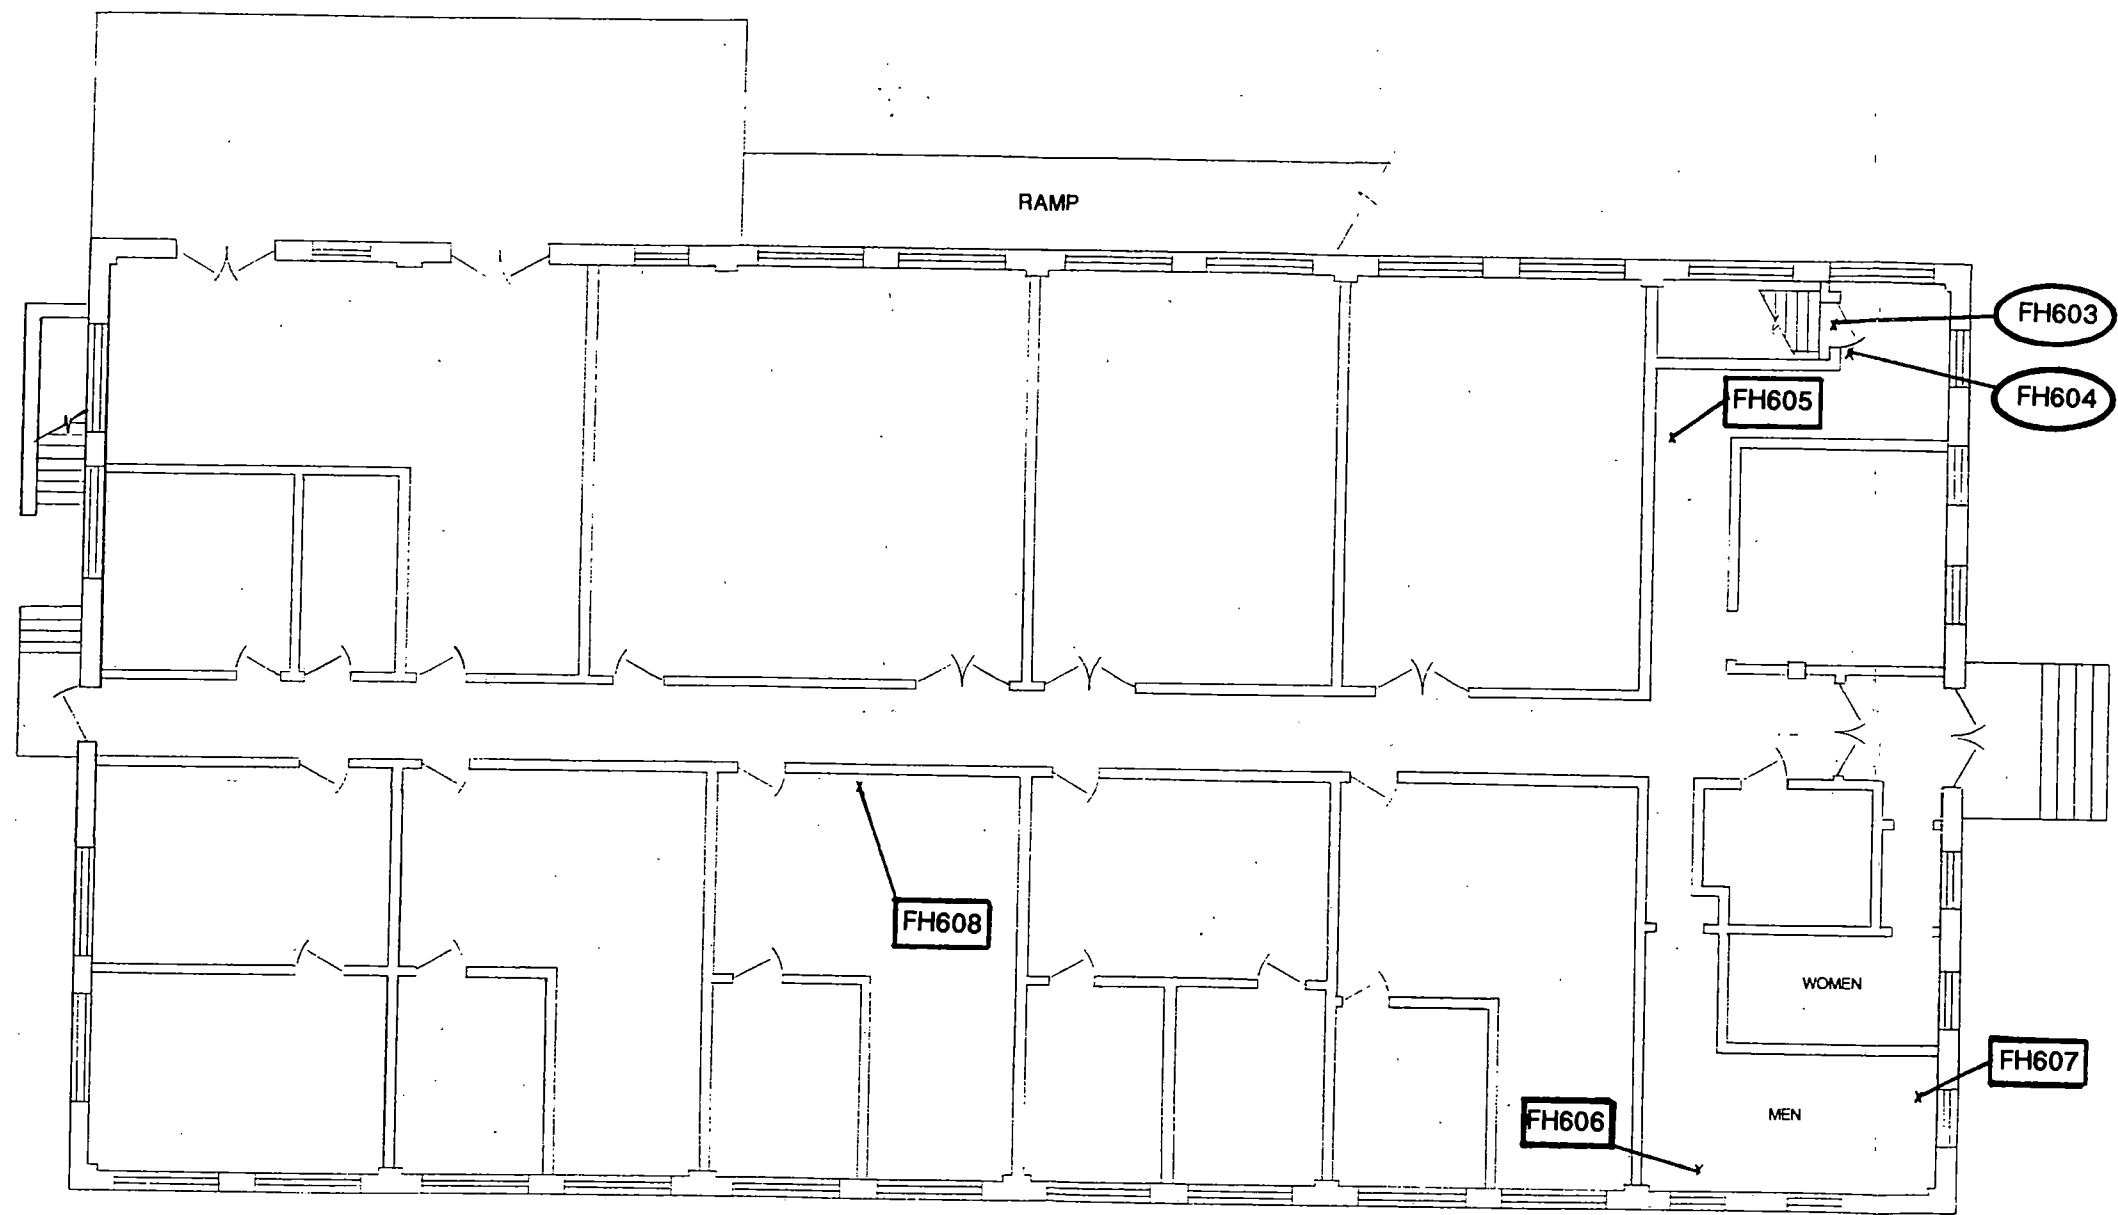
BLDG. 9042  
FIRST LOOR PLAN

Bldg. 9042 - First Floor: Sample FH603, 9 x 9" gray floor tiles tested positive; sample FH604 9 x 9" gray floor tiles (not shown) also tested positive.
