**U.S. Army Corps of Engineers  
Philadelphia District**

***Volume II - Building Reports for a  
Comprehensive Asbestos  
Survey in Various Buildings at  
Fort Monmouth, New Jersey***

Contract Number DACA61-89-D-0013

**June 1991**

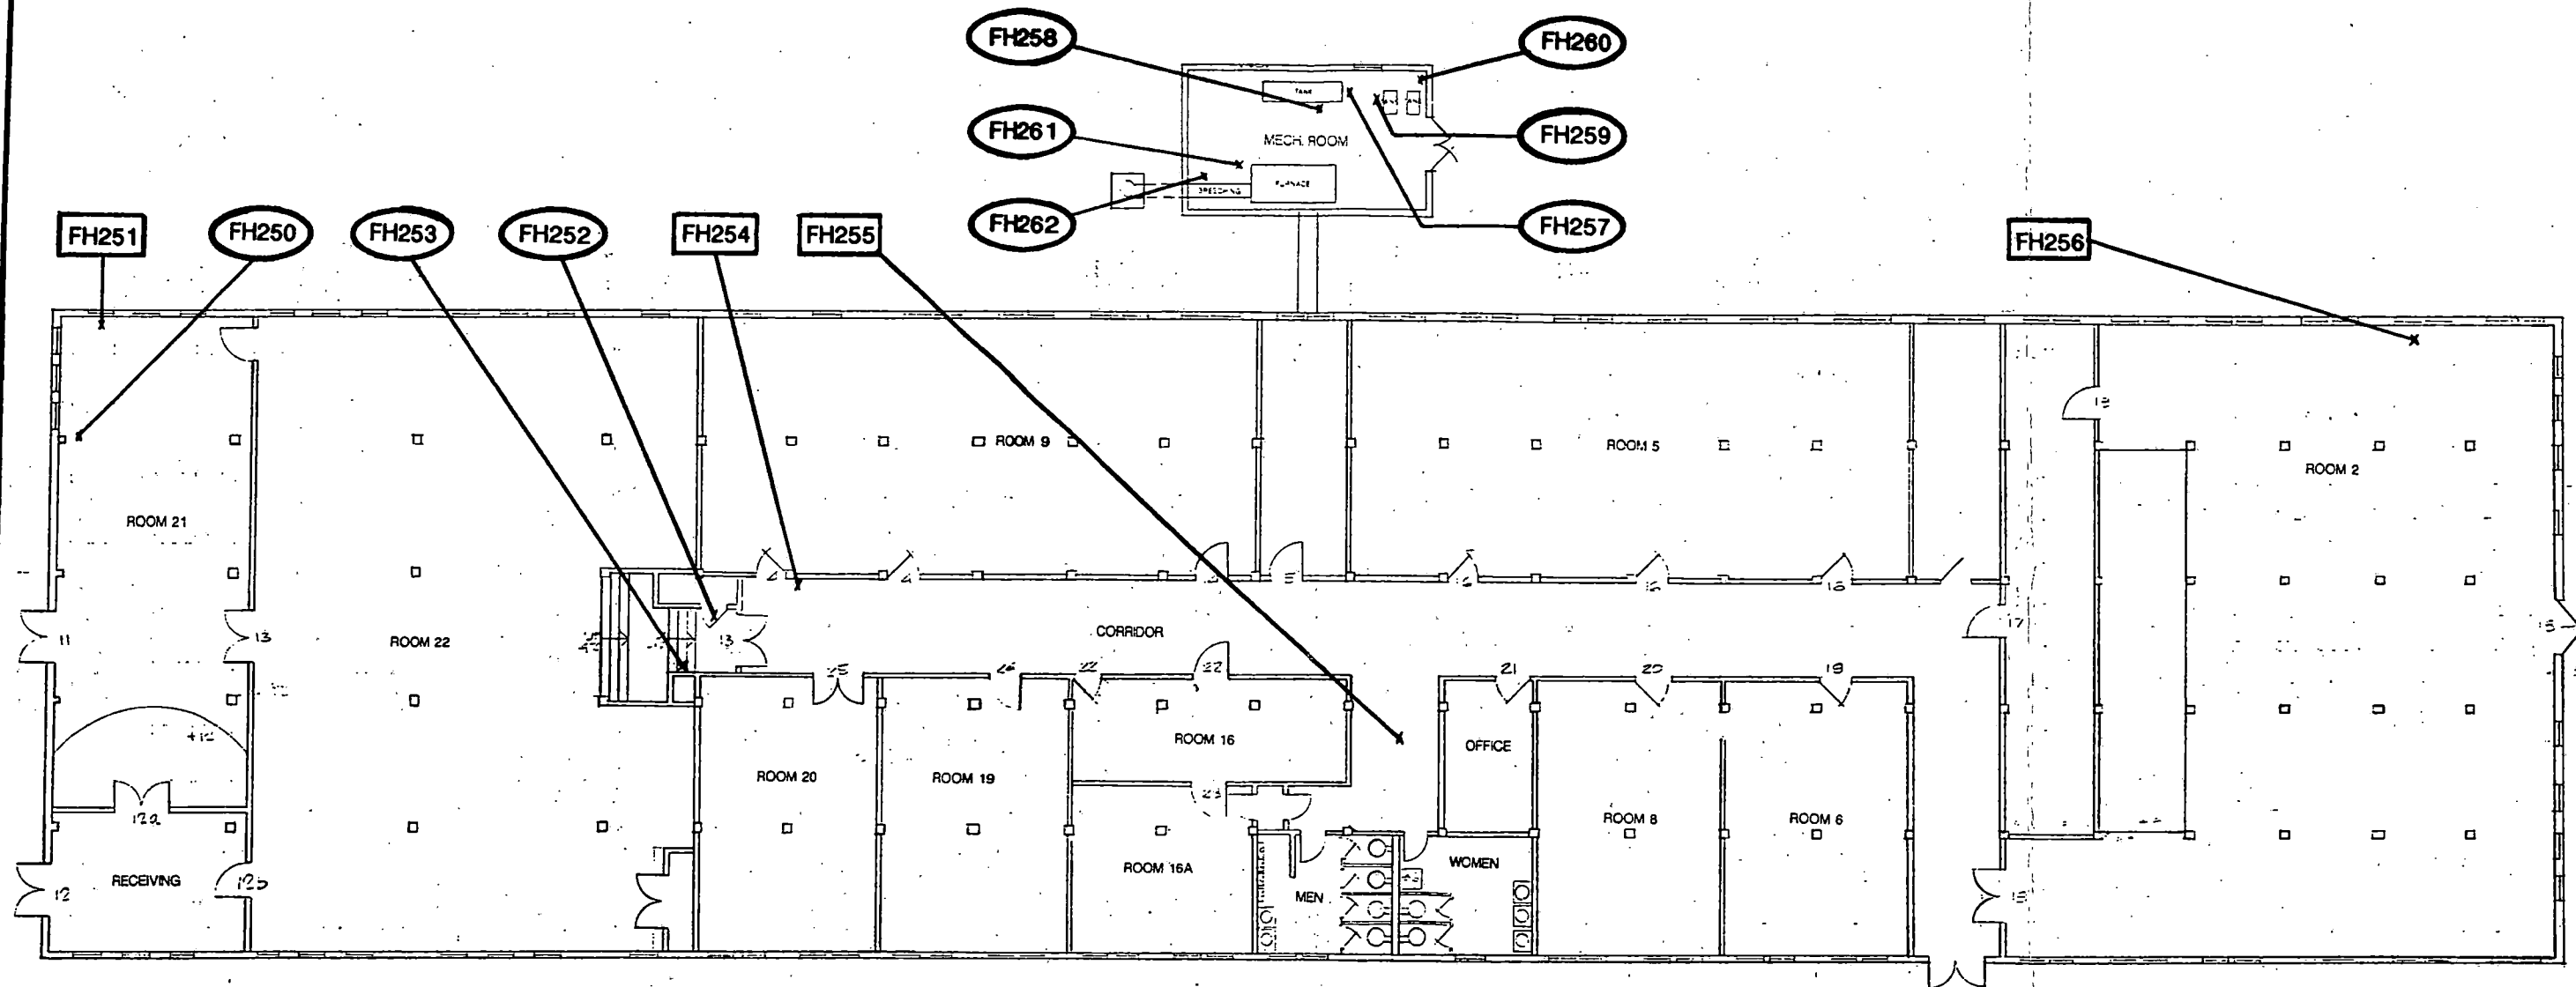
Bldg. 288

Mechanical Room: (Greater Than 14 In.) Breeching  
Insulation (Associated With An American Standard  
Boiler Model A72B-52) Sample FH262 Tested Positive.

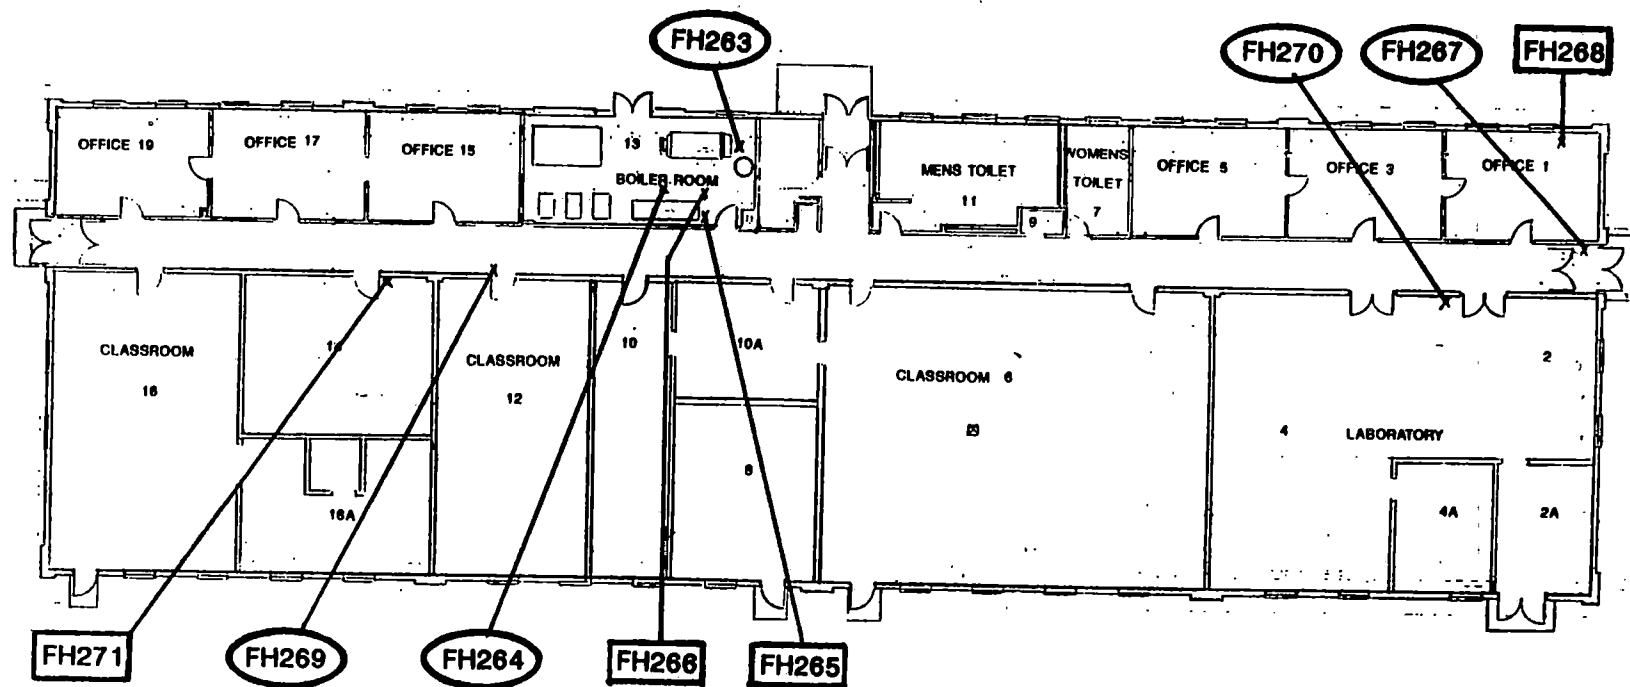
Bldg. 291

Mechanical Room: (4 In. - 8 In.) Fitting  
Insulation Sample FH264 Tested Positive. Pipe Run  
Insulation Is Fiberglass.

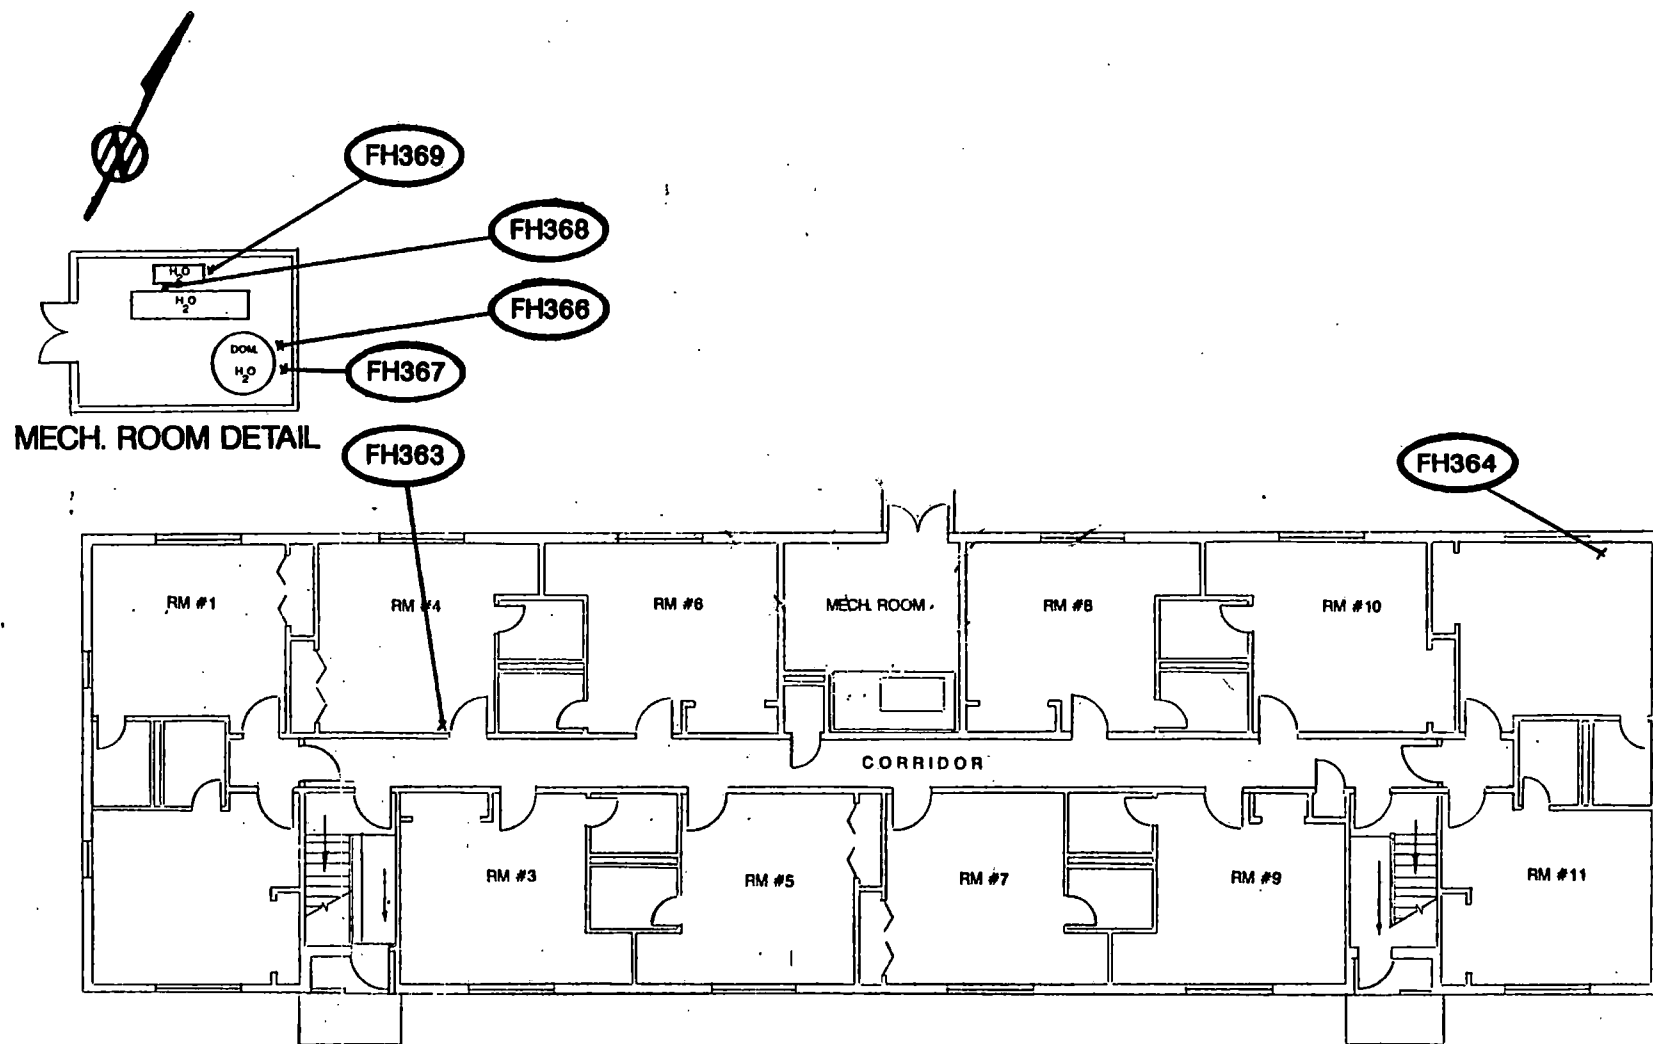
Bldg. 364: Mechanical Room: Tank insulation (end cap) sample FH369 tested positive.

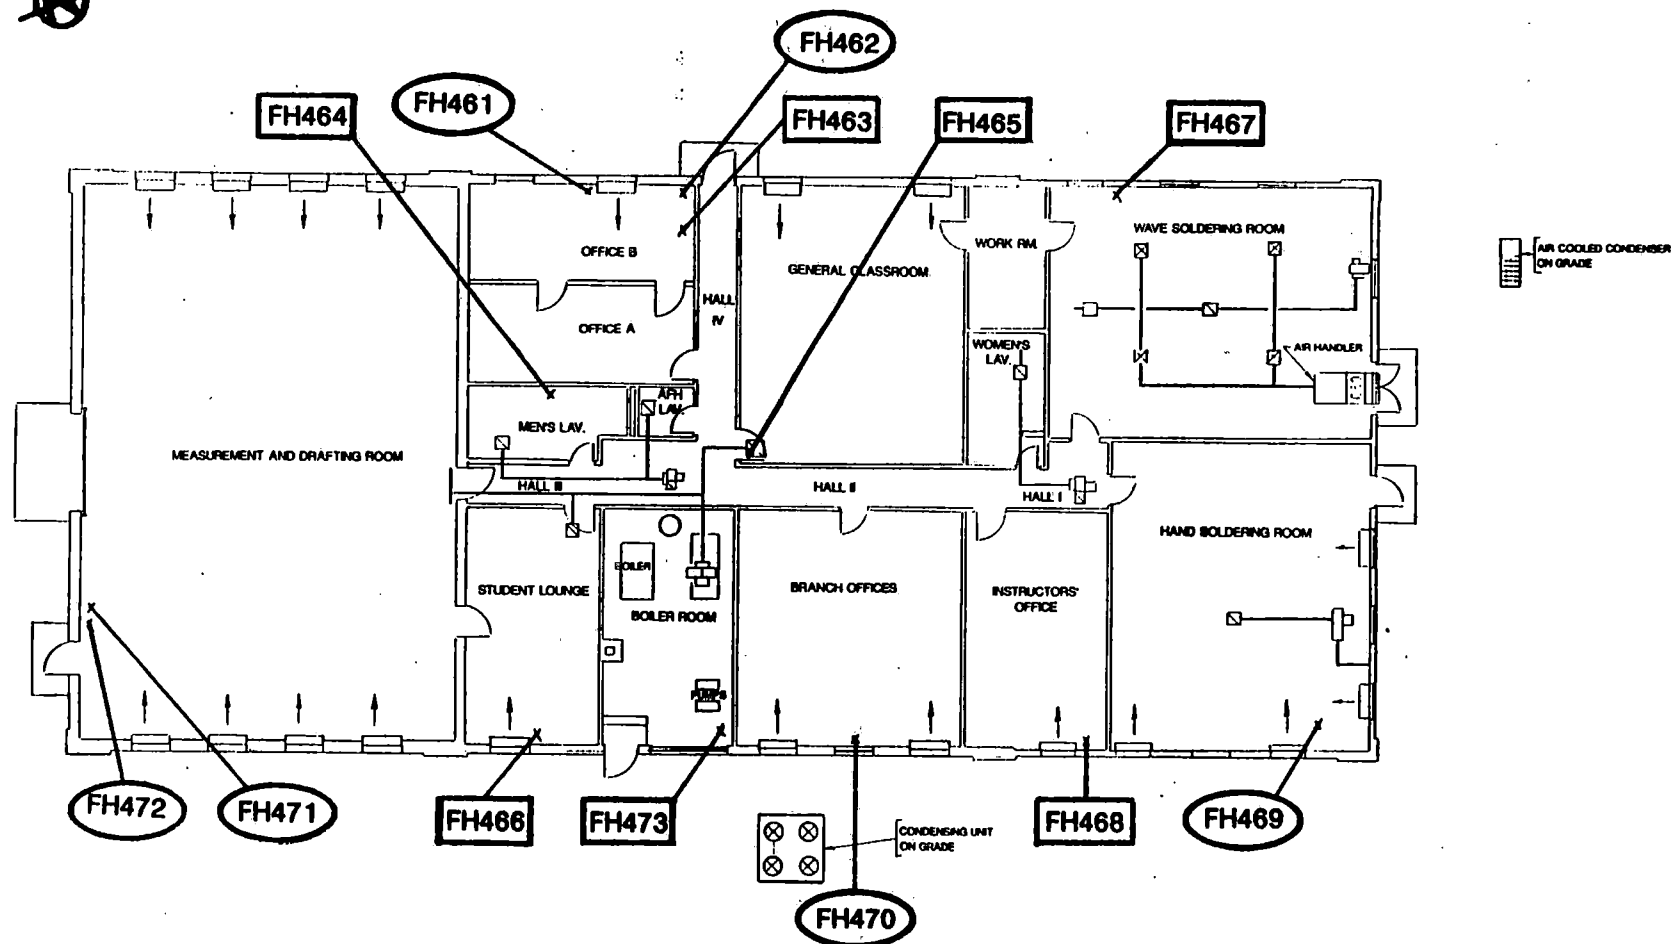
918-9

Bldg. 918: 9 x 9" brown floor tile under 12 x 12" tan floor tile tested positive.

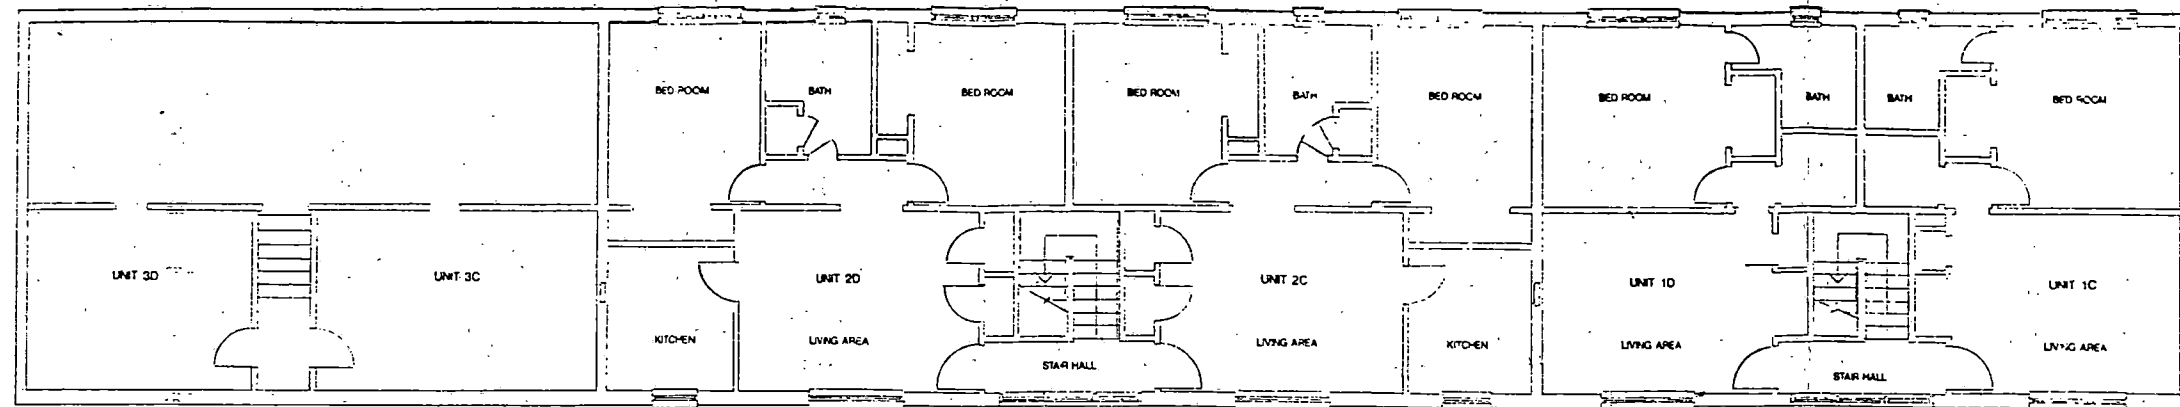
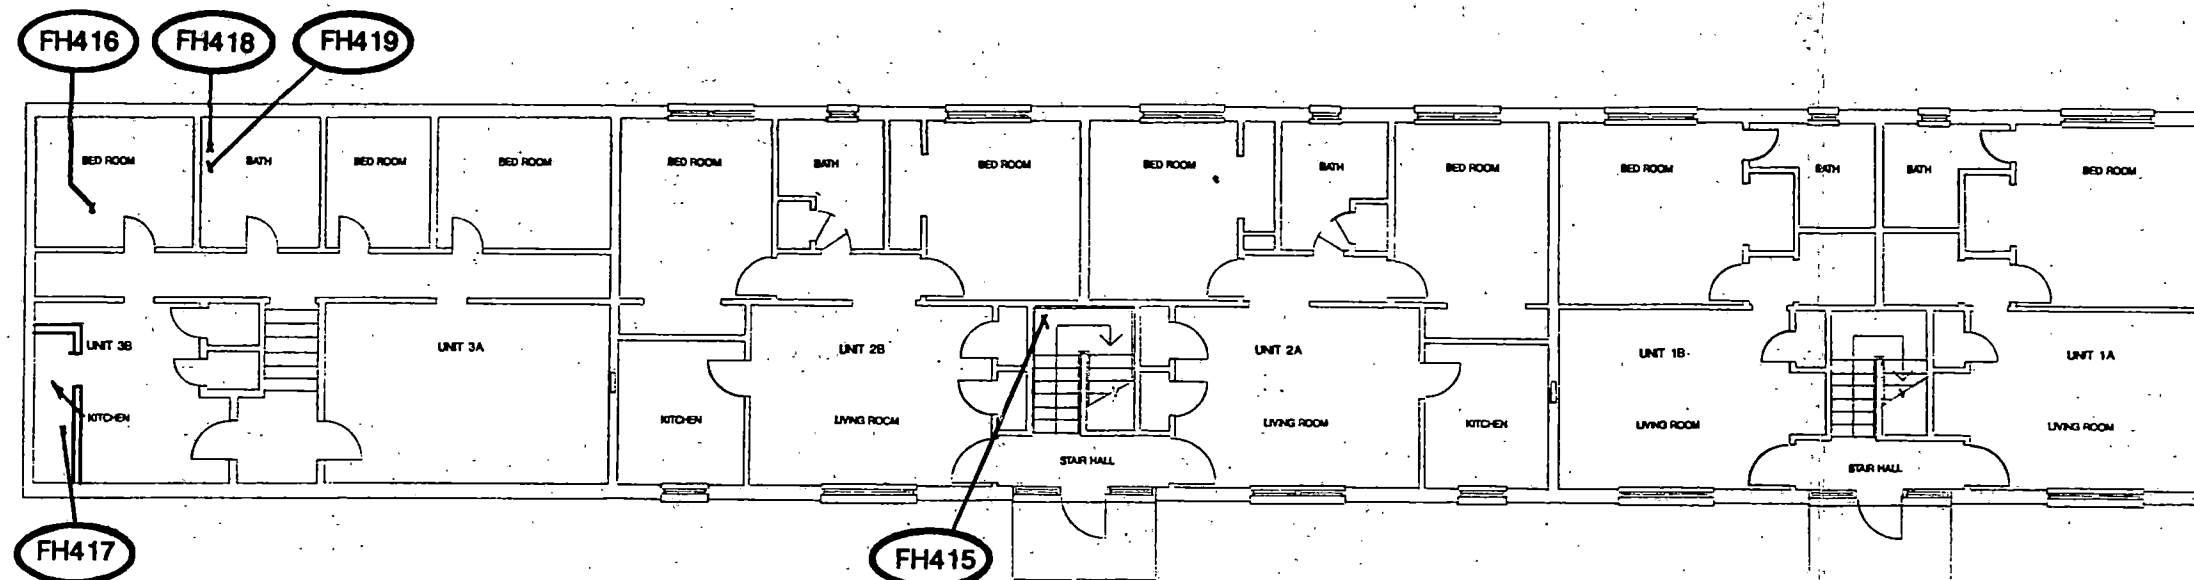
Bldg. 1078: Mechanical Room Pit: <4" pipe runs going underground in pipe trench to Bldg. 1078 tested positive. Samples FH418 < 4" mud fitting; FH419 < 4" pipe run; FH421 < 4" pipe run (not shown) also tested positive.

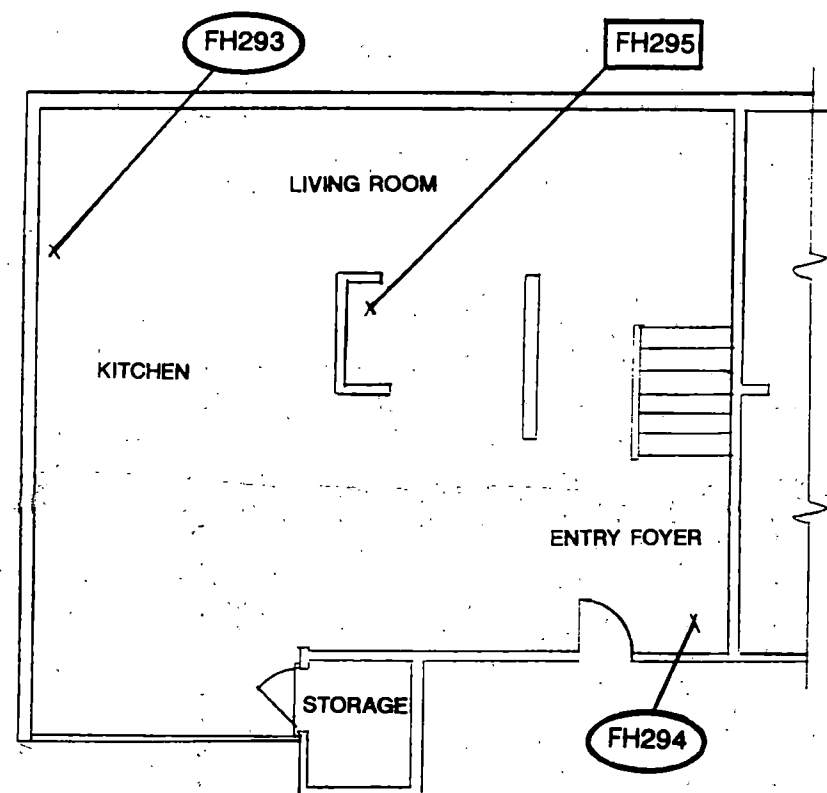
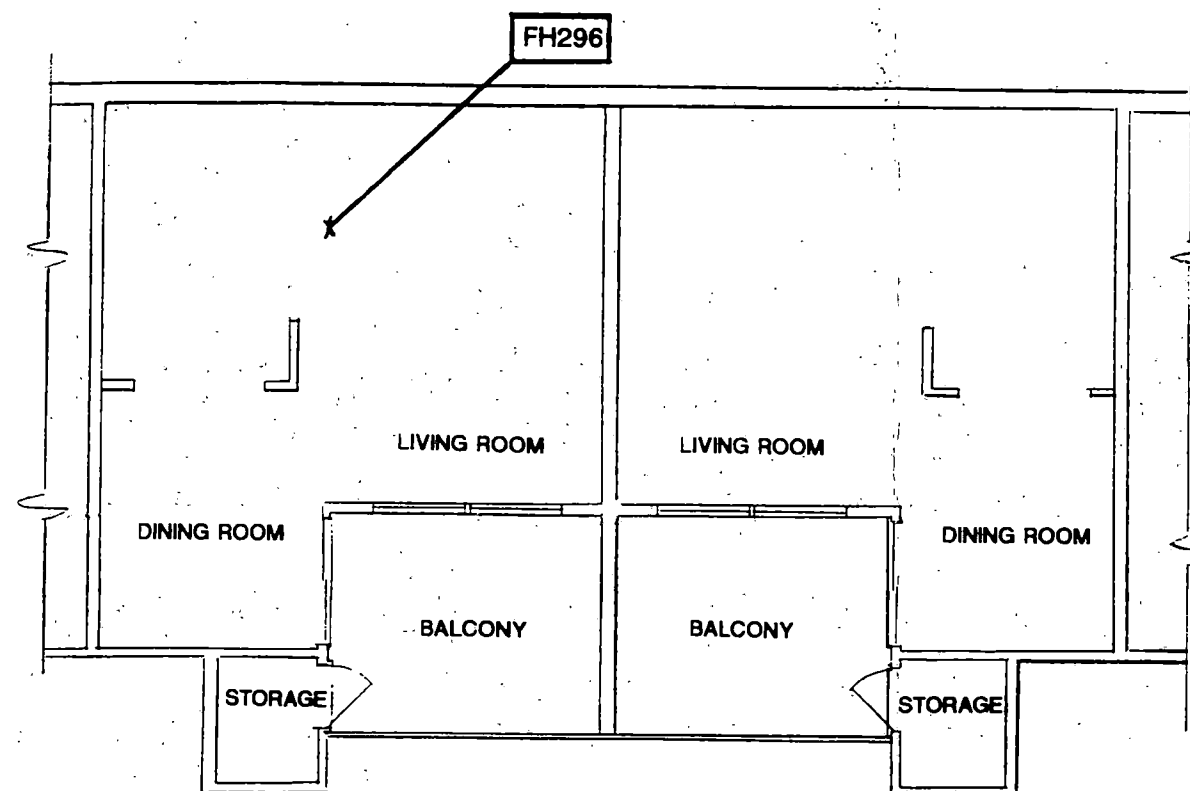
Bldg. 2105

Unit 4, Entire First Floor: (Sample FH293) (12 In. x 12 In.) Tan Floor Tile Tested Positive. Gray Floor Tile (12 In. x 12 In.) On The Second Floor And First Floor Closet Tested Negative.

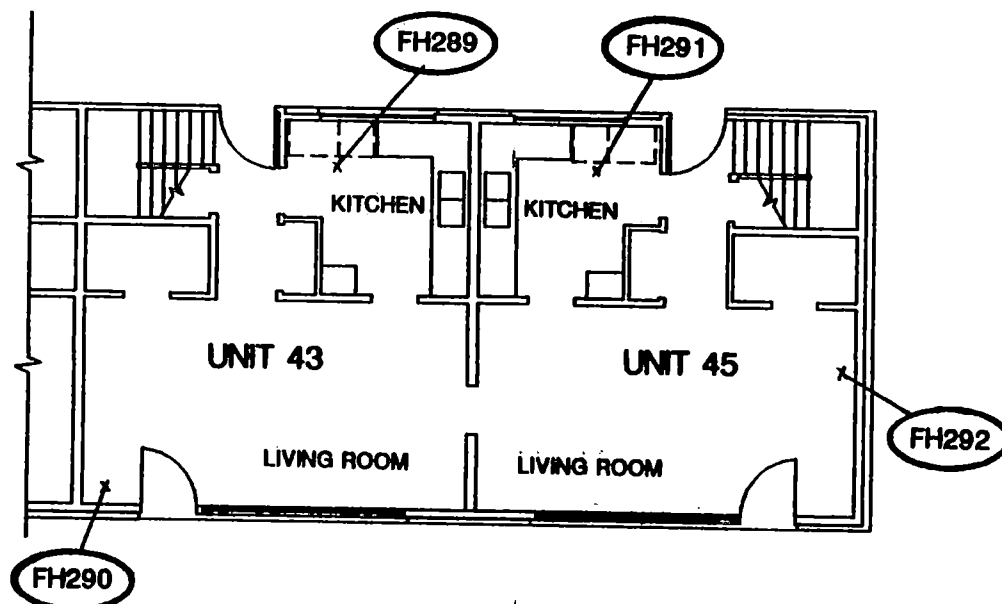
Bldg. 2251

Unit 45, Living Room: (Sample FH292): (9 In. x 9 In.) Brown Floor Tile Tested Positive. Floor Tile In The Kitchen (Green, 9 In. x 9 In.) Also Tested Positive (Sample FH291).

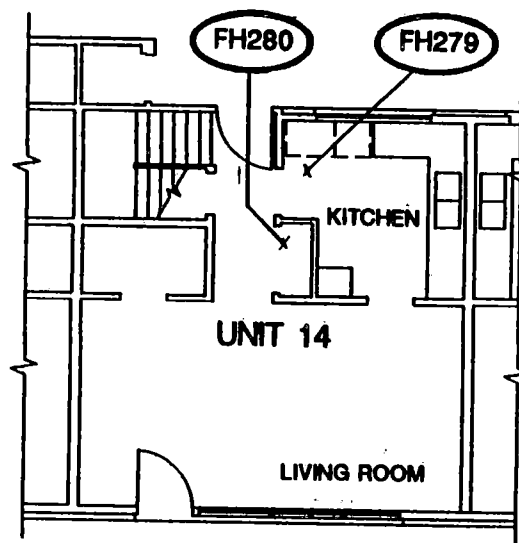
2462-9

Unit 14, Closet: (Sample FH280) (9 In. x 9 In.)  
Brown Floor Tile Tested Positive.
