Underground Storage Tank Closure and Site Investigation Report

Building 117A
Main Post-East Area

NJDEP UST Registration No. 90010-11

December 1997

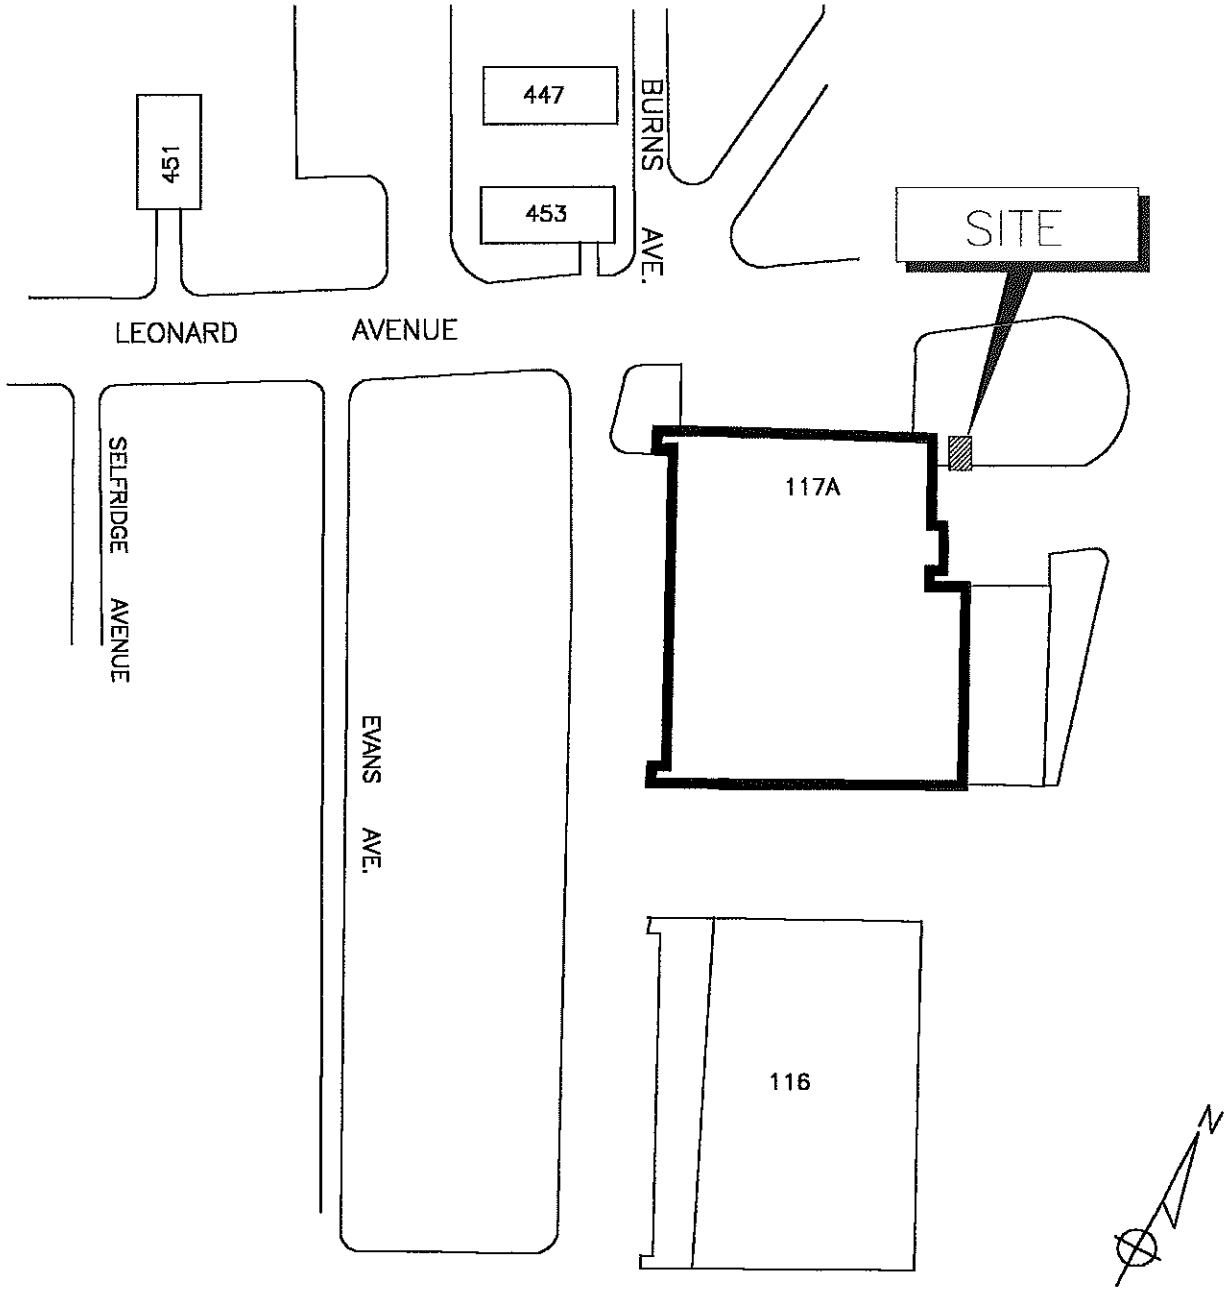
FIGURE 2
SITE MAP
BUILDING 117A
FORT MONMOUTH ARMY BASE
MONMOUTH COUNTY, NJ

Building 117A is located in the Main Post-East area of the Fort Monmouth Army Base. UST No. 90010-11 was located east of Building 117A. Appurtenant copper piping was approximately nine (9) feet in length and ran west to Building 117A. The fill port was located directly above the tank. A site map is provided on Figure 2.

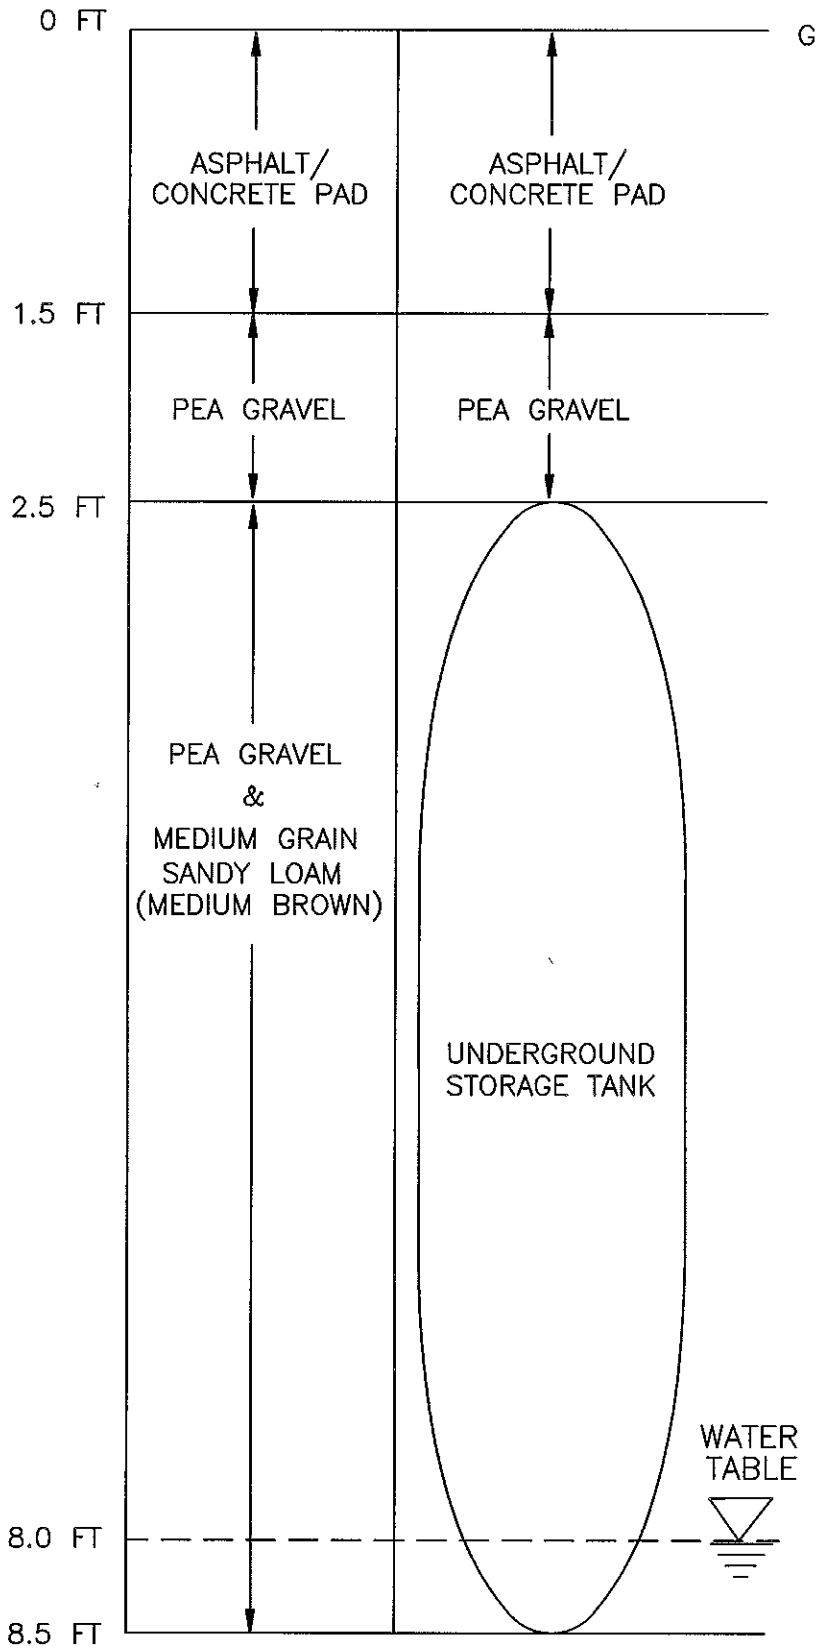
FIGURE 3
CROSS SECTIONAL VIEW
BUILDING 117A
FORT MONMOUTH ARMY BASE
MONMOUTH COUNTY, NJ

After the UST was cleaned, it was staged on polyethylene sheeting and examined for holes. No holes were observed during the inspection by the Sub-Surface Evaluator. Soils surrounding the UST and piping were screened visually and with an OVA for evidence of contamination. No evidence of contamination was observed. Groundwater was encountered at 8.0 feet bgs and no sheen was observed. See Figure 3 for a cross-sectional view of the excavated area.

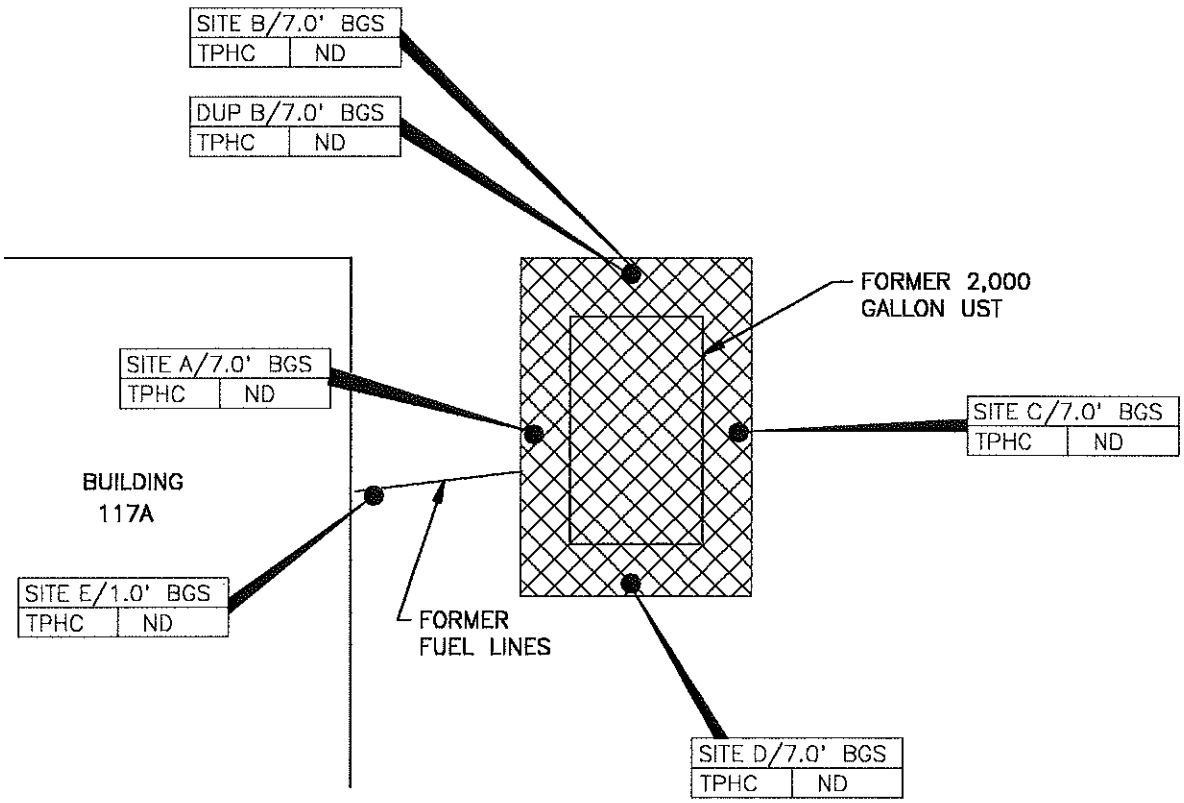
FIGURE 4
SOIL SAMPLING LOCATION MAP
BUILDING 117A
FORT MONMOUTH ARMY BASE
MONMOUTH COUNTY, NJ

To evaluate soil conditions following removal of the UST and associated piping, post-excavation soil samples were collected on April 24, 1997 from a total of five (5) locations. All samples were analyzed for TPHC and total solids. The post-excavation sampling results were compared to the NJDEP residential direct contact total organic contaminants soil cleanup criteria of 10,000 mg/kg (N.J.A.C. 7:26D and revisions dated February 3, 1994). A summary of the analytical results and comparison to the NJDEP soil cleanup criteria is provided in Table 2 and the soil sampling locations are shown on Figure 4. The analytical data package is provided in Appendix E.

All post-excavation soil samples collected on April 24, 1997, from the UST excavation and from below piping associated with the UST contained concentrations of TPHC below the NJDEP soil cleanup criteria. Samples contained non-detectable levels of TPHC.
