DEPARTMENT OF THE ARMY

OFFICE OF ASSISTANT CHIEF OF STAFF FOR INSTALLATION MANAGEMENT  
U.S. ARMY FORT MONMOUTH  
P.O. 148  
OCEANPORT, NEW JERSEY 07757

**Re: Proposed Test Pit Investigation Plan for Parcel 28 Historical Septic Tank Systems and Gas Station, Charles Wood Area, Fort Monmouth, New Jersey**

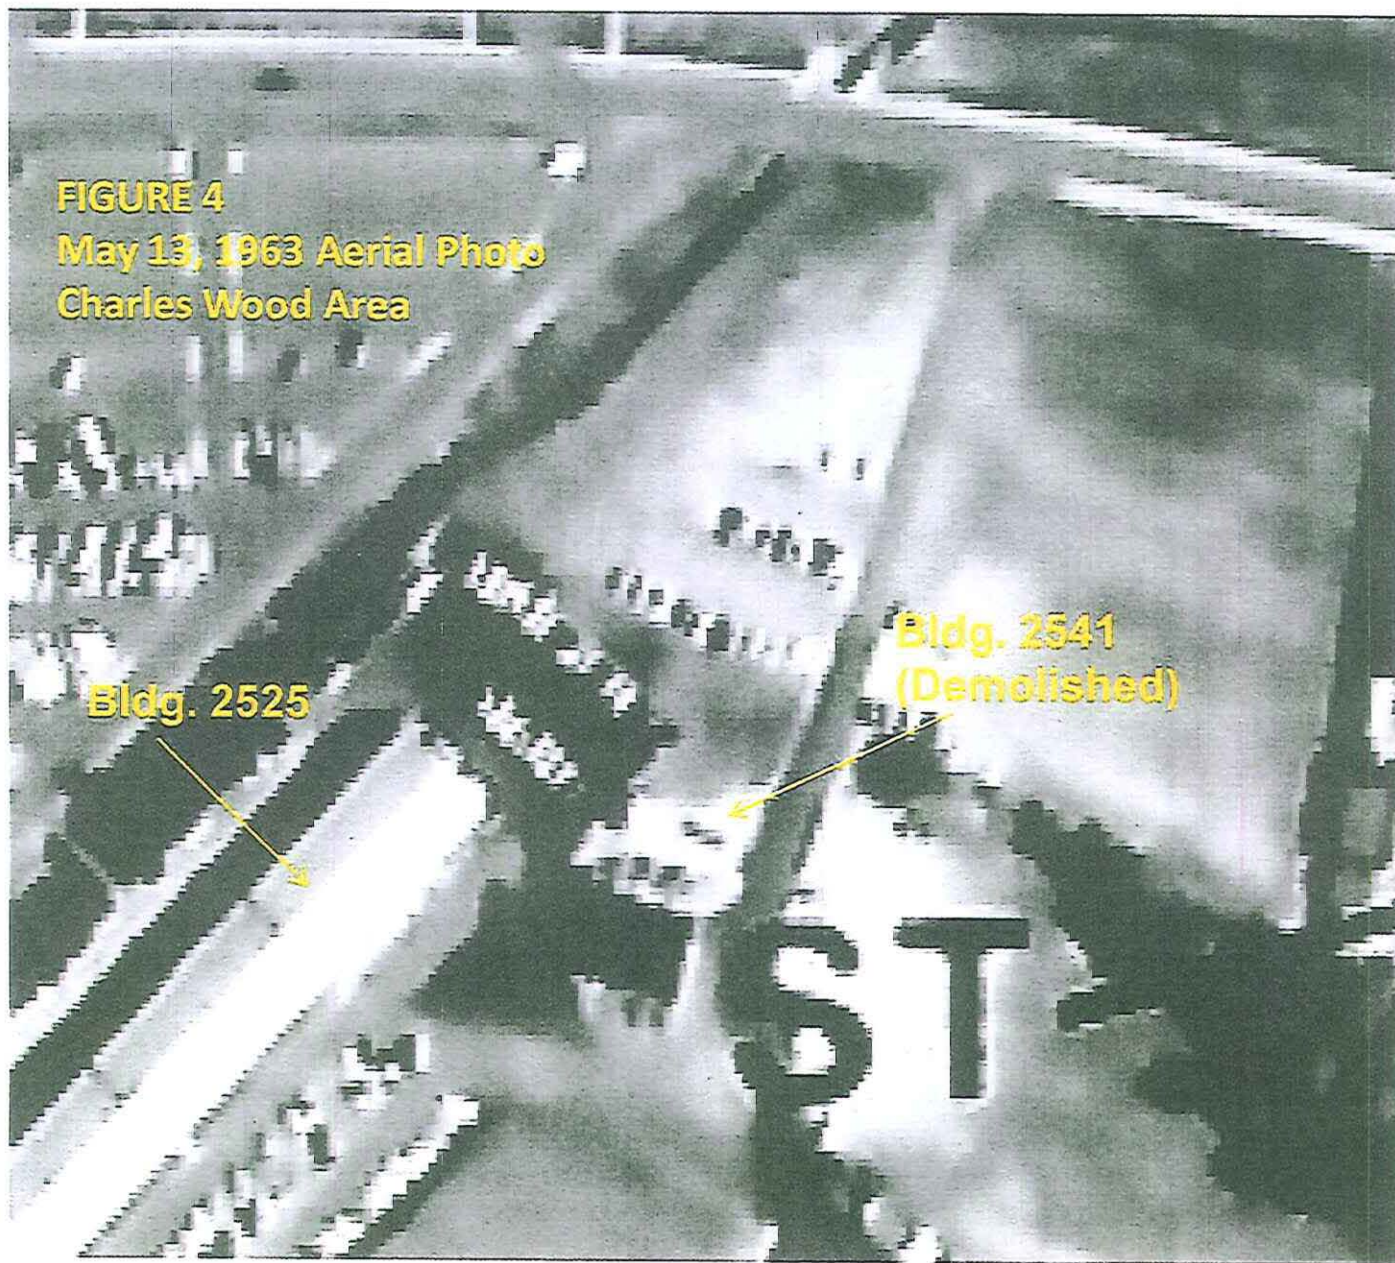
**FIGURE 4**

**May 13, 1963 Aerial Photo  
Charles Wood Area**

**Bldg. 2525**

**Bldg. 2541  
(Demolished)**

According to a June 30, 1944 hand-drawn sketch of the Charles Wood Area (**Figure 2**), former building 2541 is depicted as "gas station". The structure depicted as a gas station on the sketch is also present on a May 2, 1957 aerial photograph (**Figure 3**) of the area. In a subsequent May 13, 1963 aerial photograph (**Figure 4**), the "gas station" structure is no longer present. No other records regarding former building 2541 could be found. The Army believes the former Bldg. 2541 gas station depicted on the sketch and aerial photographs was demolished during renovation/reconfiguration of the Charles Wood Area, circa 1957-1963. The building number 2541 has since been reused, and is currently the building number of a warehouse at the Charles Wood Area.
