Underground Storage Tank Closure and Site Investigation Report

Building 439
Main Post-East Area

NJDEP UST Registration No. 90010-48
Dicar No. 96-12-18-1650-22

April 1998

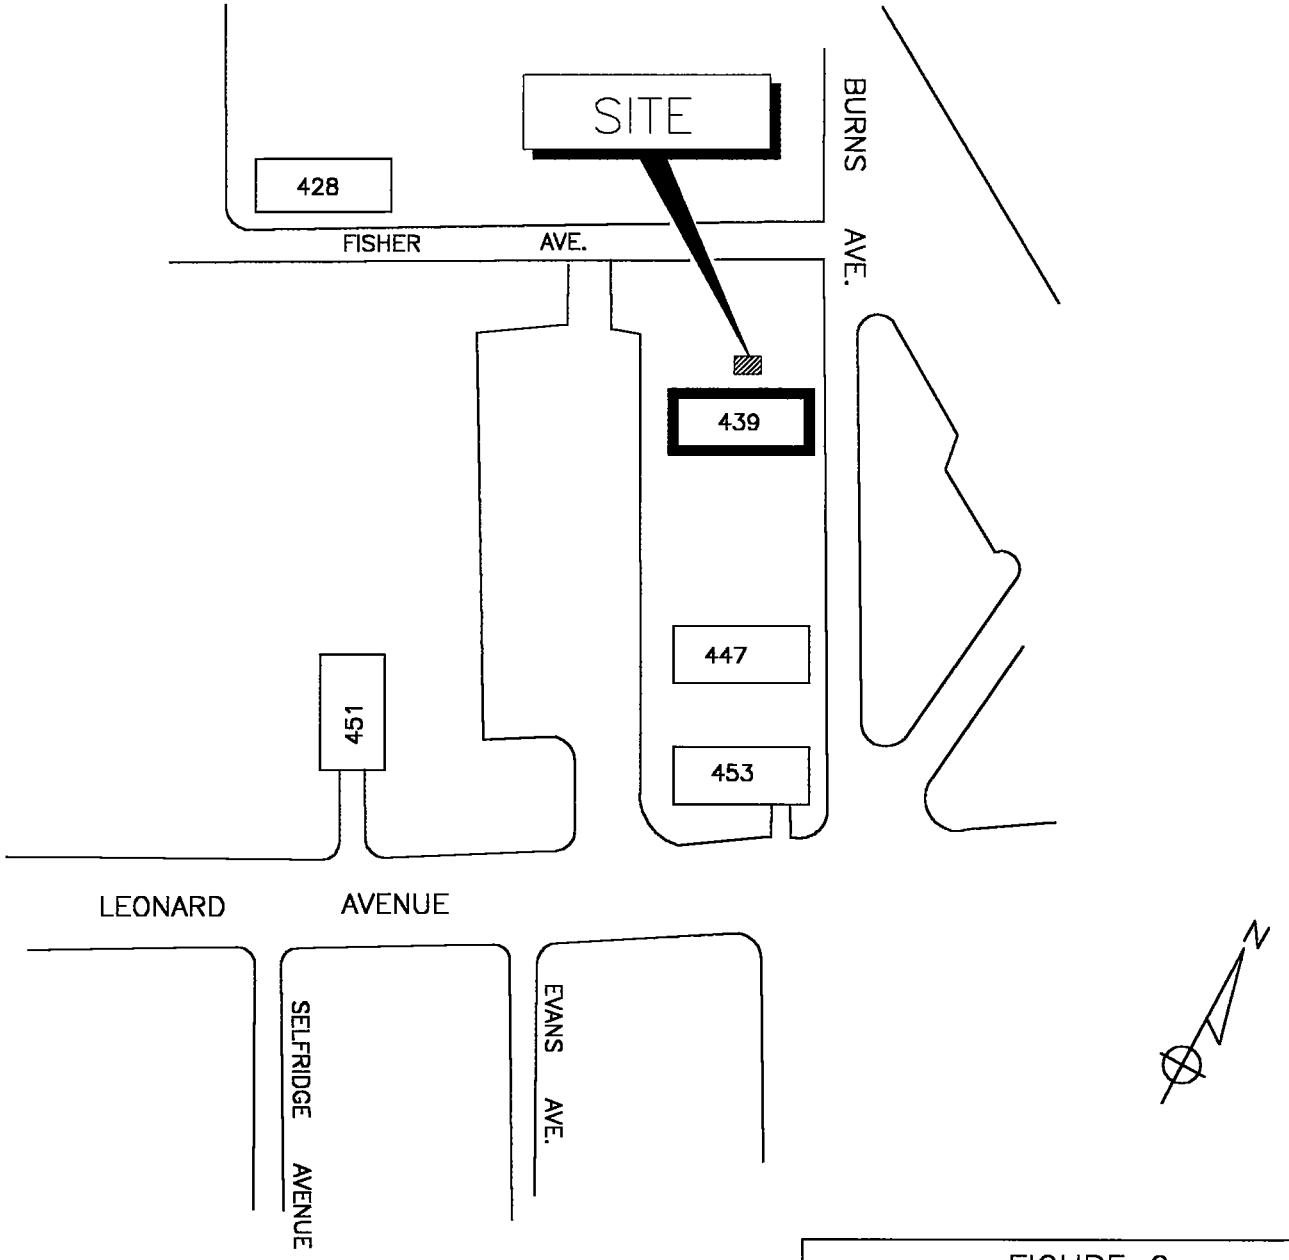
FIGURE 2
SITE MAP
BUILDING 439
FORT MONMOUTH ARMY BASE
MONMOUTH COUNTY, NJ

Building 439 is located in the Main Post-East area of the Fort Monmouth Army Base. UST No. 90010-48 was located north of Building 439. Appurtenant copper piping was approximately eighteen feet in length and ran east to Building 439. A site map is provided on Figure 2.

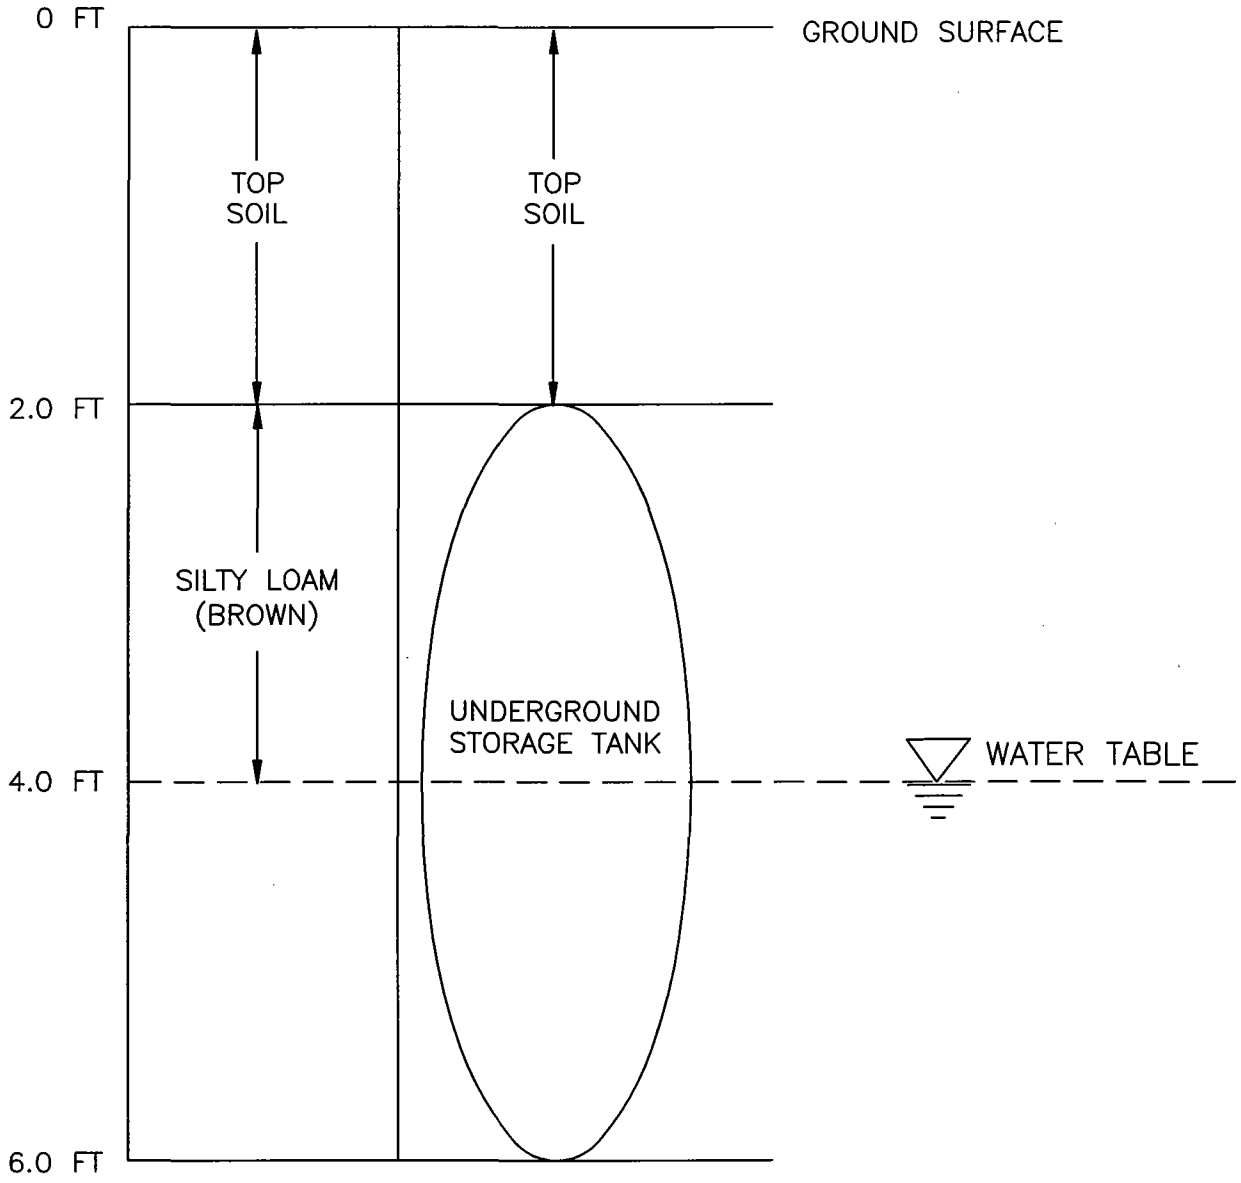
FIGURE 3
CROSS SECTIONAL VIEW
BUILDING 439
FORT MONMOUTH ARMY BASE
MONMOUTH COUNTY, NJ

After the UST was cleaned, it was removed from the excavated area and staged on polyethylene sheeting for inspection. No holes or punctures were observed during the inspection by the Sub-Surface Evaluator. Soils near the west end of the tank adjacent to the fill port were stained. It appears that the stained soil was caused by an overfill. Approximately 14 cubic yards of potentially contaminated soils were removed on December 26, 1996. Groundwater was encountered at 6.5 feet below ground surface and no sheen was observed. See Figure 3 for a cross-sectional view of the excavated area.

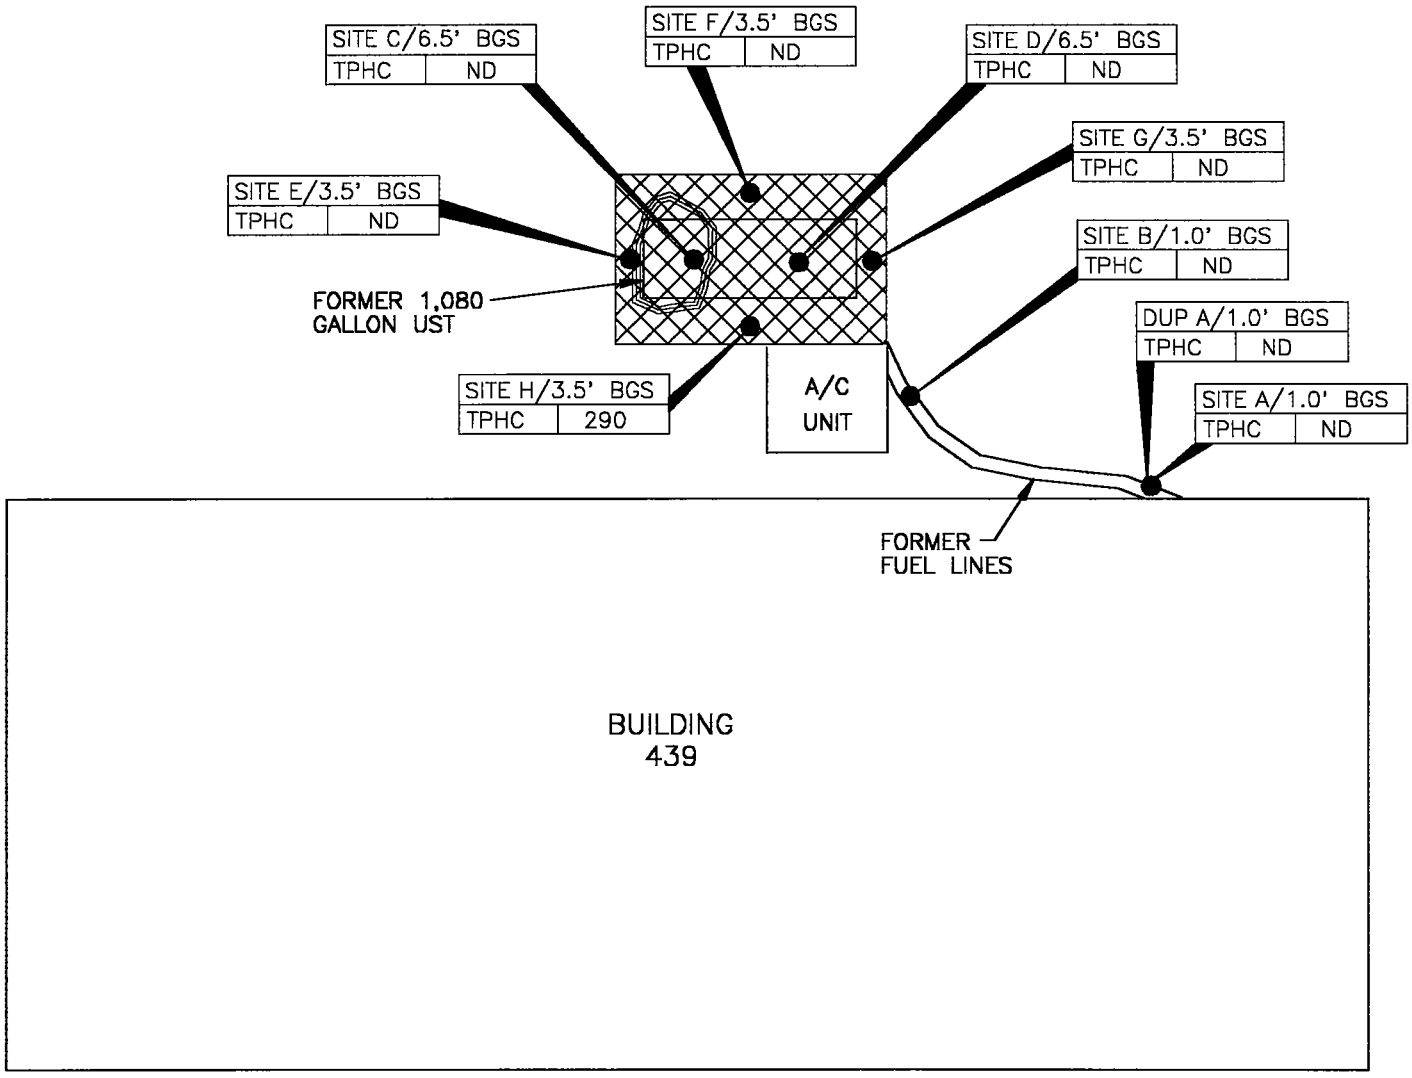
To evaluate soil conditions following removal of the UST and associated piping, post-excavation soil samples were collected on December 26, 1996 from a total of eight locations. All samples were analyzed for TPHC and total solids. The post-excavation sampling results were compared to the NJDEP residential direct contact total organic contaminants soil cleanup criteria of 10,000 mg/kg (N.J.A.C. 7:26D and revisions dated February 3, 1994). A summary of the analytical results and comparison to the NJDEP soil cleanup criteria is provided in Table 2 and the soil sampling locations are shown on Figure 4. The analytical data package is provided in Appendix E.

All post-excavation soil samples collected on December 26, 1996, from the UST excavation and from below piping associated with the UST contained concentrations of TPHC below the NJDEP soil cleanup criteria. Samples contained TPHC concentrations ranging from non-detect to 290 mg/kg. Groundwater encountered did not exhibit a sheen.
