Underground Storage Tank Closure and Site Investigation Report

Building 443
Main Post Area

NJDEP UST Registration No. 090010-49
NJDEP Closure Approval No. C-93-3913

February 1996

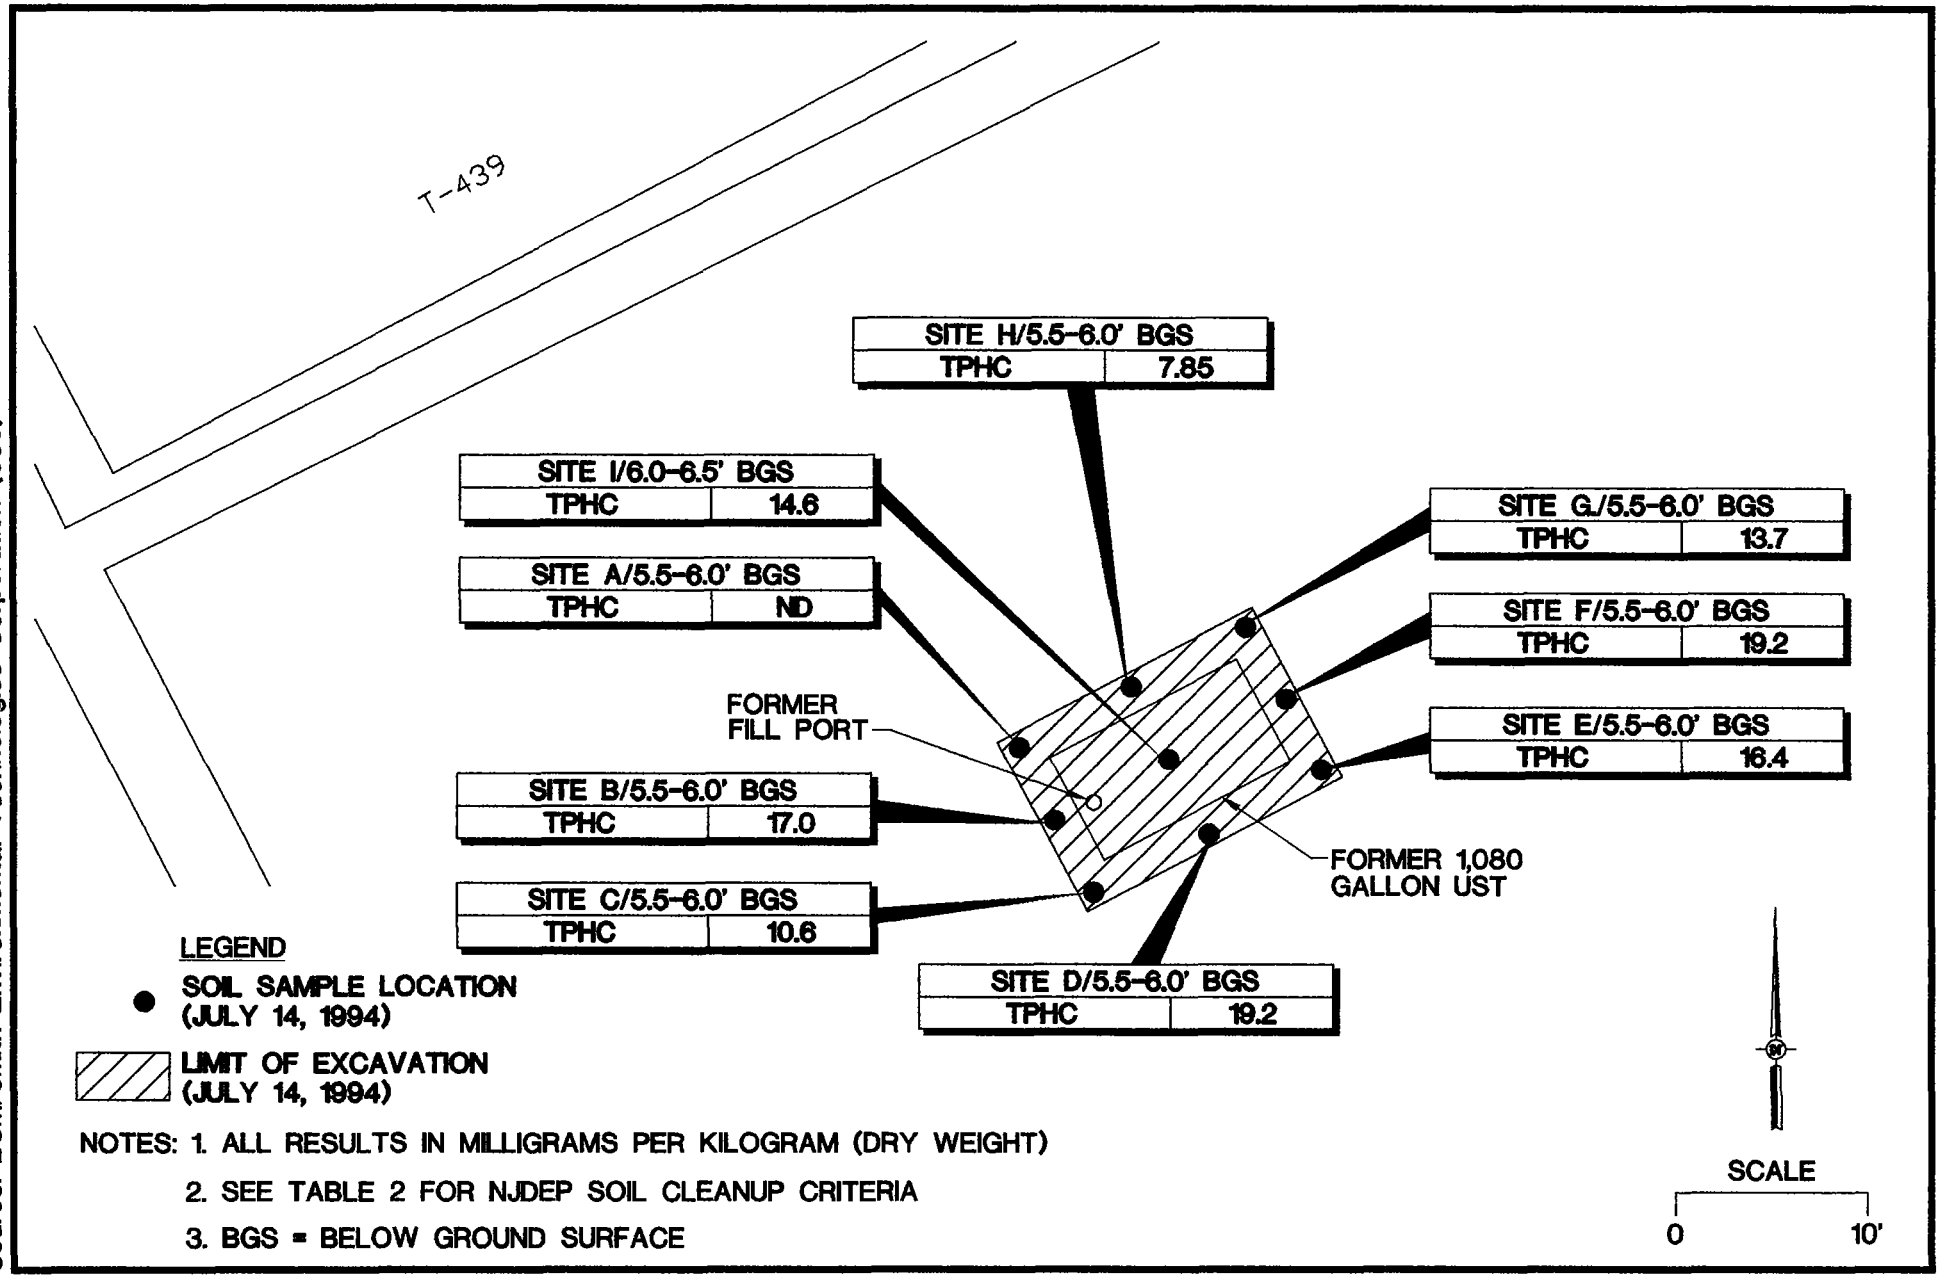
Figure 3

Building 443
Soil Sampling Results

To evaluate soil conditions following removal of the UST and associated piping, post-excavation soil samples were collected from a total of nine (9) locations on July 14, 1994. All samples were analyzed for TPHC. The post-excavation soil sample results were compared to the NJDEP residential direct contact total organic contaminants soil cleanup criteria of 10,000 mg/kg (N.J.A.C. 7:26D and revisions dated February 3, 1994). A summary of the analytical results and comparison to the NJDEP soil cleanup criteria is provided in Table 2 and the soil sampling results are shown on Figure 3. The analytical data package is provided in Appendix E.

All post-excavation soil samples collected on July 14, 1994, from the UST excavation and from below piping associated with the UST contained either non-detectable concentrations of TPHC or concentrations below the NJDEP soil cleanup criteria. B, C, D, E, F, G, H, and I, contained levels of TPHC ranging in concentration from 7.85 mg/kg to 19.2 mg/kg. Sample A contained a non-detectable concentration of TPHC.

No further action is proposed in regard to the closure and site assessment of UST No. 090010-49 at Building 443.
