Underground Storage Tank Closure and Site Investigation Report

Charles Wood – Building 2025

NJDEP UST Registration No.: 192486-6
UST No.: 192486-6

September 2010

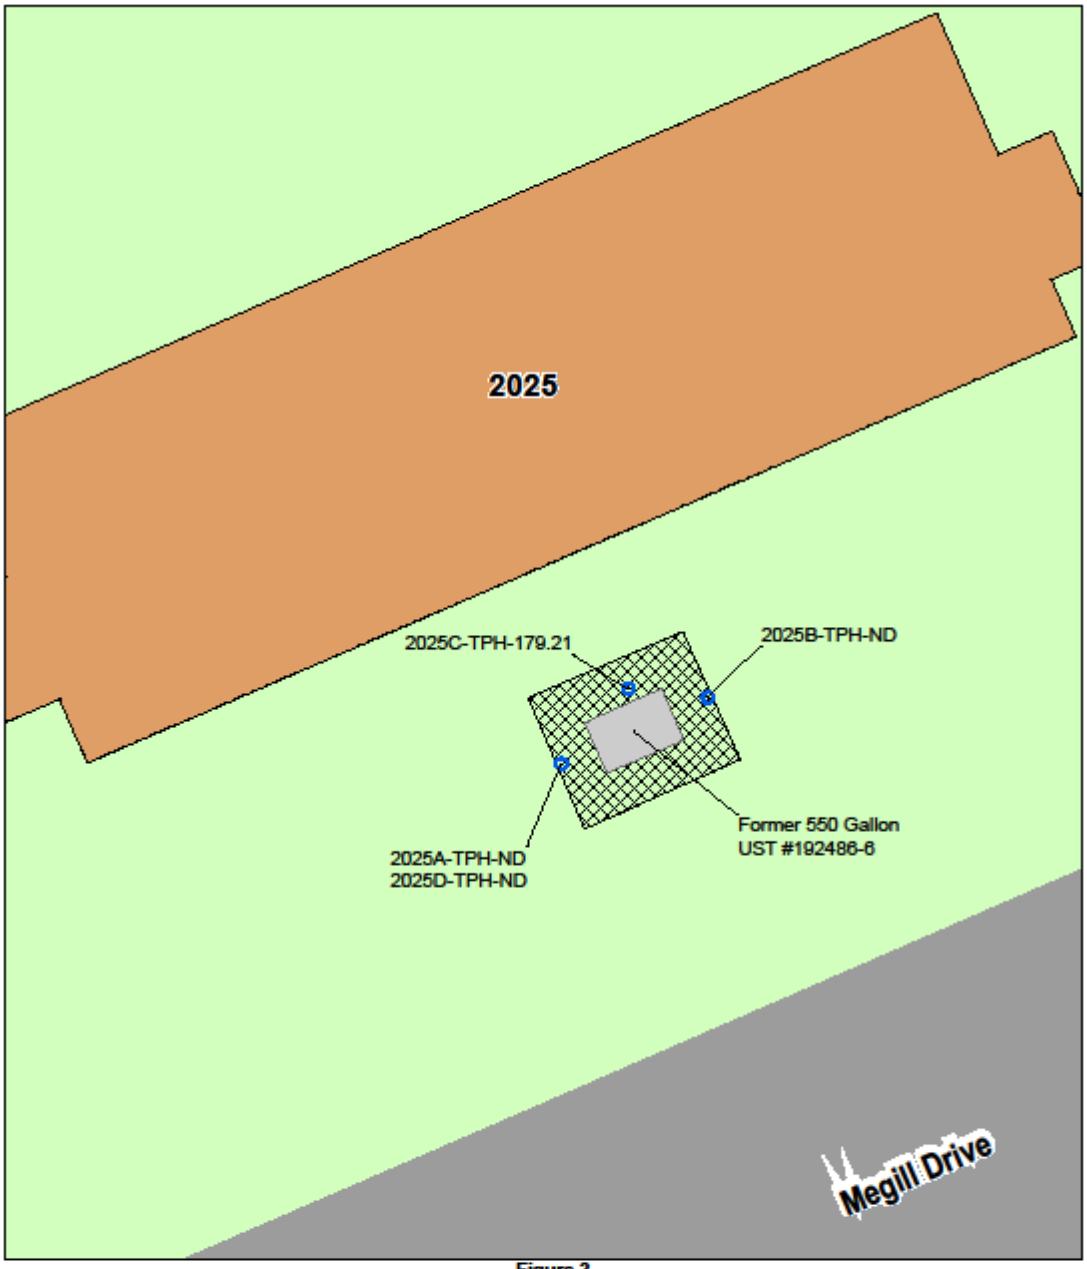
Figure 3
Soil Sampling Location Map
Building 2025, Charles Wood Area
Fort Monmouth, NJ
Date: 1/2011
UST Registration # 192486-6
UST Discharge # NA

Building 2025 (Megill Drive) is located in the Charles Wood area of Fort Monmouth, as shown on Figure 1 & 2. UST No.: 192486-6 and associated piping were located adjacent to the building, as shown on Figure 3.

On February 4, 2000, closure soil samples were collected after the removal of the UST. Closure samples 2025-A and 2025-B were collected from a total of two (2) locations along the UST bottom of the excavation for the UST No.: 192486-6. Closure sample 2025-C was collected from a location along the UST piping. A duplicate of sample 2025-A was collected. Refer to

soil sampling location map in Figure 3. All samples were analyzed for total petroleum hydrocarbons (TPH). Groundwater was not encountered in the excavation.
