Underground Storage Tank Closure and Site Investigation Report

Charles Wood – Building 2039

NJDEP UST Registration No.: 192486-20
UST No.: 192486-20

September 2010

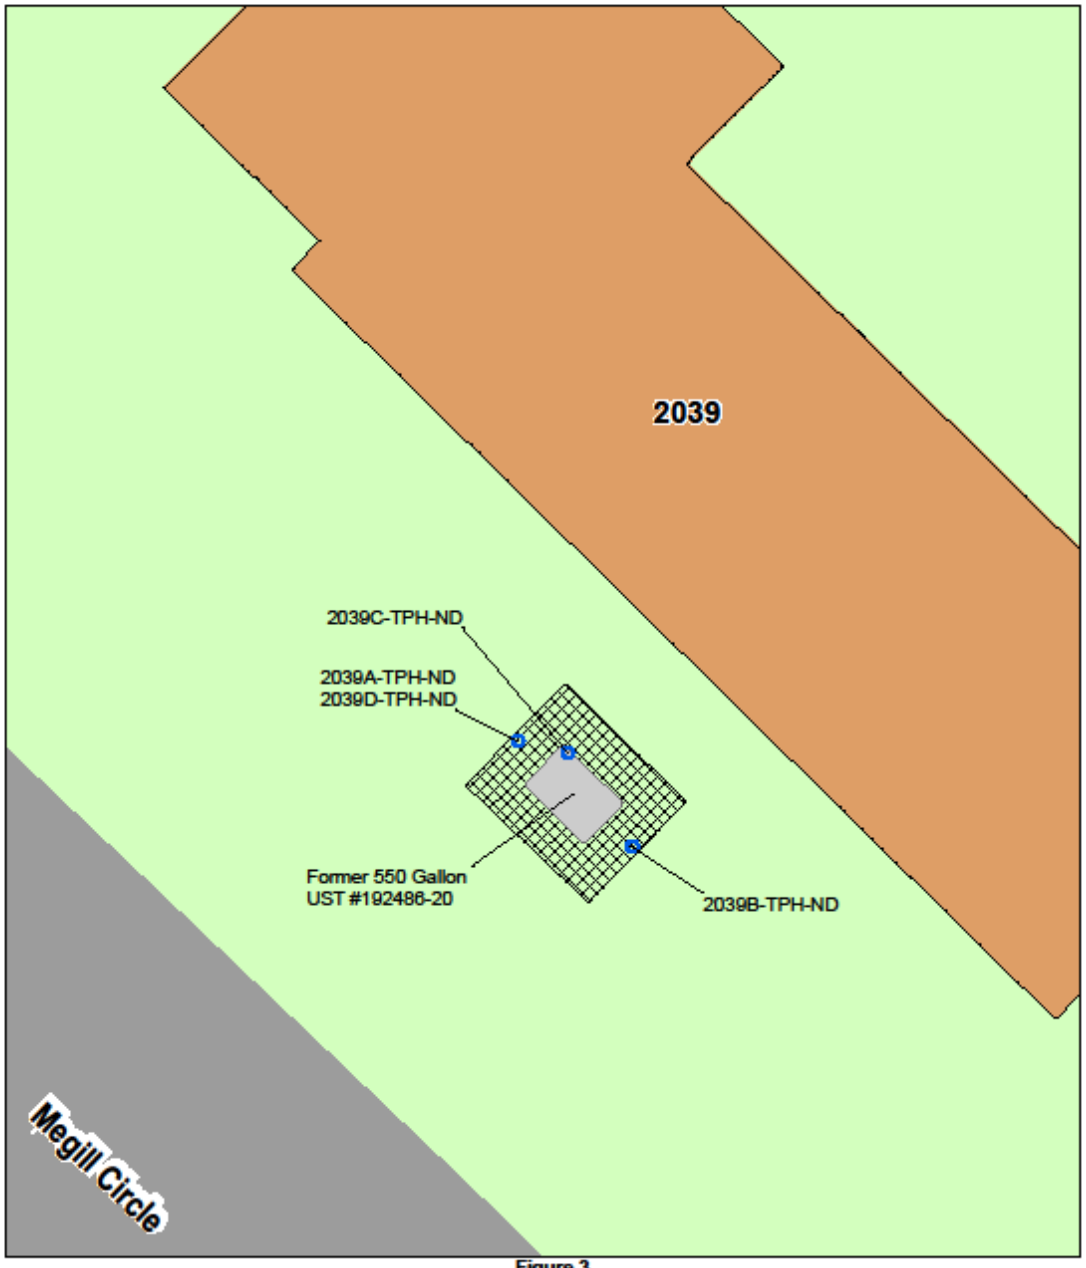
Figure 3
Soil Sampling Location Map
Building 2039, Charles Wood Area
Fort Monmouth, NJ
Date: 1/2011
UST Registration # 192486-20
UST Discharge # NA

Building 2039 (56 & 58 Megill Circle) is located in the Charles Wood area of Fort Monmouth, as shown on Figure 1 & 2. UST No.: 192486-20 and associated piping were located adjacent to the building, as shown on Figure 3.

Refer to soil sampling location map in Figure 3. All samples were analyzed for total petroleum hydrocarbons (TPH). Groundwater was not encountered in the excavation.
