### Remedial Investigation Report And Sediment Quality Evaluation

### M-12/M-14 Landfill Site

U. S. Army Installation Fort Monmouth Fort Monmouth, New Jersey

October 15, 2003

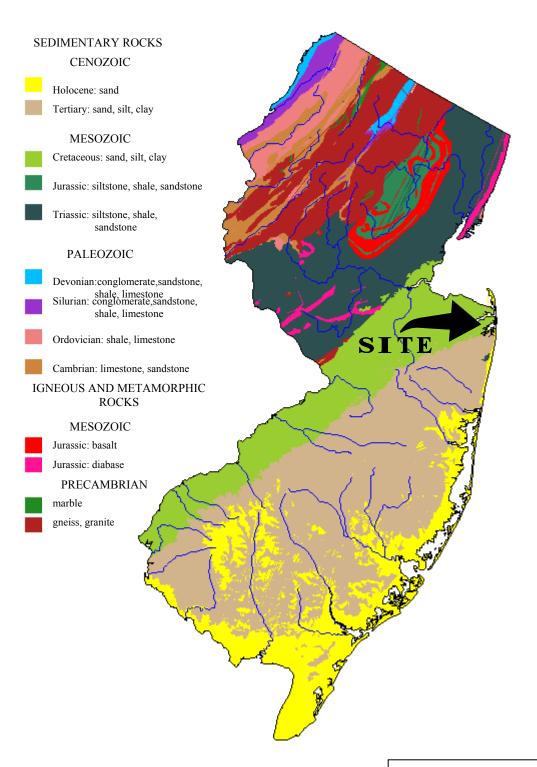
FIGURE 2-4
Geological Map of New Jersey
M-12/M-14 Landfill Site
Fort Monmouth, New Jersey

### **Geologic Map of New Jersey**

Monmouth County lies within the New Jersey Section of the Atlantic Coastal Plain physiographic province. The M-12/M-14 Landfill Site is located in what may be referred to as the Outer Coastal Plain subprovince, or the Outer Lowlands. The geologic map of New Jersey is provided as **Figure 2-4**.

Based on the regional geologic map (Jablonski, 1968), the Cretaceous age Red Bank and Tinton Sands outcrop at the Main Post Area. The Red Bank Sand conformably overlies the Navesink Formation and dips to the southeast at 35 feet per mile. The upper member (Shrewsbury) of the Red Bank Sand is a yellowish-gray to reddish brown clayey, medium-to-coarse-grained sand that contains abundant rock fragments, minor mica and glauconite (Jablonski). The lower member (Sandy Hook) is a dark gray to black, medium-to-fine grained sand with abundant clay, mica and glauconite.

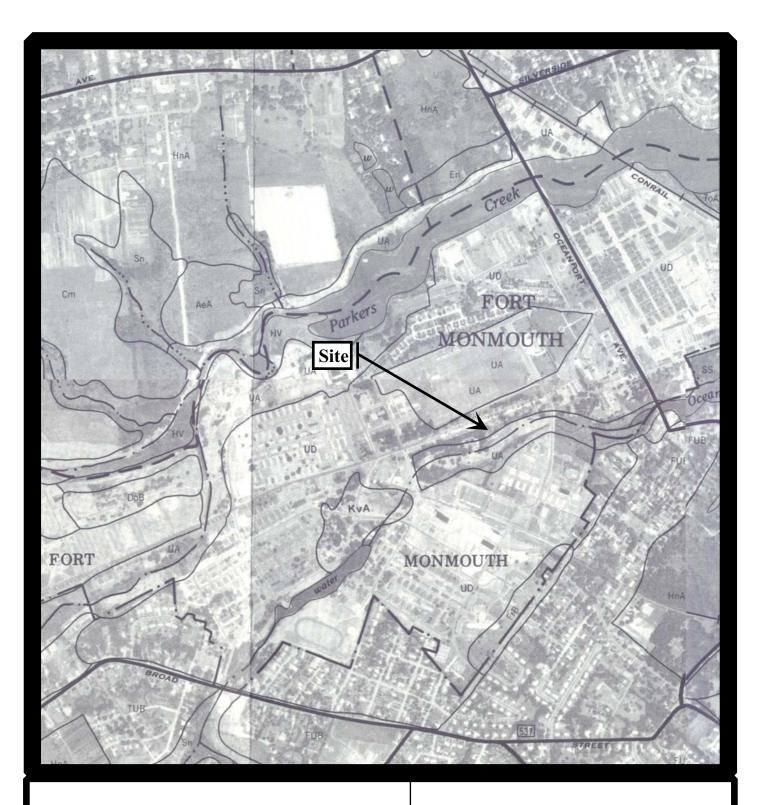
FIGURE 2-5

Soil Map of Monmouth County, New Jersey

According to the U.S. Department of Agriculture (USDA), Soil Conservation Service, Monmouth County Soil Survey, the majority of the Main Post area is covered by urban land (**Figure 2-5**). The soil survey described urban land as areas where concrete, asphalt, buildings, shopping centers, airports or other impervious surfaces cover 80 percent or more of the surface. In addition, the survey indicated that the natural subsurface soils have largely been replaced with artificial or foreign fill materials (developed land with disturbed soils). The following soil series and classification units are mapped in the Main Post Area:

glass. The soils in the vicinity of the M-12/M-14 Landfill Site are classified as UA to UD, Udorthents, smoothed to Udorthents, urban land complex.

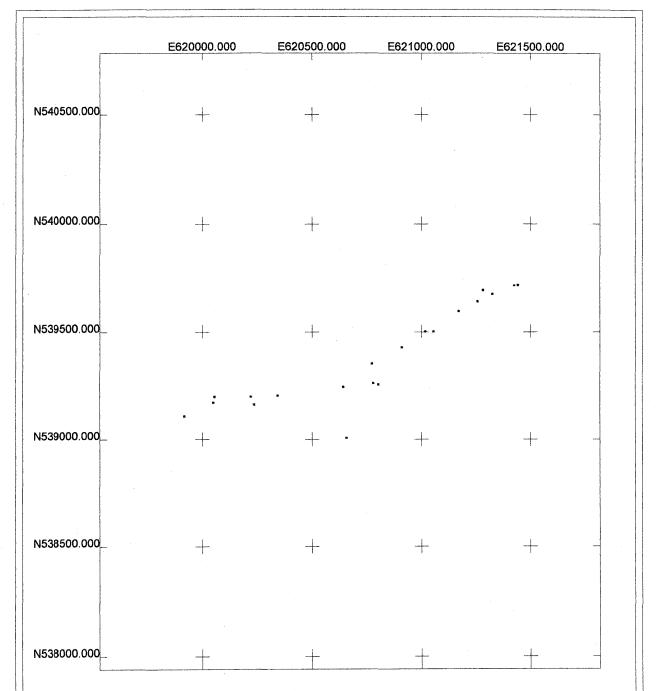
## M12 and M14 Landfills Husky Brook Sediment PCBs Samples GPS Map

US State Plane 1983 New Jersey (NY East) 2900 NAD 1983 (Conus)

Twenty-five sediment samples were collected, including two duplicate samples for QA/QC, from 11 borings using a Wildco Sediment Sampler. The samples were obtained along the 1,700-foot portion of Husky Brook that flows through the Site. Sample depths ranged from surface (0 to 6 inches) to near-surface (6 inches to 12 inches below grade) at each boring location, with the exception of Borings B-1, B-4 and B-6, which were also sampled at a depth of 18 inches to 24 inches below grade. The samples consisted of black to brown fine sandy silt to green/black clay and sandy clay with black bands, some organic material and small angulars. Boring logs are provided in **Appendix C**.
