Underground Storage Tank Closure and Site Investigation Report

Building 1110
Main Post-West Area

NJDEP UST Registration No. 0081533-170

September 1998

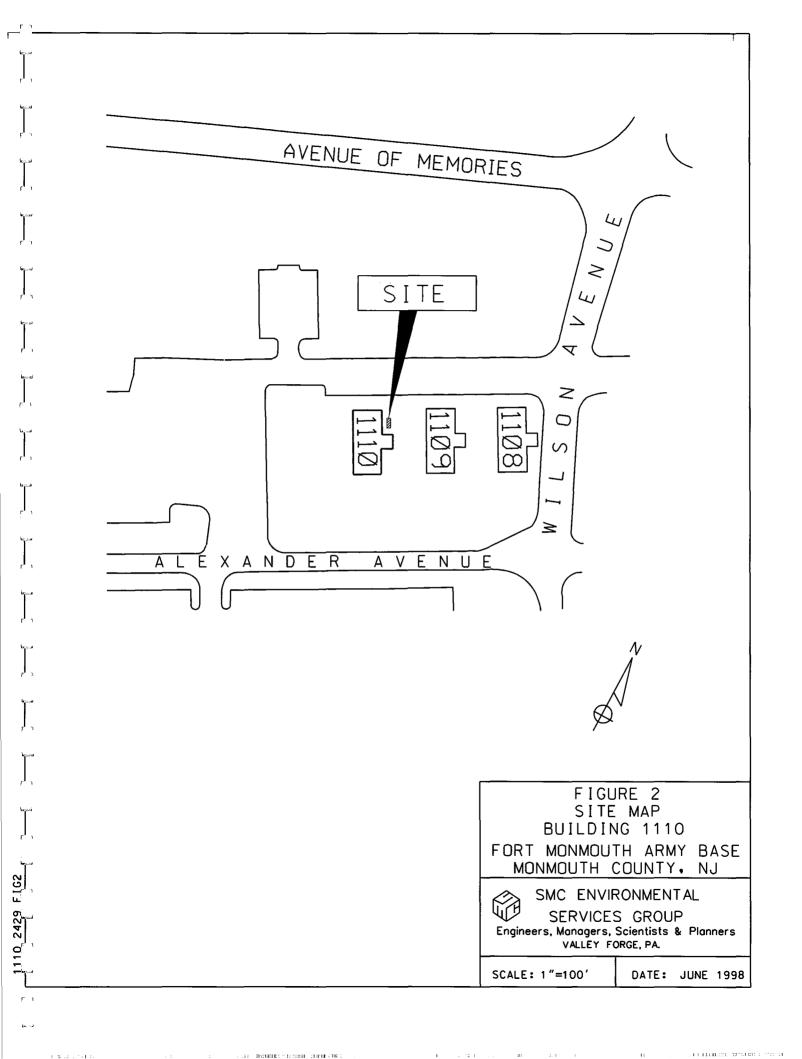
Figure 2 Site Map

Building 1110 is located in the Main Post-West area of the Fort Monmouth Army Base. UST No. 0081533-170 was located north of Building 1110 and appurtenant copper piping ran approximately five (5) feet southeast from the excavation to Building 1110. A site map is provided on Figure 2.

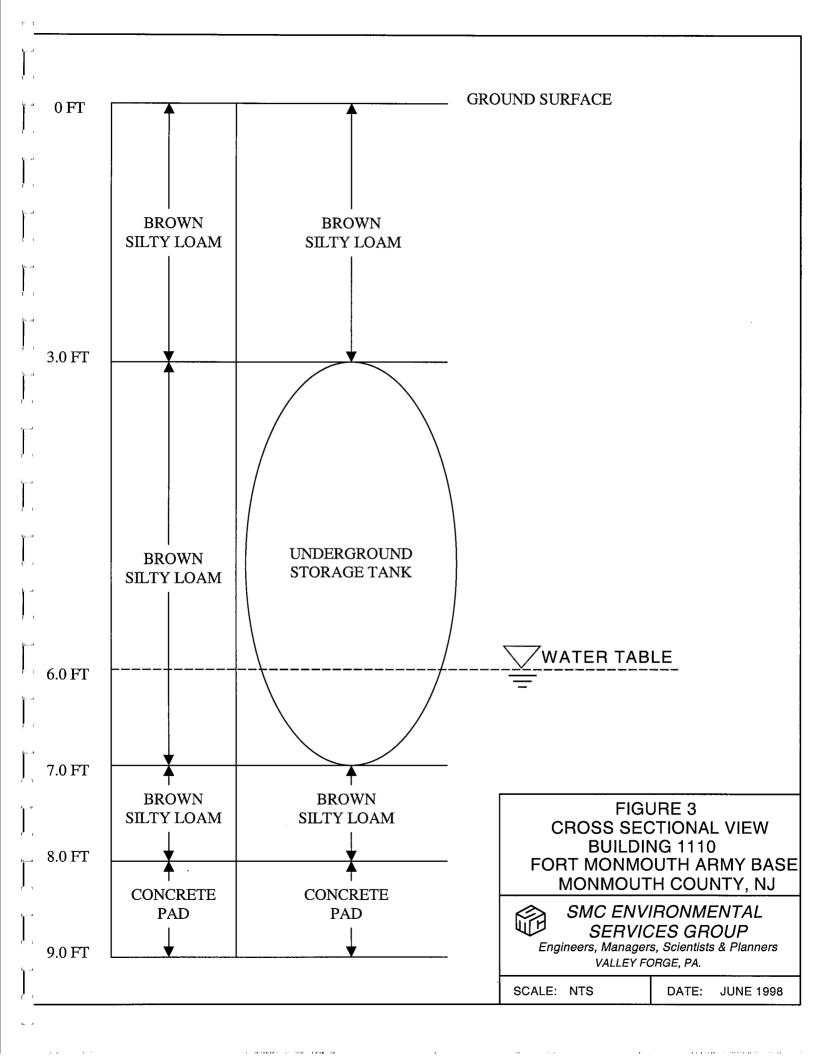
Figure 3 Cross Sectional View

The UST was cleaned prior to removal from the excavation in accordance with the NJDEP-BUST regulations. After the UST was removed from the excavation, it was staged on polyethylene sheeting and examined for holes. No holes or punctures were observed during the inspection by the Sub-Surface Evaluator. Soils surrounding the UST were screened visually and with an OVA for evidence of contamination. No evidence of contamination was observed. Soil screening was also performed along the piping run associated with the UST closure. No contamination was noted anywhere along the piping length. Groundwater was encountered at 6.0 feet bgs and no sheen was observed. See Figure 3 for a cross-sectional view of the excavated area.

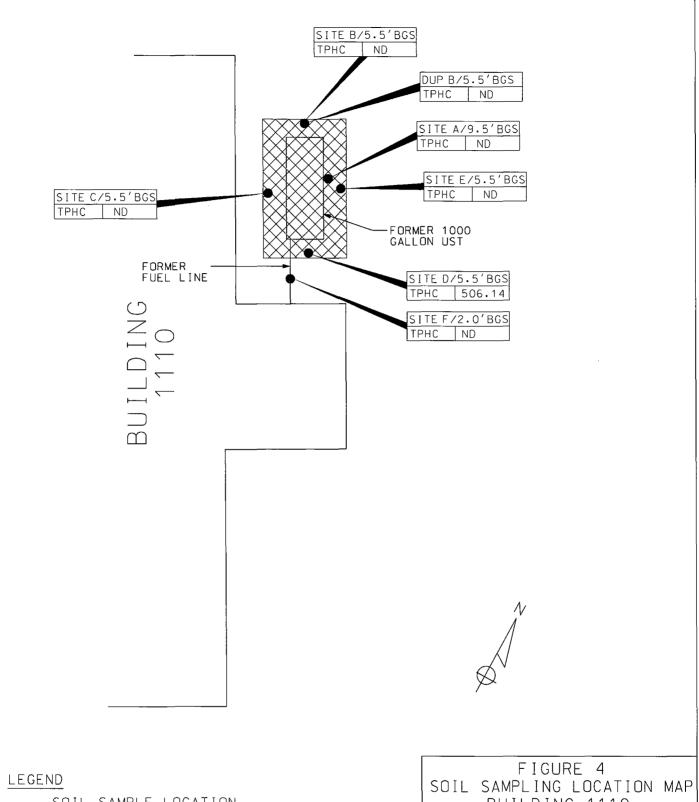
SOIL SAMPLE LOCATION (JUNE 30, 1998)

- 1. ALL RESULTS IN MG/KG.
- 2. SEE TABLE 2 FOR NJDEP SOIL CLEANUP CRITERIA
- 3. BGS = BELOW GROUND SURFACE

To evaluate soil conditions following removal of the UST, post-excavation soil samples were collected on June 30, 1998, from a total of five (6) locations. All samples were analyzed for TPHC and total solids. The post-excavation sampling results were compared to the NJDEP residential direct contact total organic contaminants soil cleanup criteria of 10,000 mg/kg (N.J.A.C. 7:26D and revisions dated February 3, 1994). A summary of the analytical results and comparison to the NJDEP soil cleanup criteria is provided in Table 2 and the soil sampling locations are shown on Figure 4. The analytical data package is provided in Appendix E.

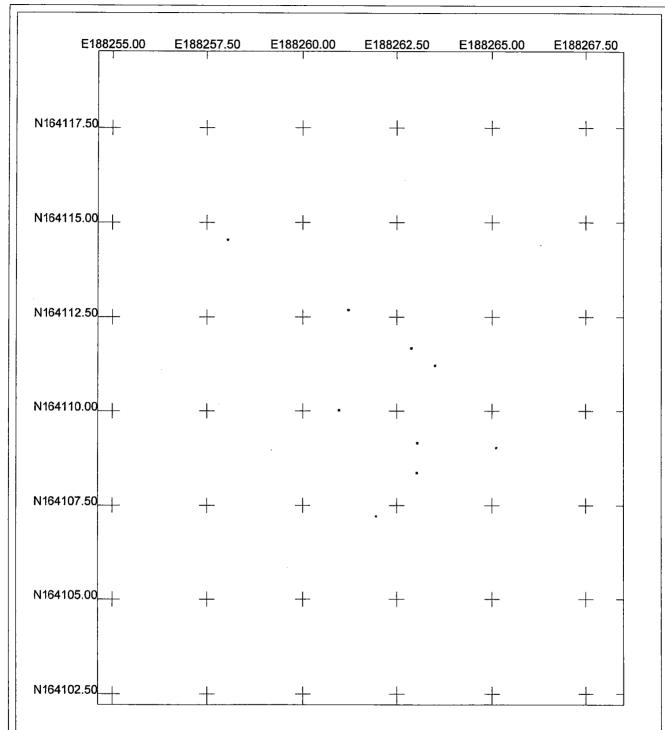
Figure 4 Sampling Locations Map

<u>Locations</u>	Y Coord. (Northing)	X Coord. (Easting)				
1110 A	164111.689	188262.877				
1110 B	164112.7	188261.202				
1110 C	164110.031	188260.95				
1110 D	164109.164	188263.035				
1110 E	164111.221	188263.496				
1110 F	164108.373	188263.022

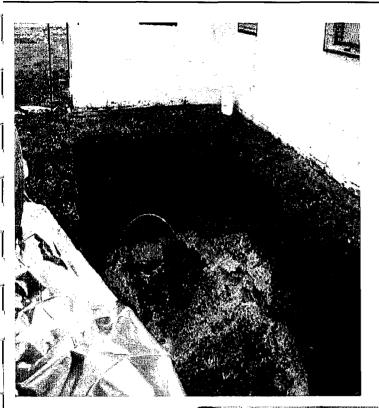
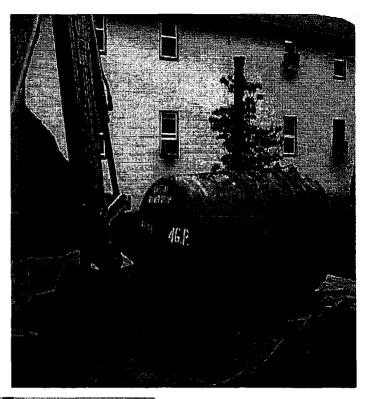
PHOTOGRAPHIC LOG

The tank was transported to Marpal Disposal Company, Inc. See Appendix D for a copy of the UST disposal certificate and Appendix F for photographs of the UST. The transportation of the UST was in compliance with all applicable regulations and laws.
