**U.S. Army Corps of Engineers  
Philadelphia District**

***Volume II - Building Reports for a  
Comprehensive Asbestos  
Survey in Various Buildings at  
Fort Monmouth, New Jersey***

**February 1992**

Roy F. Weston, Inc.  
West Chester,  
Pennsylvania 19380

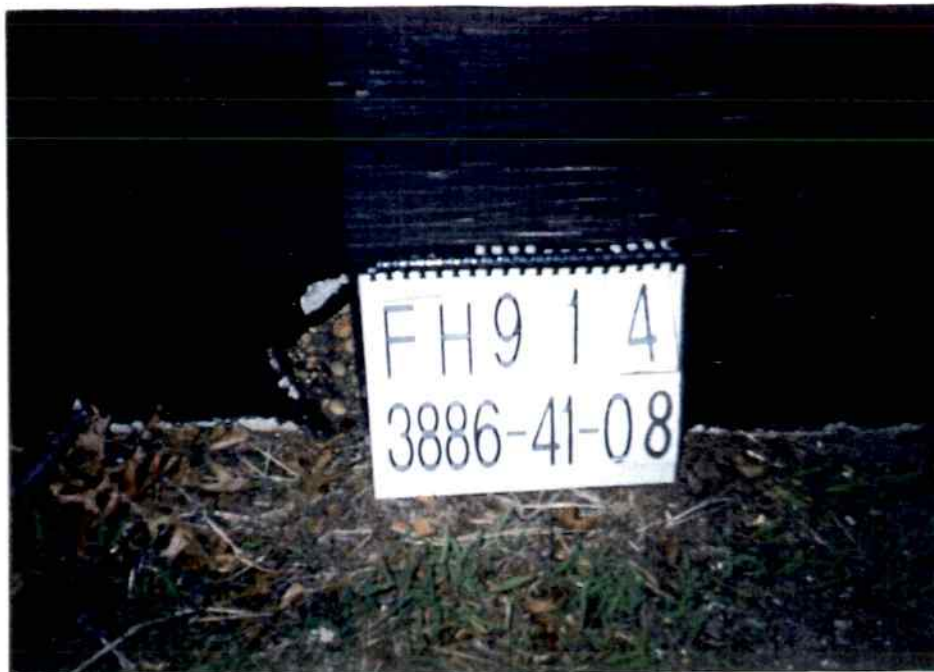
BLDG. 673

EXTERIOR WALL: (SAMPLE FH914) GRAY TRANSITE  
PANEL BOARD TESTED POSITIVE.

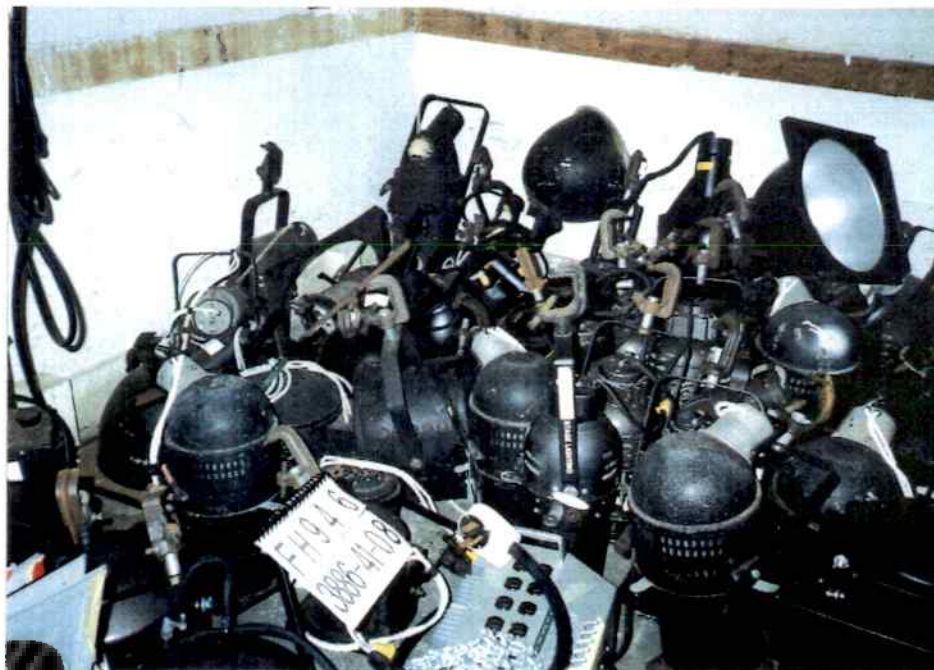
BLDG. 673

FIRST FLOOR: (SAMPLE FH946) WHITE ELECTRICAL  
LAMP WIRE TESTED POSITIVE.

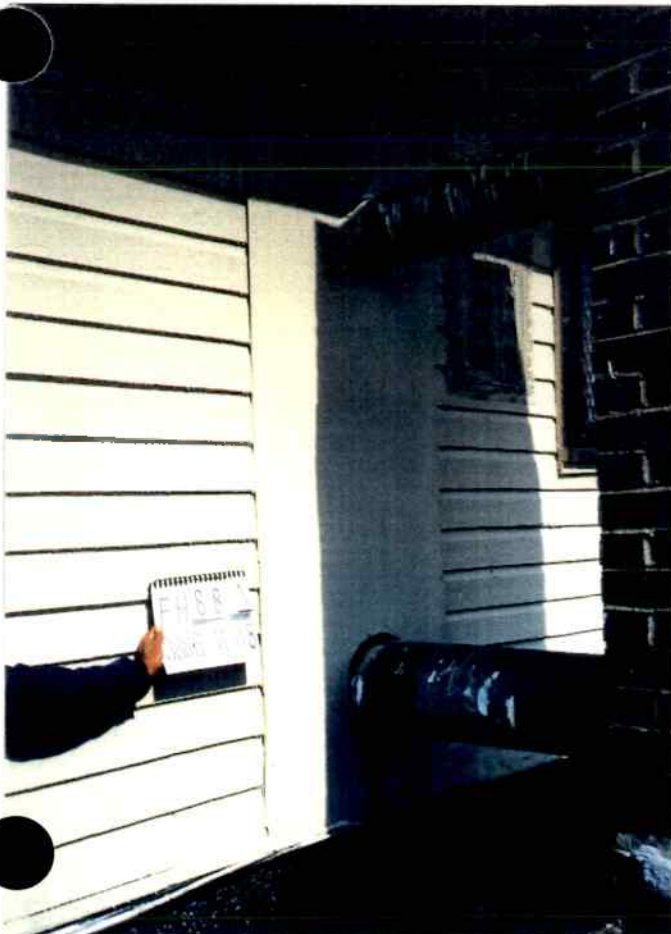
BLDG. 682

HEATER ROOM EXTERIOR WALL:  
(SAMPLE FH881) GRAY TRANSITE  
PANEL TESTED POSITIVE.

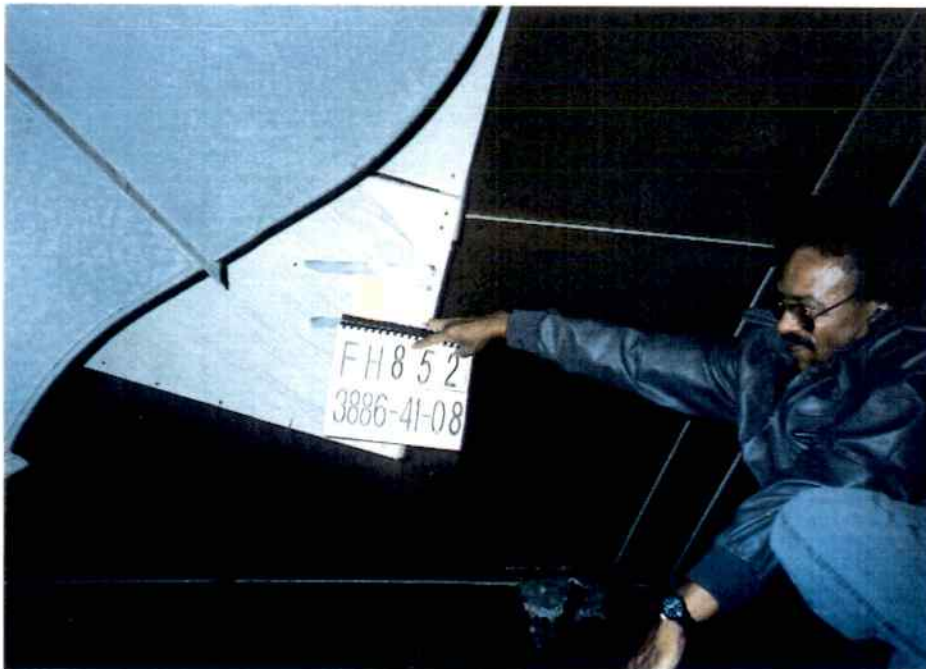
BLDG. 707

HEATER ROOM: (SAMPLE FH852) WHITE TRANSITE  
PANELBOARD TESTED POSITIVE.

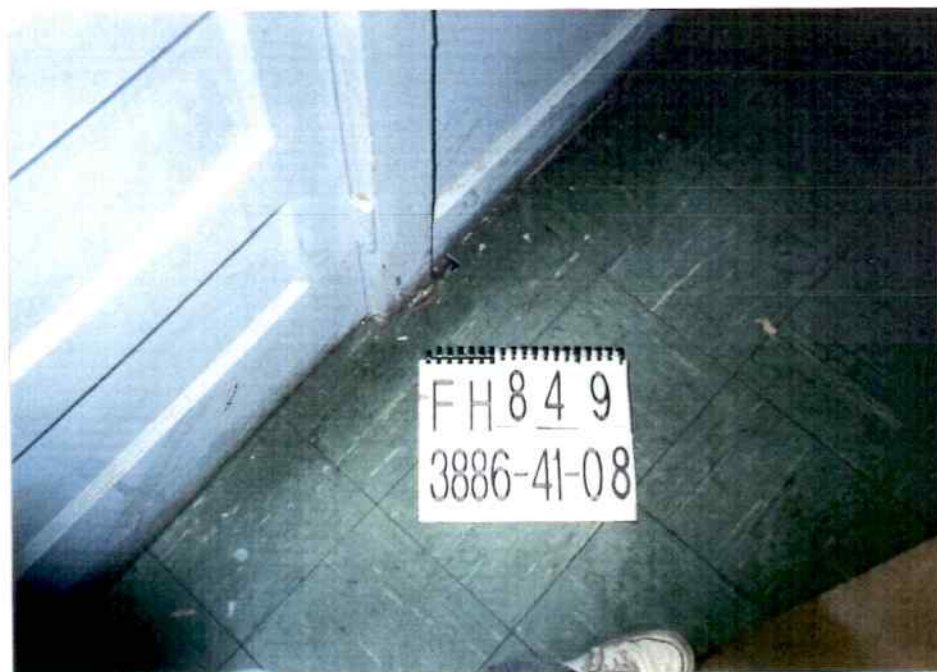
BLDG. 707

RESTROOM: (SAMPLE FH849) GREEN 9" X 9"  
FLOOR TILE TESTED POSITIVE.

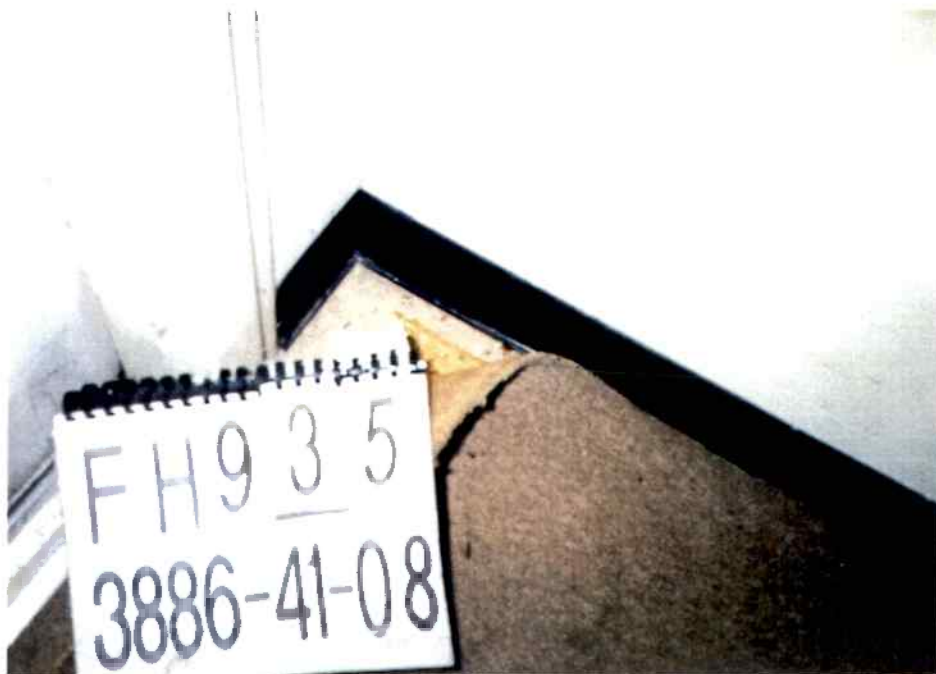
BLDG. 746

OFFICES 101 AND 102: (SAMPLE FH935) TAN 1' X 1' FLOOR TILE TESTED POSITIVE. THIS TAN 1' X 1' FLOOR TILE IS ALSO PRESENT IN GENERAL OFFICE 103 AND WOMEN'S LOUNGE 104.

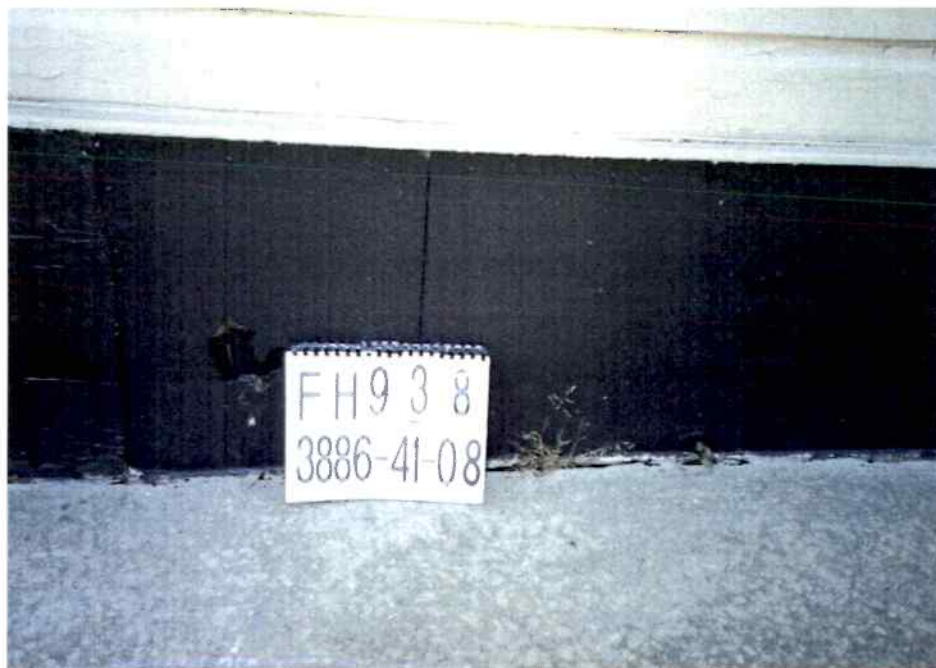
BLDG. 746

EXTERIOR WALLS: (SAMPLE FH938) GRAY TRANSITE PANEL TESTED POSITIVE.

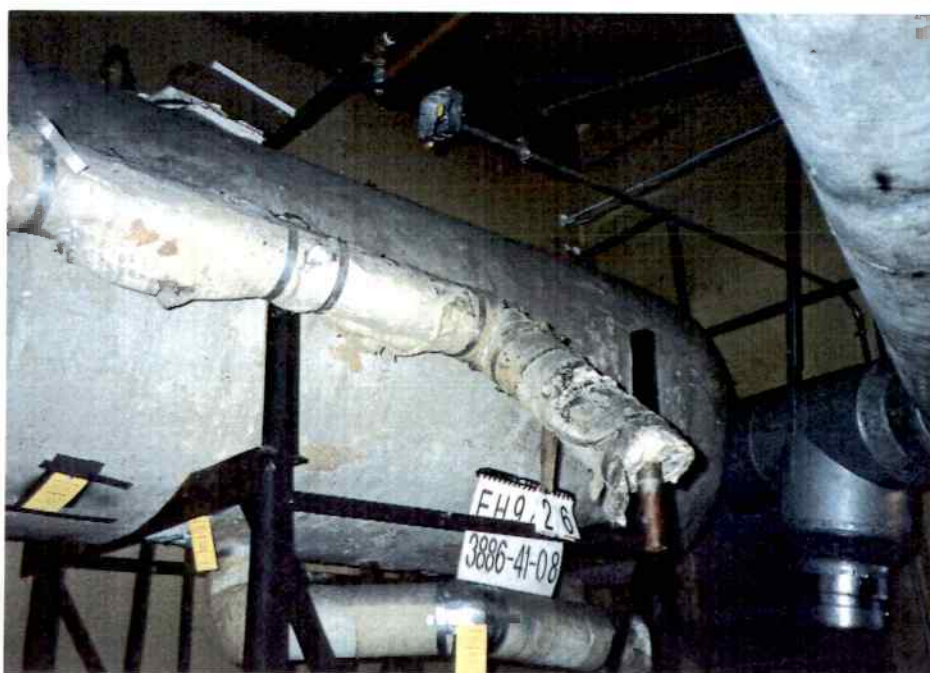
BLDG. 800

BOILER ROOM: (SAMPLE FH926) GRAY TANK INSULATION TESTED POSITIVE.

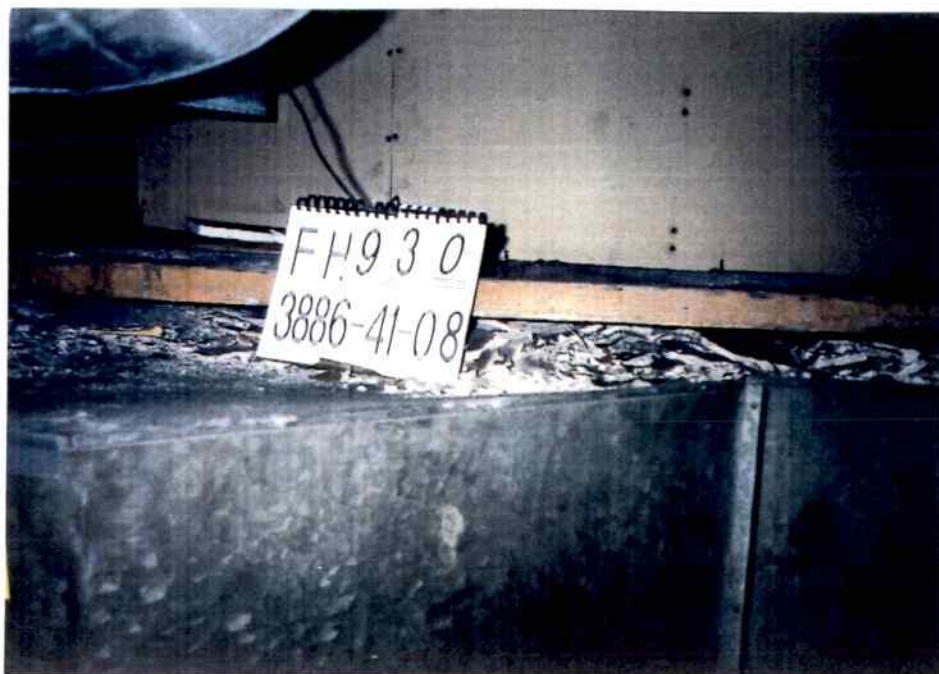
BLDG. 800

BOILER ROOM: (SAMPLE FH930) GRAY DEBRIS  
TESTED POSITIVE.

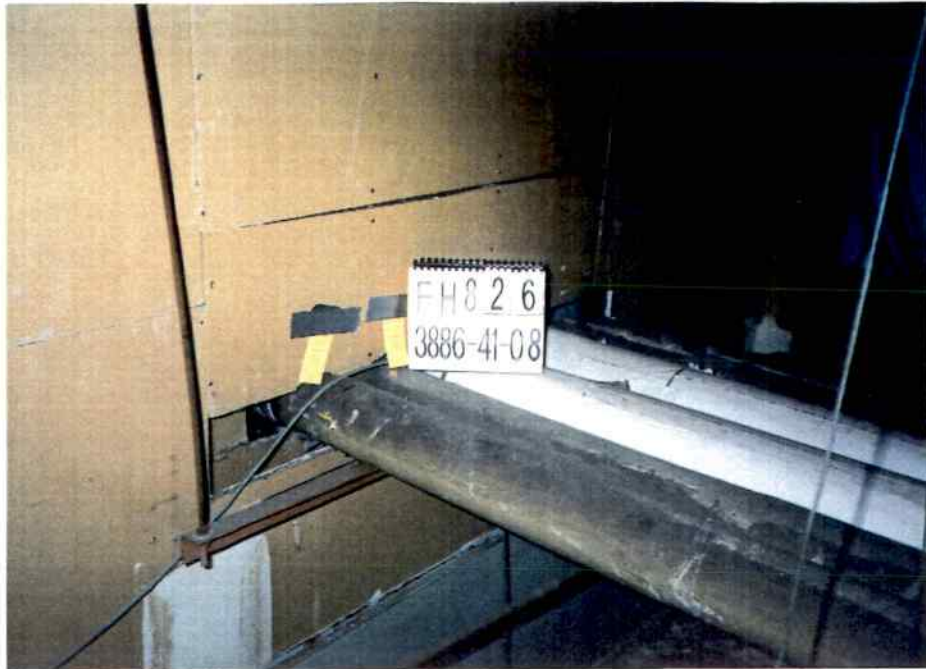
BLDG. 1004

BETWEEN RECEIVING AND BOILER ROOM: (SAMPLES FH826 AND FH827) WHITE 4" TO 8" PIPE RUN INSULATION TESTED POSITIVE.

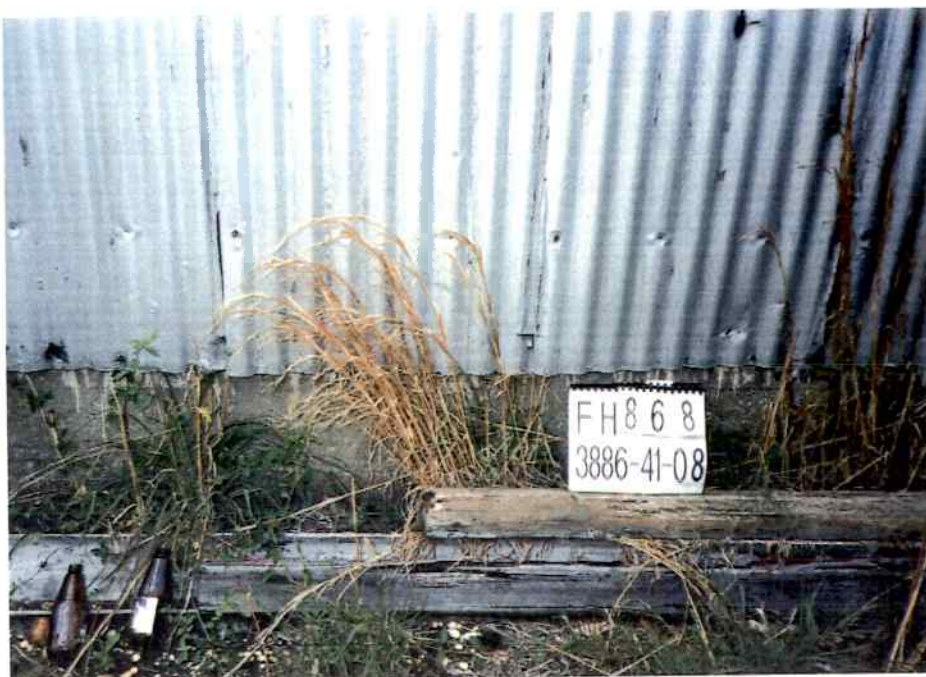
BLDG. 9352

EXTERIOR WALL: (SAMPLES FH868 AND FH869)  
BROWN BUILDING STRIPS TESTED POSTIVE.

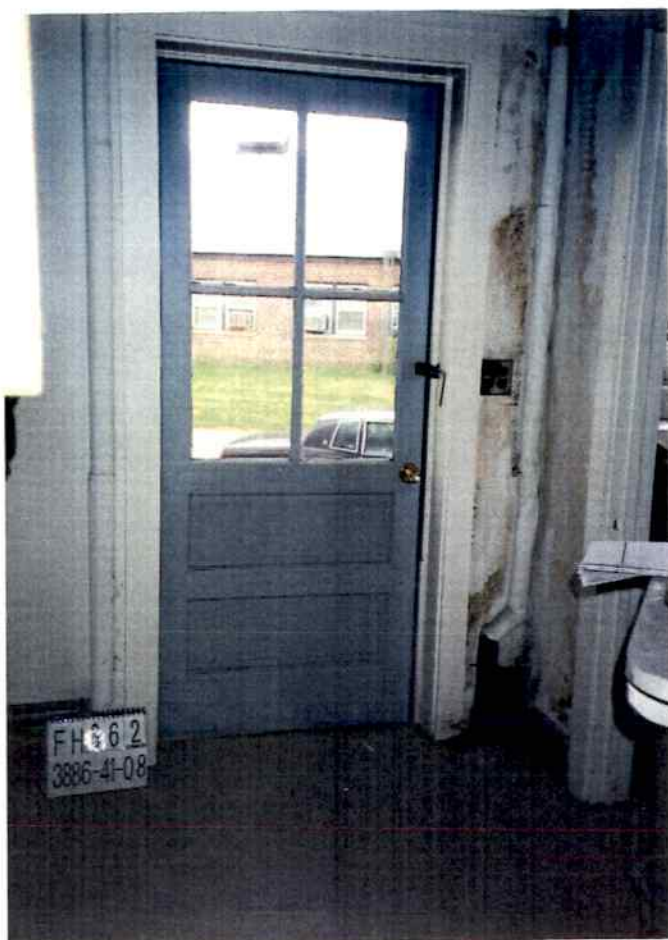
BLDG. 9392

BOILER ROOM: (SAMPLE FH865 AND FH866) TRANSITE  
PANELS TESTED POSITIVE.

- **Building 9392's paint shop and exterior walls qualify for the Army Asbestos Deficiency Abatement Project.**
- **Asbestos-containing floor tile and transite panel should be labeled under the O&M Program.**
